AIRWORTHINESS BULLETIN

Aircraft Circuit Breaker Maintenance &
Operation

AWB 24-011 **Issue :** 1
Date : 27 April 2016

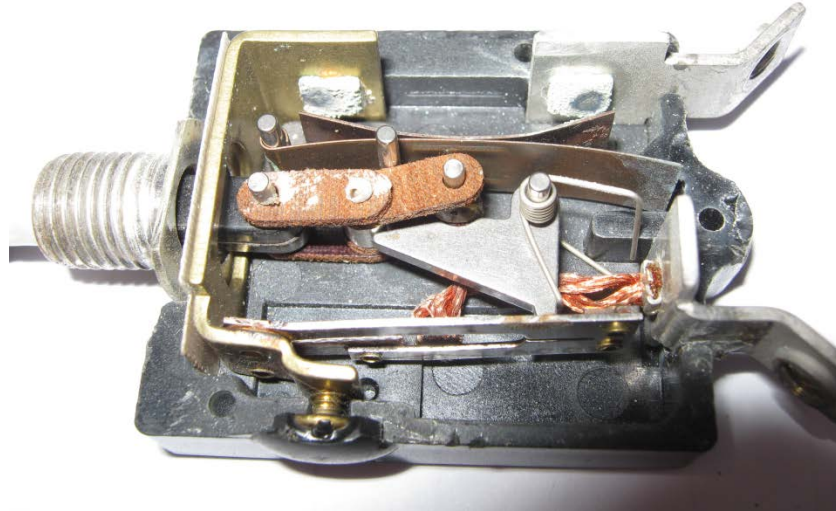
Figure 2 - Corroded contacts

Corroded contacts have been known to cause high resistance connections (see Figure 2). This CB was used to power AC inverter in a Piper 31-350 aircraft. The high resistance resulted in strong burning electrical smell and smoke in the flight compartment. This causes low voltage delivery to the equipment and heating at high resistance connections which can result in a fire in high ampere loads. The output voltage had reduced from approximately 27VDC to 6VDC as a result of the corrosion. In extreme cases the contacts have been known to weld together preventing the CB from tripping.

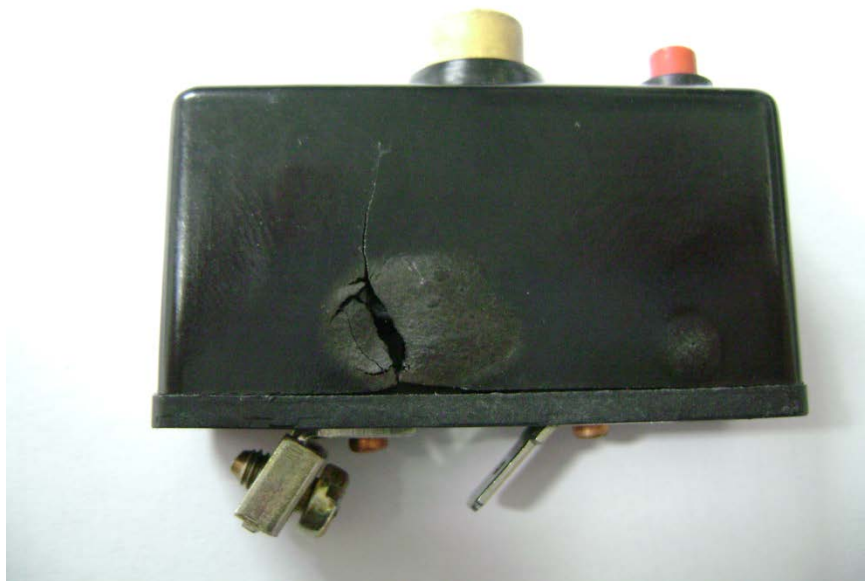
Figure 3 - Internal short

A Socata TB10 Tobago used for flight training, had a failure with CB part number ZOO.N7173141105, that was used in the Taxi light circuit had an internal short circuit see (Figure 3). Pilot reported smoke in cabin and electrical burning smell. High hours were suspected as the contributing factor. These CBs are push-reset and they cannot perform a deliberate circuit isolation function.

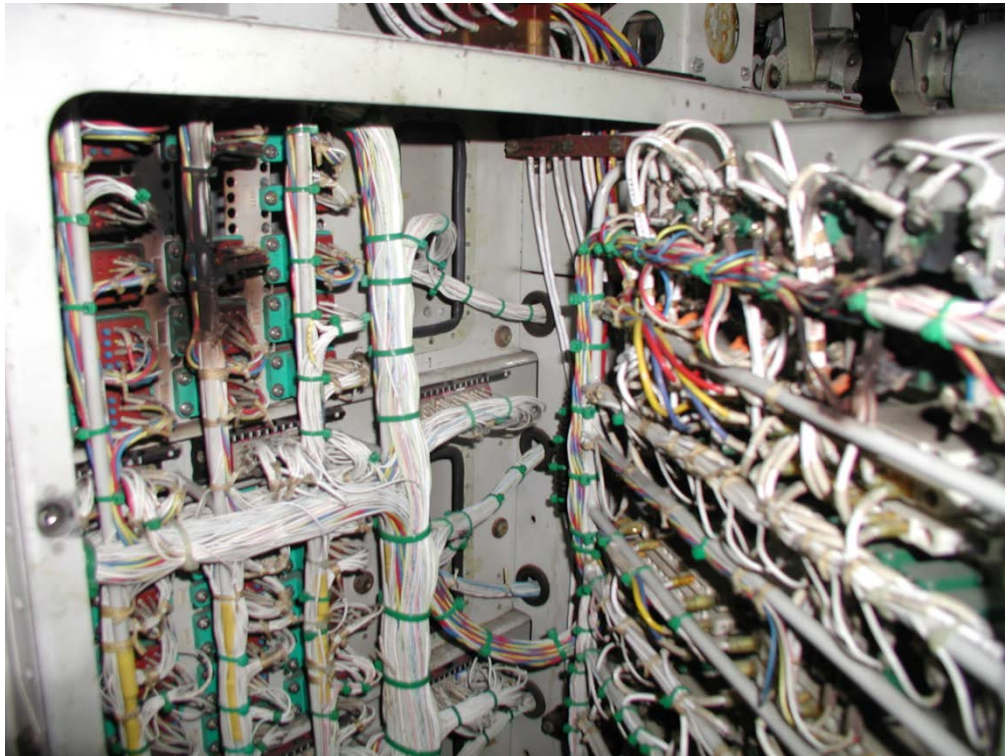
Figure 4 – Burnt wiring and 3 phase CB for windshield heat

In the case below in Figure 4, three-phase CB part number 6TC25, fitted in a BAe 146-100 that supplied power to windshield heat circuits, had failed causing damage to wiring and terminals. Investigation into the cause of overheating has identified a possible age related deterioration of the units. This problem was the subject of CASA [AD/BAe 146/124](#).

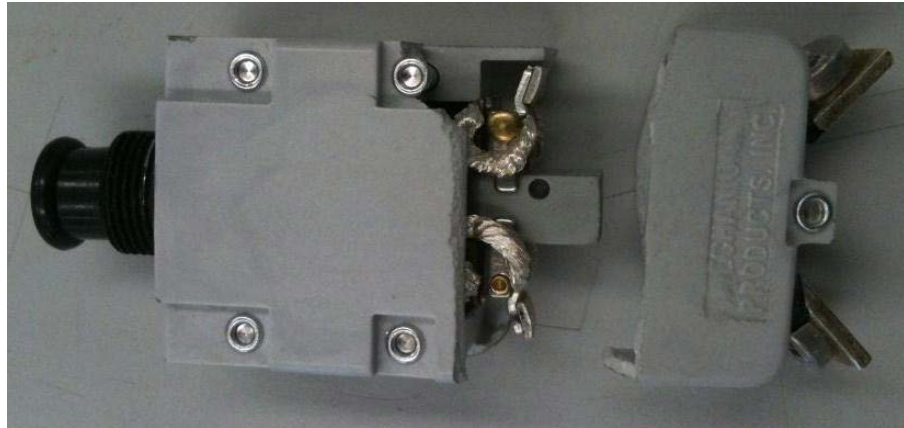
Figure 5 – Propeller Auxiliary feather CB damaged by placement on panel

In the CB shown in Figure 5, the problem was caused by the position of the CB on the panel fitted to a Bombardier DHC-8402. This CB for the propeller auxiliary feather power is located on the most forward position on the panel. The damage occurred when the associated panel was opened for maintenance, the CB caught on the structure. This could have been a major problem as there was no way to tell there was a problem if the need to use the Aux Feather controls in flight was required. CBs that are improperly placed are prone to damage.

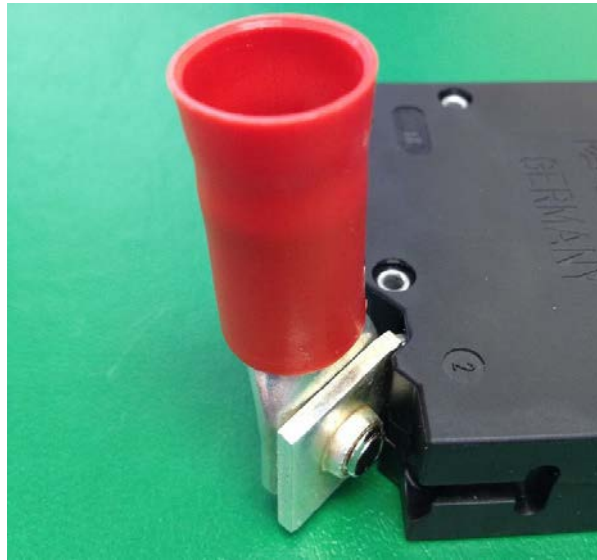
Figure 6 - Improperly crimped CB fitted to emergency medical equipment

In the difficulty reported in Figure 6, the CB part number 452K14LN2, the power wire had not been correctly crimped. This CB was fitted to emergency medical equipment in a Pilatus PC12. This could cause intermittent arcing or sparking of wiring with associated fires and possible loss of patient life in service. For further information on crimping see the current applicable maintenance data on standard wiring repairs or in the absence of this information see [Chapter 6](#) of AC 21.99.

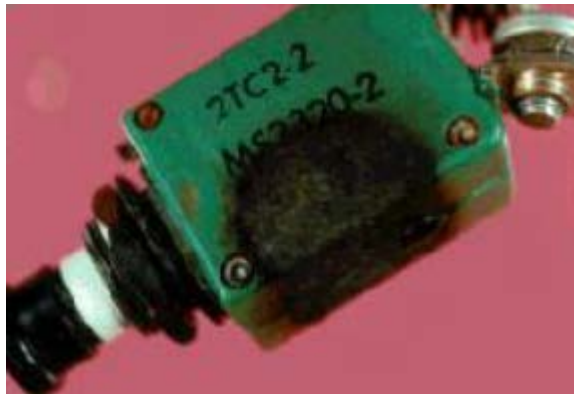
Figure 7 - Heat damaged CB

There are risks associated with inappropriate resetting of tripped CB's see Figure 7. CASA recommends exercising caution in resetting tripped CB's and adhering to general safety practices.

Resetting a tripped CB is often thought to have no adverse results. However, a review of Service Difficulty Reports involving tripped and reset CB's reveals that the opposite is sometimes true. Smoke, burned wires, electrical odours, arcing, and loss of related aircraft systems have been reported as a result of resetting tripped CB's. These findings are supported by other National Airworthiness Authorities.

Do not reset a tripped CB in flight unless allowed in the approved operating manual used by the flight crew. A pilot in command can reset a CB if they believe that a catastrophic event could occur if it is not reset.

Do not reset a circuit breaker unless the nature of the fault is positively confirmed and no further risks will occur. CASA recommends following OEM procedures for resetting CBs. In the absence of this information, the guidance in this AWB can assist in the development of procedures and/or approved manuals.

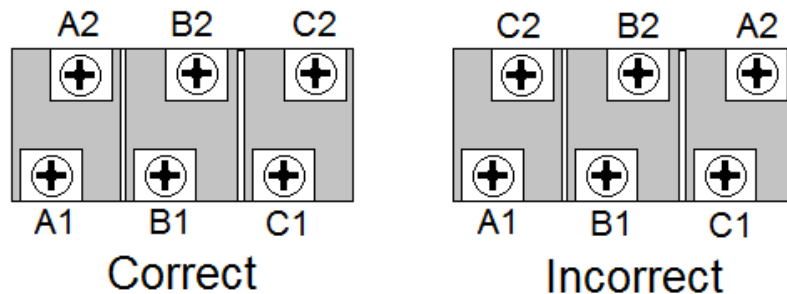
Figure 8 - Faulty circuit breaker phase identification

4330 series CBs manufactured by Mechanical Products Inc. were previously found with manufacturing defects caused during labelling of the terminals (see Figure 8). Investigation by the supplier of this item revealed a number of similar anomalies over a range of these products. These issues have not been an issue recently; however stocks may exist that have not been removed from potentially entering service.

The faulty CB's were found included as part of service bulletin kit supplied by Bombardier. Bombardier produced notification to inspect the circuit breakers prior to use and to inspect those in service.

The faulty C/B had the phasing identifications interposed on the line and load sides of the C/B see Figure 88.

CASA recommends that all aircraft Registered Operators and Maintenance Organisations, quarantine all affected stock as per Figure 8 and Figure 9 of this AWB.

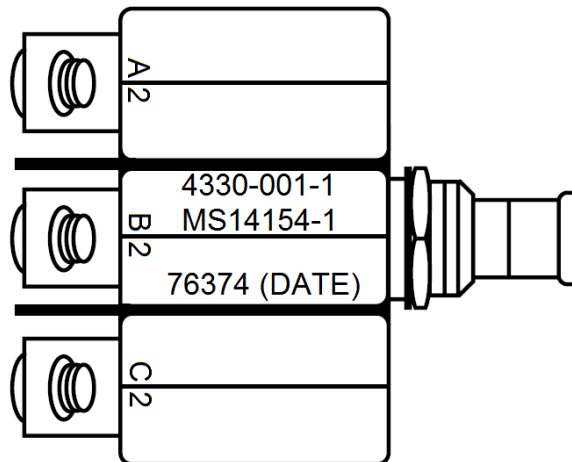
Figure 9 - Product and date code identification

On the side of the breaker stamped with the part number you will find the date code see Figure 9, it is printed immediately after the "U.S. Government Cage Code" 76374.

The first two digits are the year of manufacture; the second two digits are the week of manufacturer. So "0046" indicates the breaker was manufactured in the year 2000, in week forty-six. The faulty products of which Mechanical Products is aware of are limited to week 46.

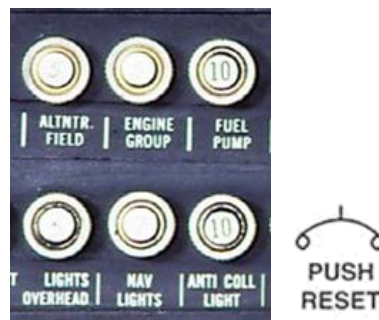
Figure 10 - Push-reset CB

Push-reset CBs cannot cycle due to their design see Figure 10; therefore it is difficult to test these CBs in-situ and replacement is considered appropriate after a period of time in service.

In the absence of hard replacement times from the OEM it is recommended to replace the CBs. FAA has put out [Special Airworthiness Information Bulletin CE-13-22](#) which recommends discarding CBs every 2000 hours.
