AIRWORTHINESS BULLETIN

Aircraft Lead Acid Main Battery Failures

AWB 24-008 **Issue :** 1
Date : 16 September 2013

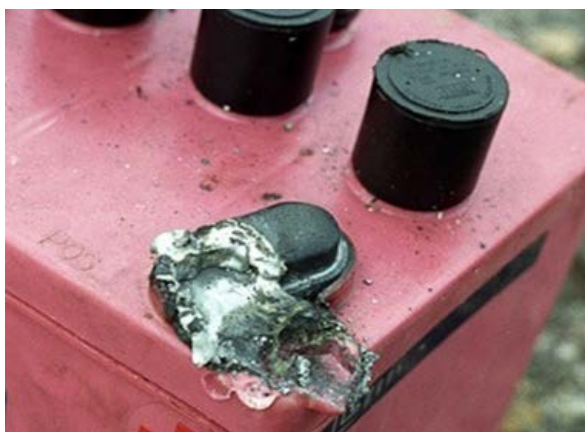
Figure 1

Battery terminal separation failures (pictured) are typically caused by excessive heat resulting from high current draw during engine starter motor cranking the engine and high resistance between the battery terminal post and the aircraft main system supply terminal.

High battery terminal resistance can be caused by inadequately torqued battery terminal attaching hardware, or tight terminal connections but having a layer of corrosion build-up between the contact faces of the battery terminal and the aircraft main system supply terminals.

1. Remove the battery from the aircraft for servicing (usually about every twelve months) and check that the aircraft battery compartment is serviceable, secure and clean, has adequate anti-corrosive coatings and that the drain and vent tubes are secure, clear and correctly oriented.
2. Any time the battery is removed, consider rinsing the empty battery compartment (and lid) with a water and baking soda solution to neutralise any acid and to check battery compartment drain function.
3. Check that the battery structural tie-down arrangement is serviceable.
4. Inspect the battery case for deterioration, cell caps for function and cells for charge state. If the battery terminals are damaged, loose or deformed, the battery should not be installed.

CAUTION. Do not over tighten the terminal wing nut. Over tightening may result in deformation of the terminal post material which will eventually result in the terminal post becoming loose in service.

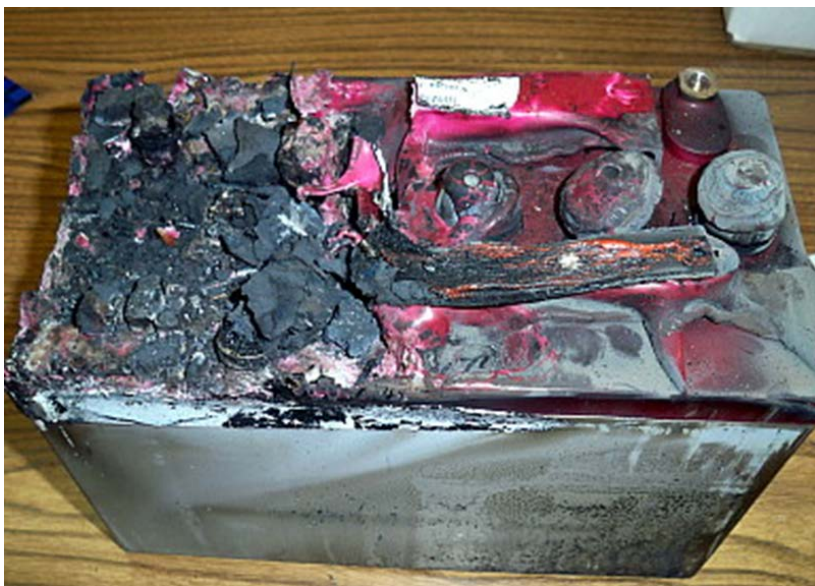
Figure 2

During a period of high current draw, typically during extended engine starting attempts on the ground, explosive mixtures of hydrogen gas accumulate in the aircraft battery compartment. Should a battery terminal overheat to the point of melting, the spark generated as it separates from the battery can ignite the hydrogen and oxygen gas mixture given off by the discharging battery and has resulted in an explosion and fire on more than once occasion. (See Figure 2).

Because the typical simple small aircraft battery compartment venting system works best during flight, explosive and noxious mixtures of hydrogen gas can accumulate in the battery box during both starting and charging on the ground, when there is insufficient air circulation in the aircraft battery compartment. For this and many other reasons, battery manufacturers generally advise against "jump" starting an aircraft using an alternate external battery power source when the installed aircraft battery has been depleted. Such action also allows the aircraft alternator to immediately deliver a high charge rate to the depleted battery, which will occur even at idle RPM on the ground following a "jump" start and can damage the battery.

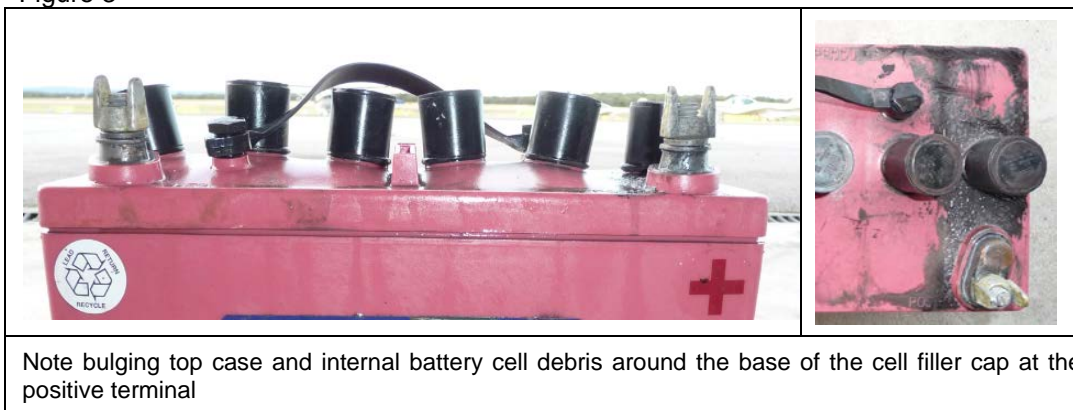
Figure 3

Some batteries have failed with sections of the top part of the case bulging upward, due to a combination of overheating, low electrolyte levels, internal failure and pressure build-up inside the battery case, due to the rubber tip seal in the cell cap failing to re-open. (See Figure 3). Aircraft battery cell caps allow the individual cells to vent gasses and also have some form of “non-spill” arrangement inside the cap to prevent electrolyte leakage from the cell during turbulence and unusual manoeuvres. A popular version of non-spill cap uses an inverted hollow “U” shaped lead weight which pulls a rubber tip into the vent hole and seals the cell when the battery is in unbalanced flight. (See Figure 4).

Whenever servicing the battery, ensure correct level of electrolyte in each cell and check that the self-sealing function in each cell top is free (rattles) and that the rubber sealing tip drops clear of the vent hole when the top is held near vertical.
