Aircraft Parts And Development (CALL AIR)  
A-9 Series - Main Undercarriage Failures.

**AWB** 32-025 **Issue :** 1  
**Date :** 10 March 2016

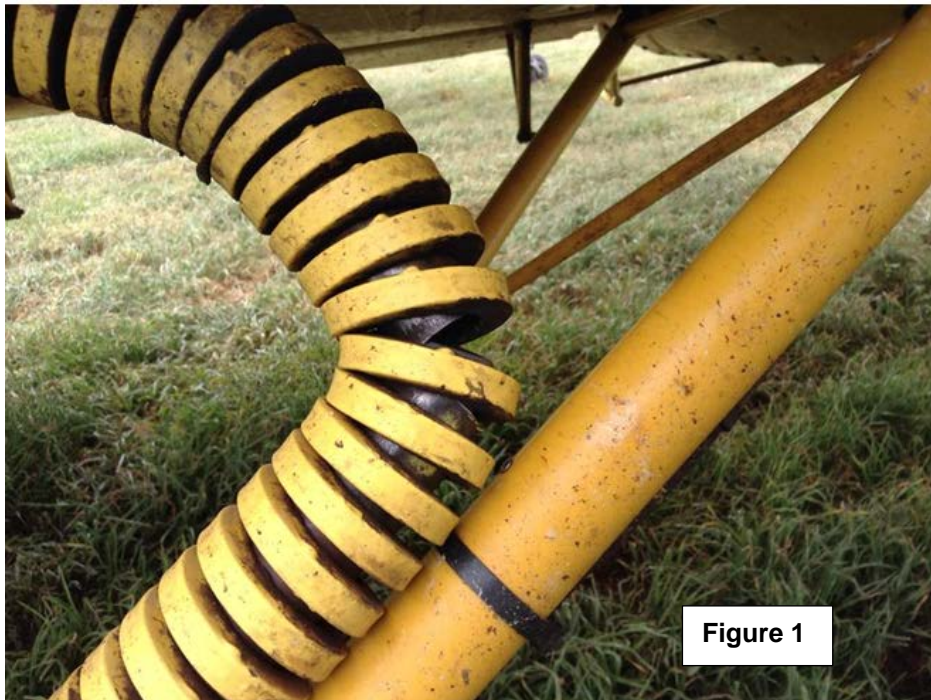
Figure 1

The main undercarriage failure (Figure 1) was due to the inside surface of the main compression spring of the oleo assembly sliding on and wearing away the wall of internal tube, to the point of failure.

Previous technical assessments of identical failures came to the conclusion that adverse wear on the internal structural tube could not be detected using the manufacturer's maintenance data, or by the requirements of CASA Schedule 5.

In order to prevent in service failures, CASA recommends that operators consider implementing a landing cycles based inspection interval co-ordinated with the normal periodic inspection in order to detect wear before it becomes critical, by:

1. Dismantling the main undercarriage legs at the next scheduled periodic inspection to measure the wear on the internal structural tube, and
2. Replace the tube if wear is at or below the manufacturer's limit, or if found serviceable;
3. Reinspect the tube at a future scheduled periodic inspection, determined by the amount of wear found on the internal structural tube at the number of landings at the last inspection.
