1. All Light Aircraft

AIRWORTHINESS BULLETIN

Assessment of Hail Damage

AWB 51-010 **Issue :** 1
Date : 7 March 2016

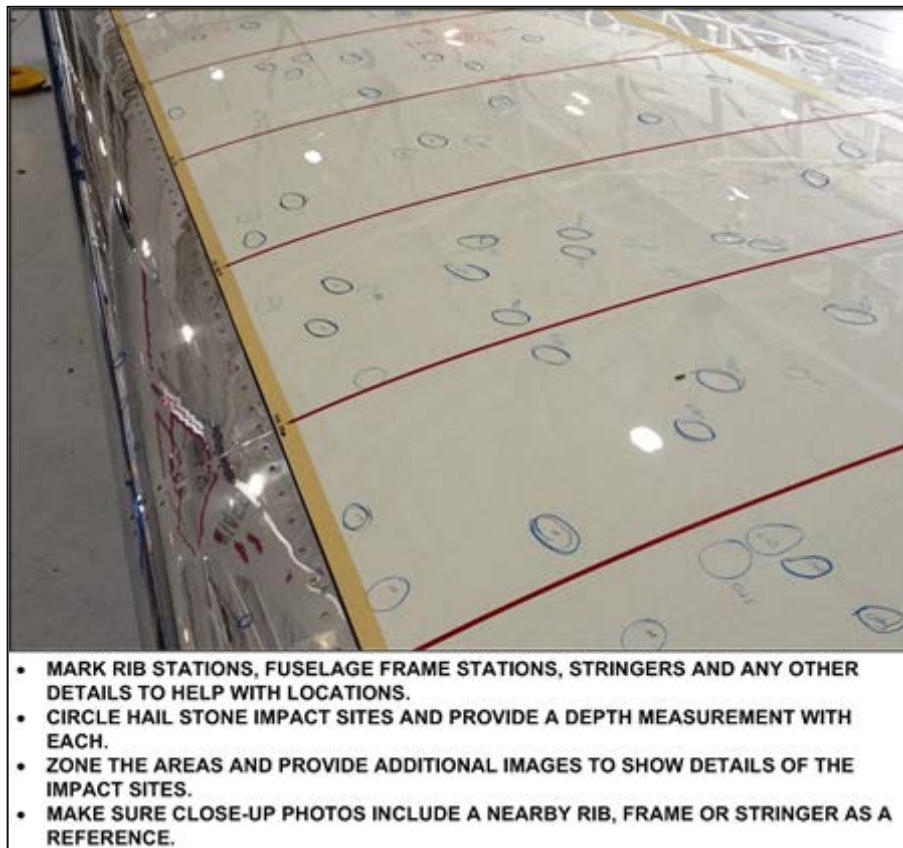
Figure 1

- 1) Record of damage – this can be in the form of a 'damage map' depicting location and depth of damage. This can be time consuming, but removes any doubt of future damage issues. Alternatively physically marking the aircraft and taking photos may be acceptable (see Figure 1).

Cessna Hail Assessment Guidance
