Beechcraft 19, 23 and 24 Series
Stabilator Hinge – Fastener Shearing

AWB 27-017 **Issue** : 1
Date : 5 September 2013

AIRWORTHINESS BULLETIN

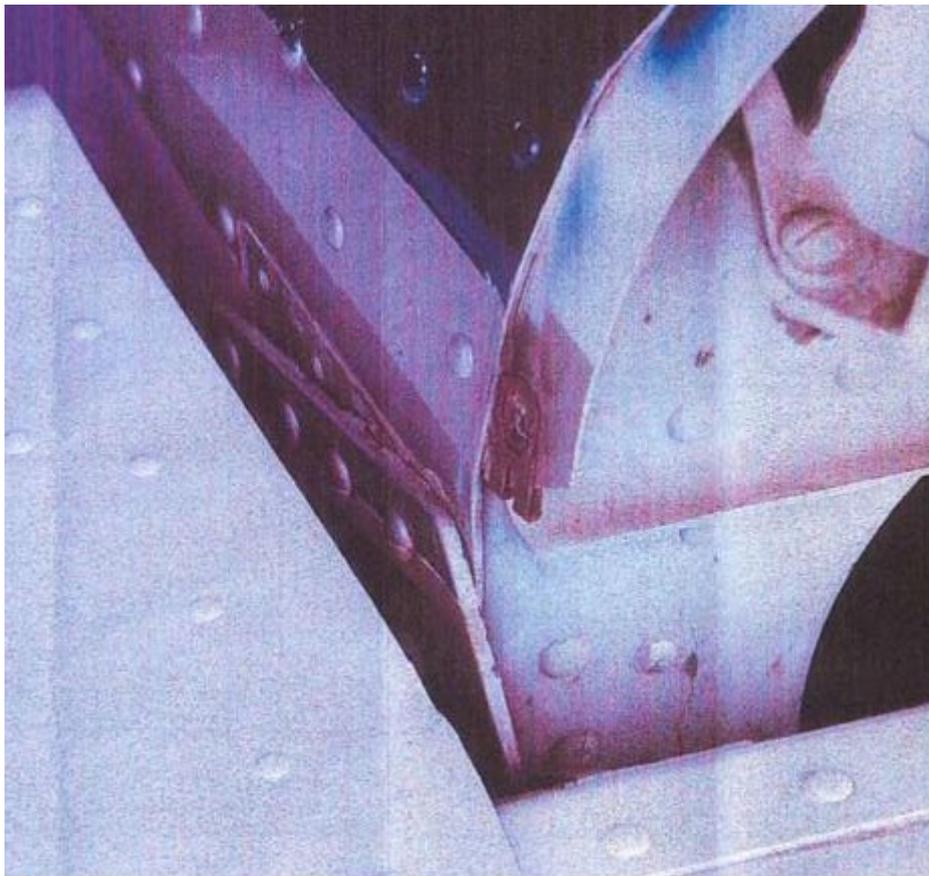
Figure 1

During a very light tail strike during a “ground loop” event, all of the attachment rivets sheared in each attachment bracket on each side of the fuselage allowing the brackets to pivot around the AN525–10 Screw. See Figure 1. There was no other damage.

The rivets had failed, but no rivet heads were missing and apparently none of the accompanying signs of impending failure mentioned in Beech SB 2182 were evident. The stabilator was essentially attached to the aircraft by only two AN525-10 screws.

It now appears that the rivet strength may be severely compromised by undetected corrosion on the shanks of the aluminium rivets, in a narrow zone between the steel plate of the stabilator hinge block and the supporting aluminium fuselage structure, allowing the heads of the rivets to stay in place.

plate to the fuselage may also suffer a latent failure due to undetected corrosion, without the signature indication of rivet heads falling off.

The strength of the stabilator hinge attachment to the fuselage may be severely compromised - at the point of failure - without exhibiting any of the signs of impending failure mentioned in CASA AD/BEECH 23/44 and Beech SB 2182.

1. Replacing all the stabilator hinge fasteners (rivets) which have been in place for 15 years or more, even though they may appear serviceable when inspected in accordance with the requirements of Beech SB 2182.
2. Inspecting the rear bulkhead structure and stabilator attachment to detect cracking bulkhead flanges and failing rivets following any nose wheel shimmy, heavy landing or flight through turbulence event.

NOTE: It is reported that working or failing rivets may also be detected by placing a finger tip on the junction between the stabilator attachment plate and the skin of the aircraft and feeling for any relative motion between the two while applying up and down pressure on the stabilator attachment plates.
