Beechcraft Rudder Brake Pedal Pivot Hole
Wear

AWB 27-015 **Issue :** 1
Date : 26 September 2012

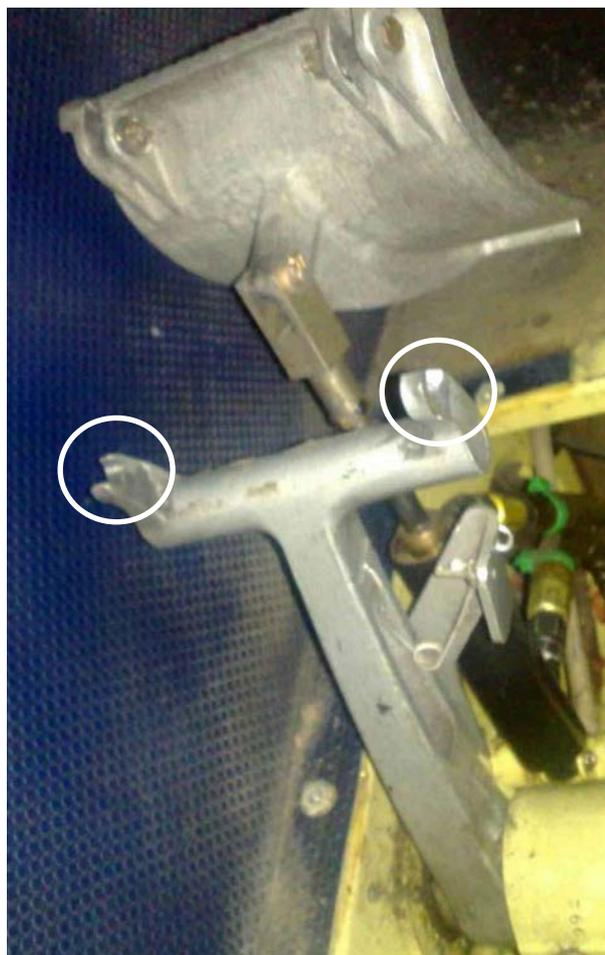
CASA has identified a number of Service Difficulty Reports (SDRs) that have described wear and sometimes failure, of the rudder pedal arm at the brake pedal pivot holes as shown in figure 1.

Figure 1: Rudder pedal arm with failed brake pedal pivot holes

- Check their aircraft records to determine whether rudder pedal arm P/N 50-524326 (all dash numbers) or P/N 002-524020 (all dash numbers) are installed.
- If either of the part numbers are installed, consult the aircraft's maintenance manual for inspection criteria and limitations of the brake pedal pivot holes.
- If no inspection instructions are provided, consult your local Beechcraft representative for appropriate guidance.
