Bell 206 Main Rotor Blade Cracking

AWB 62-003 **Issue :** 1
Date : 13 November 2006

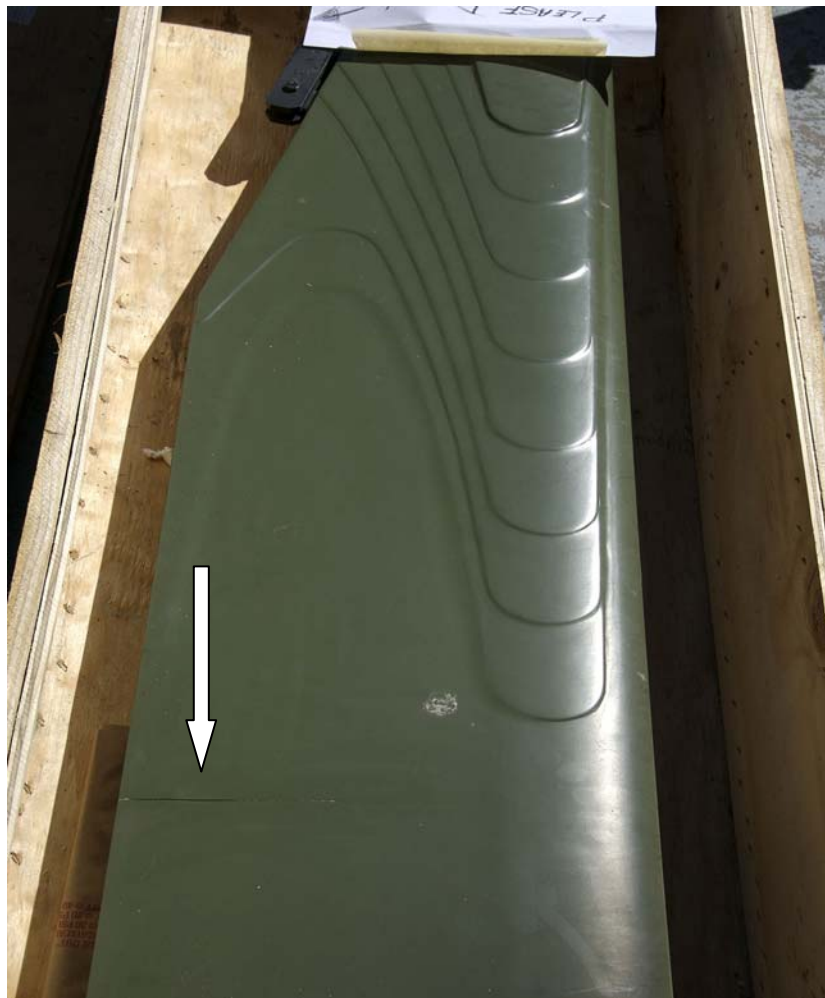
A large crack was discovered in a main rotor blade of an Australian Army Kiowa (civilian Bell 206) helicopter. The crack was running chordwise through the trailing edge of the blade and located approximately 1.5 metres from the blade root. The blade had accumulated approximately 2913 hrs TSN. See figure 1 below for crack location.

Figure 1 showing crack location

- 1) Inspect the entire upper and lower blade surface, and in particular the trailing edge, for cracks, paint damage or evidence of paint bulging caused by corrosion. Undetected corrosion could eventually result in fatigue crack initiation.
- 2) Consult relevant manufacturer's information on detection and repair of cracking or corrosion.

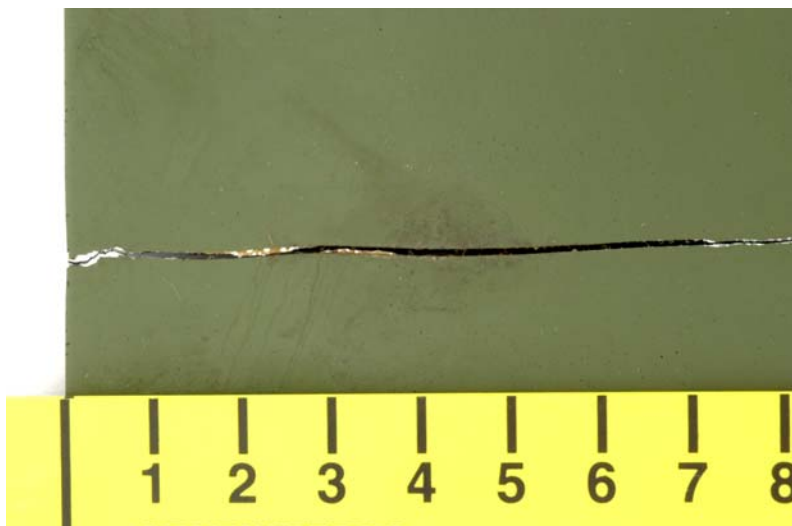
The skin crack was found to extend from the trailing edge towards the leading edge for a length of just over 200mm in both the upper and lower skins. More detailed examination of the upper skin revealed a discoloured patch of paint surrounding the crack, located approximately 45mm from the trailing edge (see figure 2 below). After sectioning of the blade, further examination of the fracture surface showed that the trailing edge spar had failed as a result of a fatigue crack, which had initiated at the forward face of the trailing edge spar (red arrow in

Figure 2 Close up of skin crack.

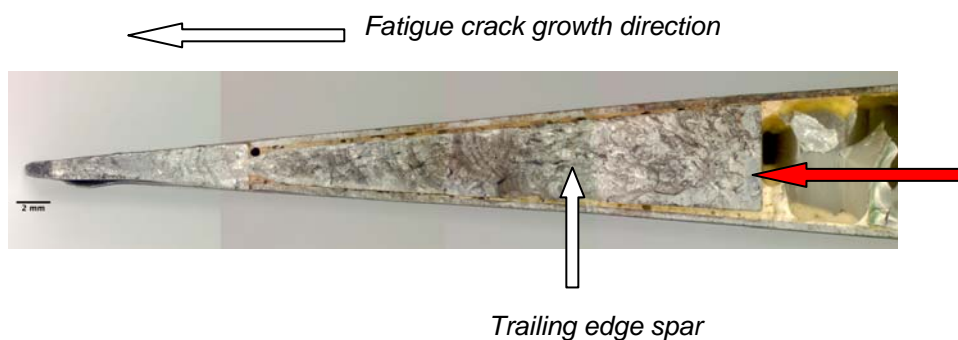
figure 3 below). The initiation point was examined and found to contain corrosion product, indicating the crack initiation was most likely due to a corrosion pit in the spar. How moisture ingress occurred to this location is not yet known.

Figure 3 fatigue crack initiation point – crack initiation point indicated by red arrow.
