Bell 206 L Tail Rotor Root End
Disbond.

AWB 64-001 **Issue :** 1
Date : 1 June 2007

Bell 206L series.

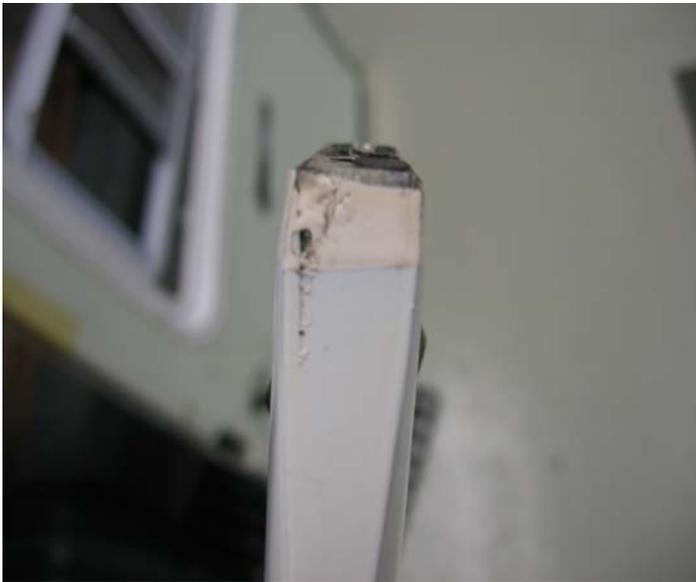
During a daily inspection, it was discovered the doubler plate had debonded at the root area on the leading edge. The end plate appeared to lack characteristic anodising. It appears that corrosion between the doubler and end plate may have caused this debonding. There have been similar reports of disbonding on high TTIS blades, this was the second occurrence of this defect on this helicopter's tail rotor blades which had been installed at manufacture. Similar defect reports note that in some cases, there is evidence of paint "touch-up" in the area.

1. Perform careful pre-flight inspections in area of the leading edge root end doubler plate, for evidence of disbonding.
2. Remove from service all blades exhibiting signs of root end doubler plate disbonding.
