BK117 Tail Rotor Flapping Hinge / Head
Attachment

AWB 64-002 Issue : 1
Date : 1 May 2012

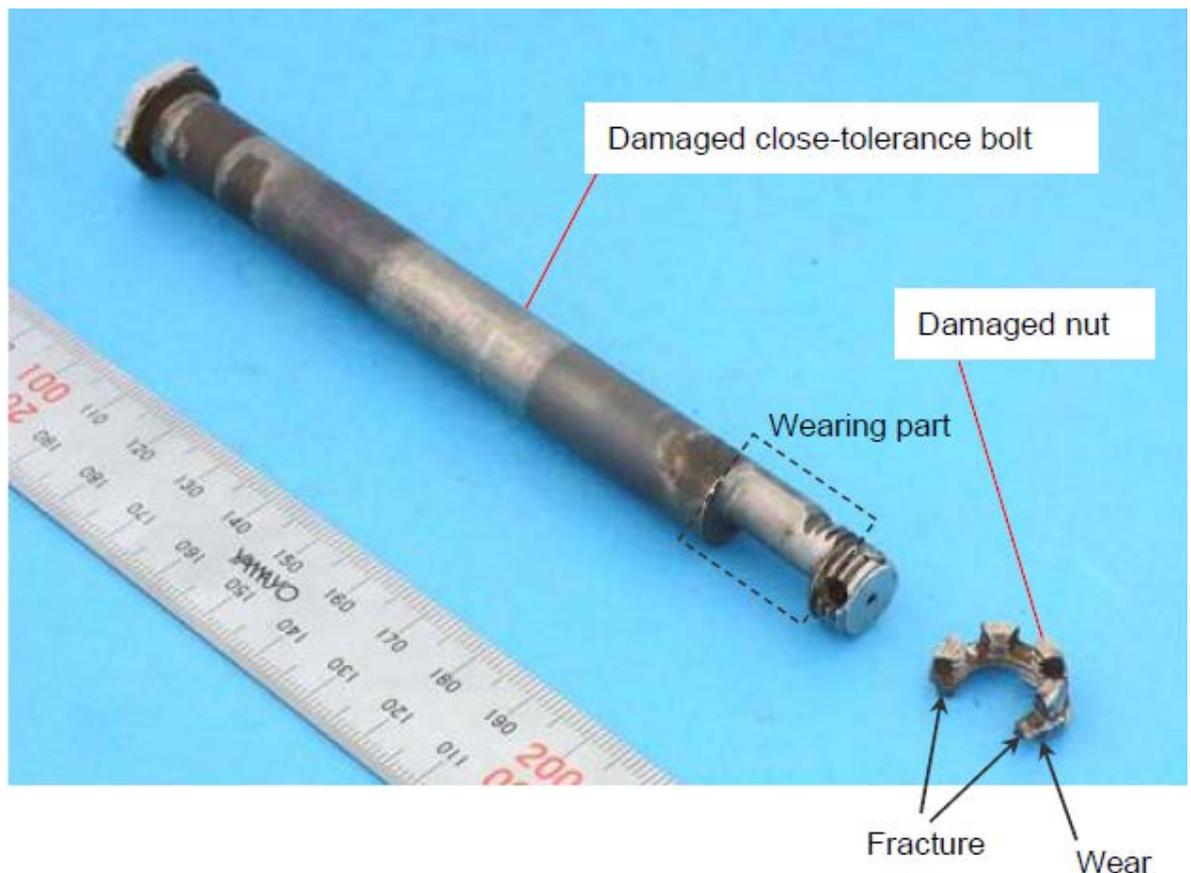
An operator of a Kawasaki BK117 noticed abnormal vibration of the tail rotor during an engine cool down cycle. A post flight inspection revealed severe wear of both the close tolerance bolt and the retaining nut.

Figure 1 - Damaged close-tolerance bolt and nut.

1. Pilots and maintenance personnel for both the Kawasaki BK117 and the Eurocopter BK117 aircraft should pay close attention to the tail rotor assembly, including the flapping hinge bolt, bearings and pitch control links during all pre-flight and periodic maintenance inspections for signs of wear.
2. Accurate dynamic balancing of the tail rotor assembly in accordance with approved data.
3. Immediately investigate any increased in-flight pedal vibration.
4. Investigate potential damage to the tail rotor gearbox bearings and gearbox housing caused by in-service vibration/ imbalance in the tail rotor assembly.
5. Immediate replacement of any bearings or shafts which exceed the tolerances in the MM/AMM.
