Airworthiness Bulletin

AWB 27-022 Issue 1 - 16 June 2025

Boeing 737 Flight Spoiler Control Cable Failures

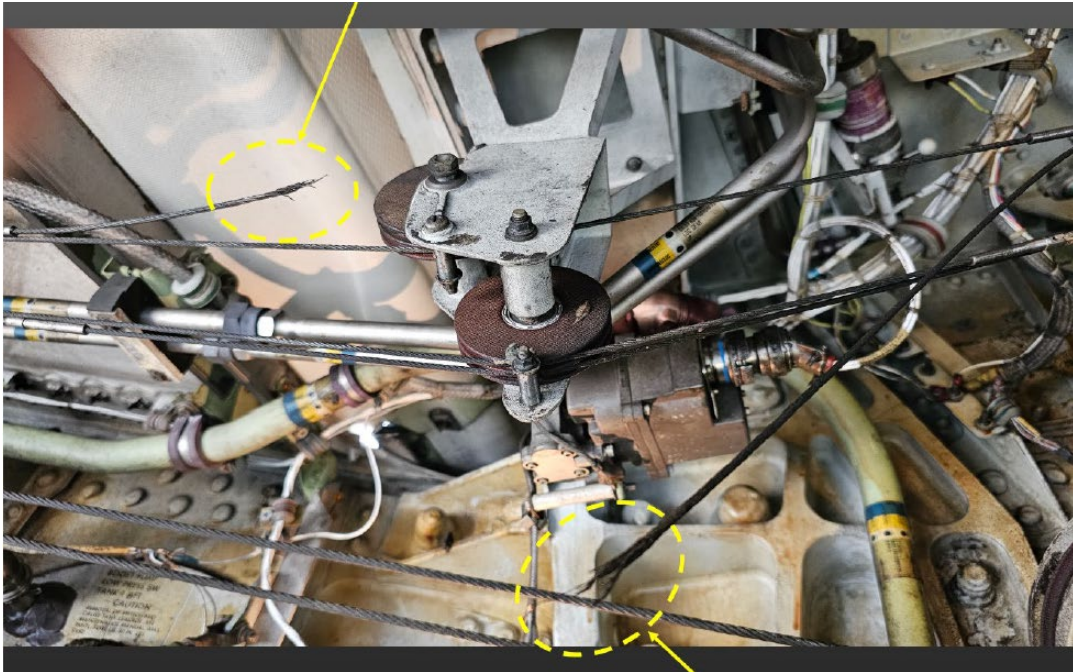
Over the past 15 years, failures of the WSA and WSB cables have occurred on multiple aircraft, across five (5) different Australian operators. Reported failure effects have included:

- uncommanded roll when speed brakes were deployed; and
- abnormal handling during commanded roll.

Figure 1. Operator-provided image of a separated spoiler cable

- Implementation of a cable discard task into the operator's AMP, relying on the OEM's guidance for determining an optimal task interval.

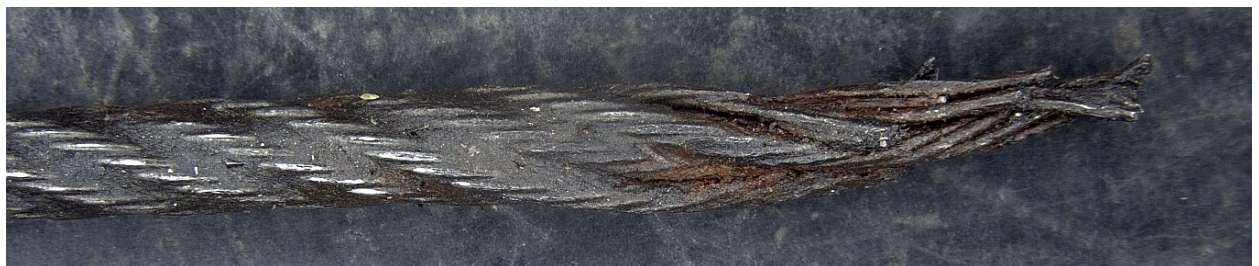
- corrosion reduces the overall cross-sectional area of the cable (see Figure 2); and
- wear is also likely to have been a common failure cause.

The WSA and WSB cables are located in the MLG wheel well (see Figure 3). Exposure to moisture and dirt kicked up from the main wheels is likely to be a contributing factor, exacerbating the corrosion and rate of wear.

Figure 2. The ATSB found substantial corrosion at the fracture site

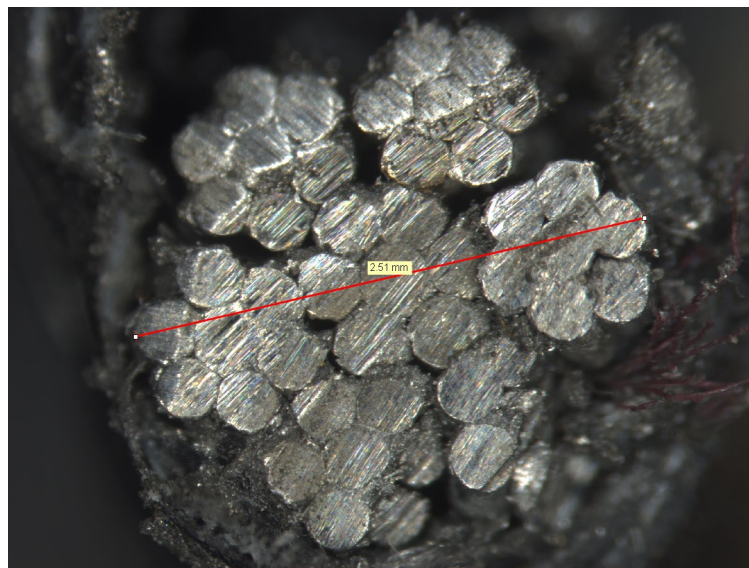
The flight spoiler control cables are carbon steel wire rope of 3/32" diameter consisting of a 7 x 7 construction (see Figure 3). Individual strands are coated with tin over zinc at production to provide corrosion resistance and lubrication. The cables are made to BMS 7-265 specifications, which require endurance testing to 35,000 test cycles in laboratory conditions.

Figure 3. Carbon steel wire rope of 7 x 7 construction
