Cessna 177 Stabilator
Balance Weight Arm - Bracket

AWB 27-014 **Issue** : 1
Date : 17 August 2012

SEB89-1
Revision 3

STABILATOR BALANCE WEIGHT ARM BRACKET INSPECTION/REPLACEMENT

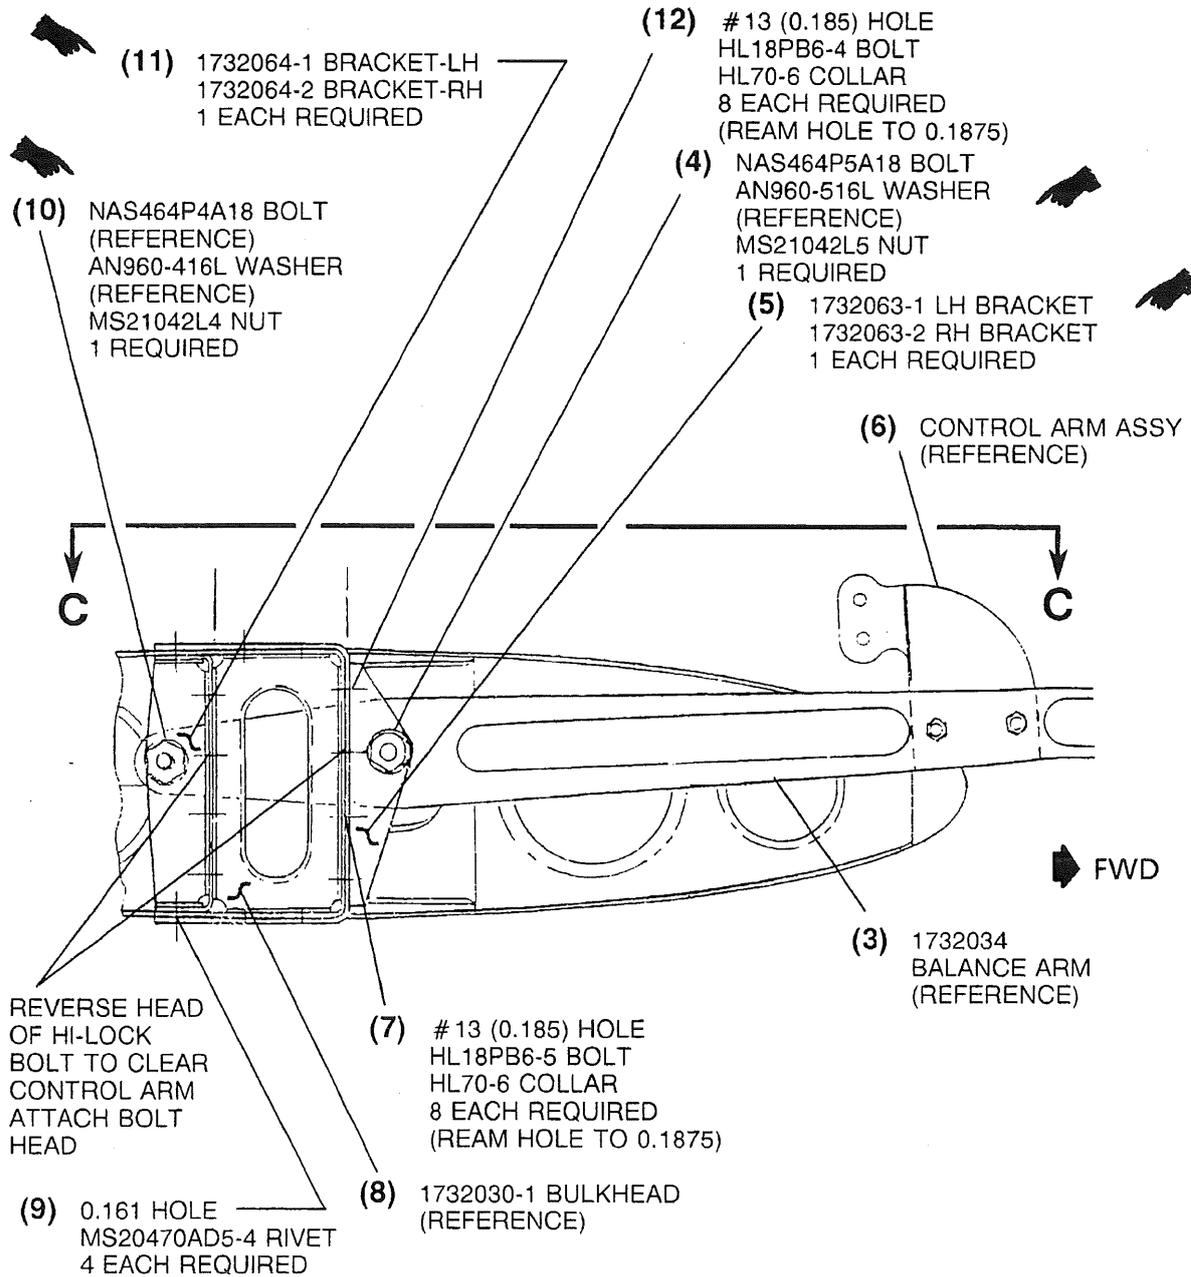
Figure 1. Stabilator Balance Weight Arm Brackets Inspection & Replacement (Sheet 2)

3. Visually inspect RH & LH brackets (5 & 11) for cracks, especially near the radius under the bolt hole. If no cracks are visible, use Eddy Current inspection to verify no small cracks have started.

2. Remove balance arm (3) from stabilator by removing bolts, washers and nuts (4 & 10), retain balance arm, bolts and washers, discard nuts (refer to Figure 1, Sheets 2 & 3).

5. If a crack or cracks are detected, proceed as follows.
 6. (Refer to Figure 1, Detail A, View B-B, C-C & D-D, Sheets 1 thru 4) With the balance arm removed, drill out existing rivets in location (7 & 12) on both RH & LH brackets (5). Remove and discard brackets.
