Cessna 300 & 400 series torque links.

AWB 32-020 Issue : 1
Date : 11 August 2011

AIRWORTHINESS BULLETIN

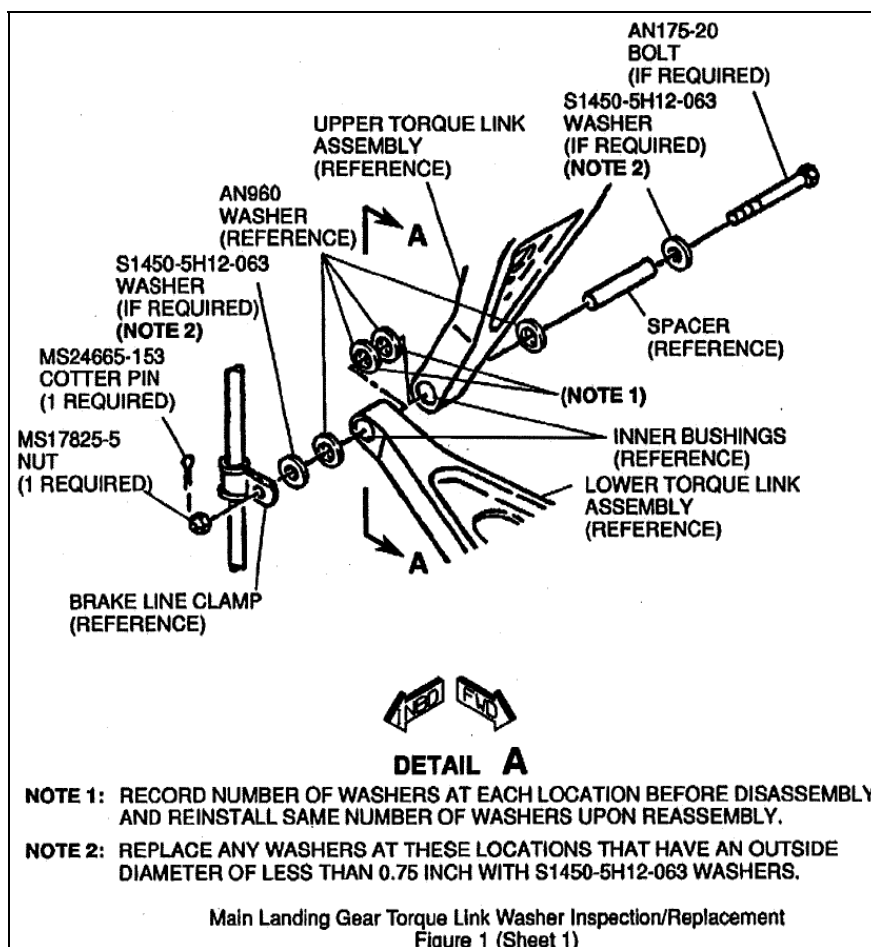
Figure 1 Cessna MEB02-12 Nov4, 2002

Various reports on the CASA SDR system describe instances where incorrect part number washers had been used on certain Cessna 300 and 400 series main landing gear torque link centre pivot. The primary result of this incorrect maintenance action is undercarriage collapse resulting in propeller and engine sudden stoppage and or primary wing structure damage. The outside dimension of the centre scissor link bushing is equivalent to the outside diameter of an AN960 washer, the S1450-5H12-063 washers specified are required to contain the individual items as a whole assembly.

- Inspect the main landing gear for correct part number / size washers on the outer positions of the torque link as per the relevant aircraft IPC. The outer washer OD should be 0.75" and the inner AN washer OD 0.5625".
- Replace any incorrect washers found fitted with correct part number items as per manufacturers IPC.
- Report all incidents of incorrect hardware to CASA through the CASA SDR system.
