# AIRWORTHINESS BULLETIN

AWB 52-004 Issue 1 – 6 August 2020

## Cessna 441 in Flight Depressurisation due to Emergency Exit door bonded skin failure

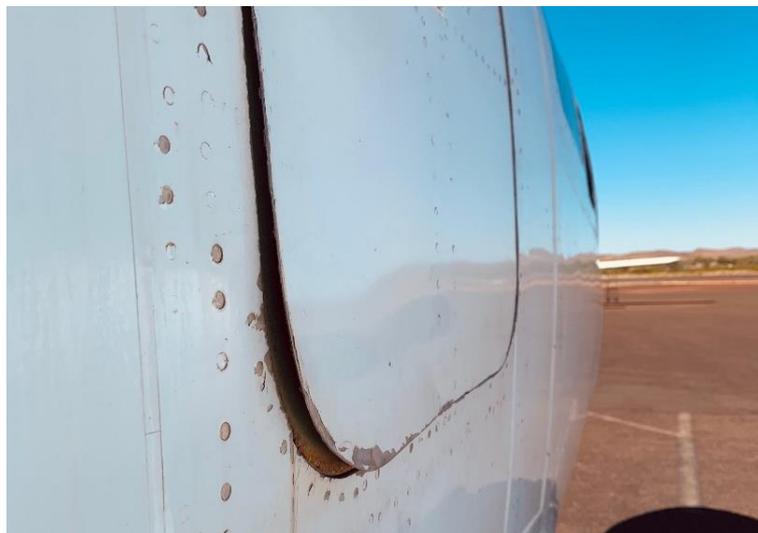
Initial investigations suggest that the bond degradation may be independent of the hours/cycles accumulated and that the primary driver may be ageing and degradation of the bond adhesive. Once degradation of the bond occurs, hours/cycles likely play a higher order role in disbond progression to failure.

**Disbonded panel viewed from outside**

It is strongly recommended that operators with Cessna 441 aircraft incorporating CASA STC SVA 528 and with greater than 22,500 hours accumulated, immediately carry out an interim visual inspection of the R/H emergency exit door to look for evidence of disbonding of the skin to frame structure.

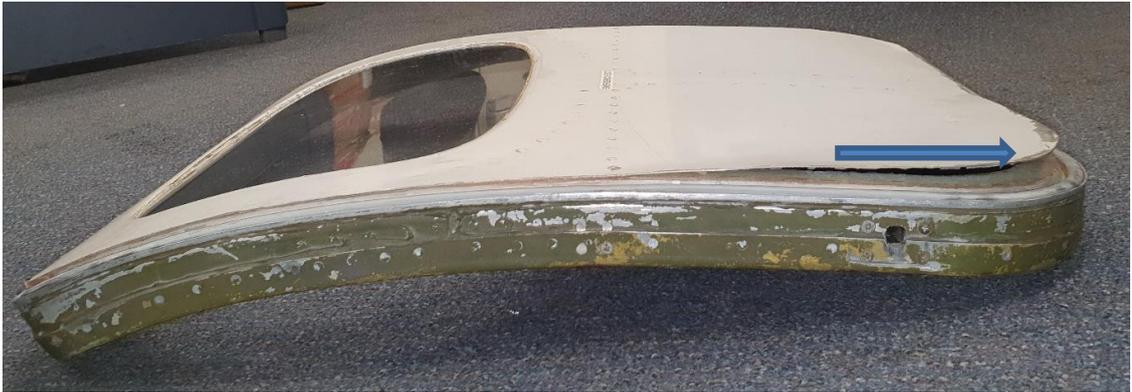
**Figure 1: Lifted edge of skin after disbond**

1. Remove the emergency exit door from the aperture in accordance with AMM 52-20-00/201.
  - A. Handle the door carefully to avoid snagging the outer skin on the fuselage.
  - B. Place the door on a work bench in a well-lit environment.
2. Using a handheld flashlight to throw light into any separated areas, carefully and slowly inspect right around the edge of the door from the angle shown in Figure 3.
3. Check for the following:
  - A. Small areas of separation of the outer skin (Figure 4).
  - B. Small tell-tale pressurisation leak marks.
  - c. Defects of the skin edge (Figure 4).
4. Check that no sealant / filler has been applied around the edge behind the seal. This may mask the problem and hide a pressurisation leak that is signalling potential failure.
5. Carefully reinstall the emergency exit door in the aperture in accordance with AMM 52-20-00/201.

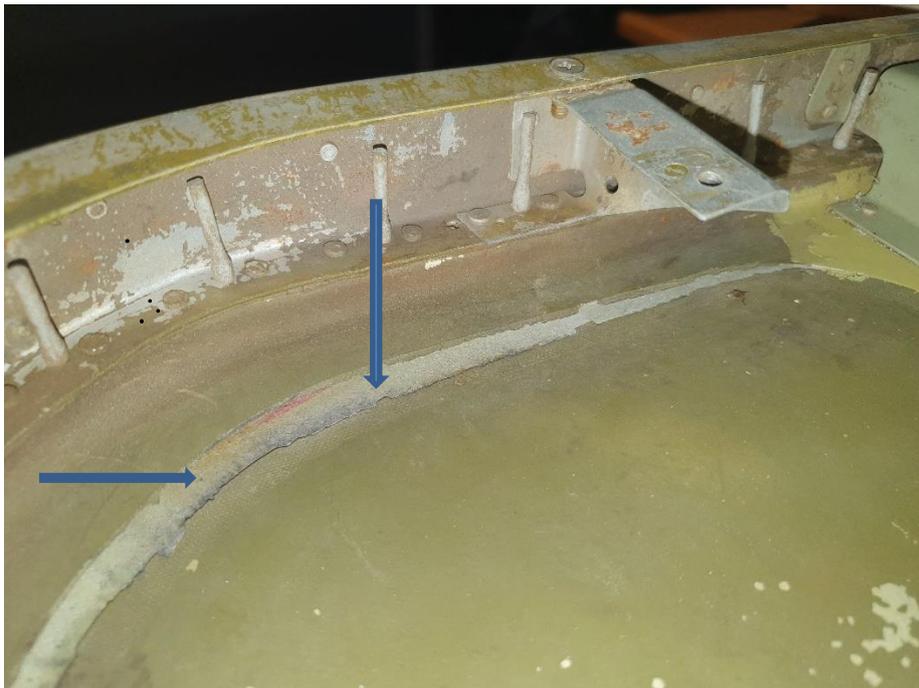
**Figure 2: View from inside door with liner removed showing filler crack/disbond**

2. Check the door frame and skin structure right round for general condition, looking for cracks and disbonds (Figure 2)
3. Do Cessna 441 Supplemental Inspection No. 52-20-01 (AMM 5-14-17).
4. Reinstall the internal liner in accordance with AMM.

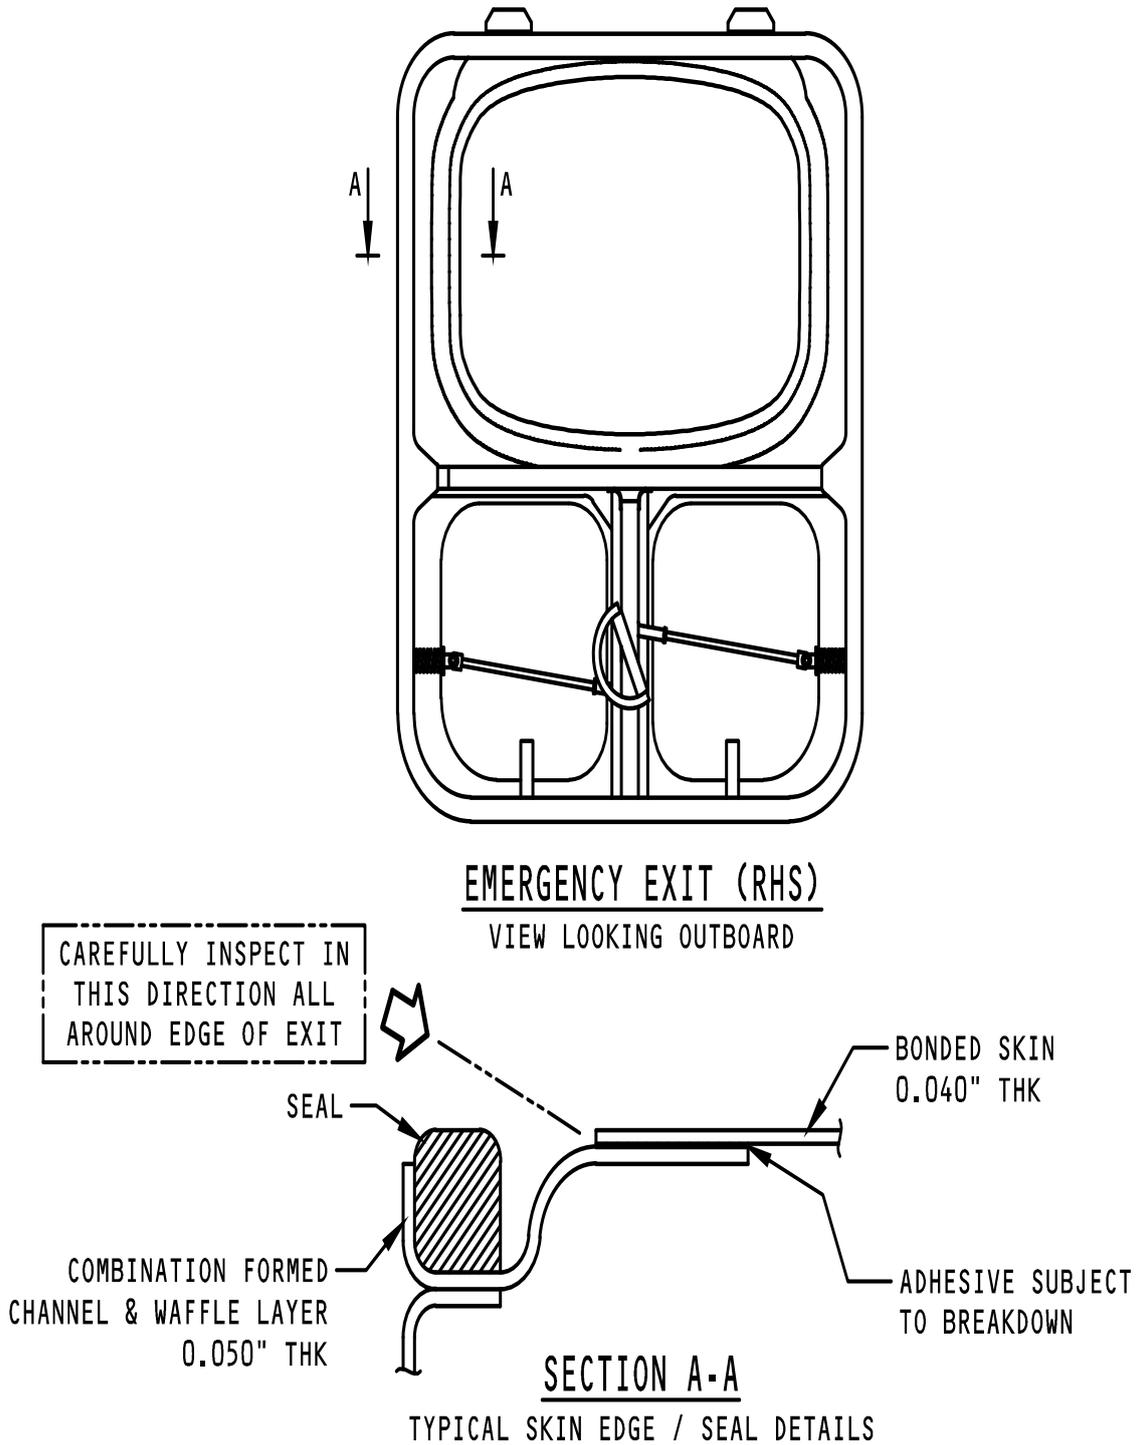
Figure 3: Schematic showing location of adhesive bond area and inspection area.

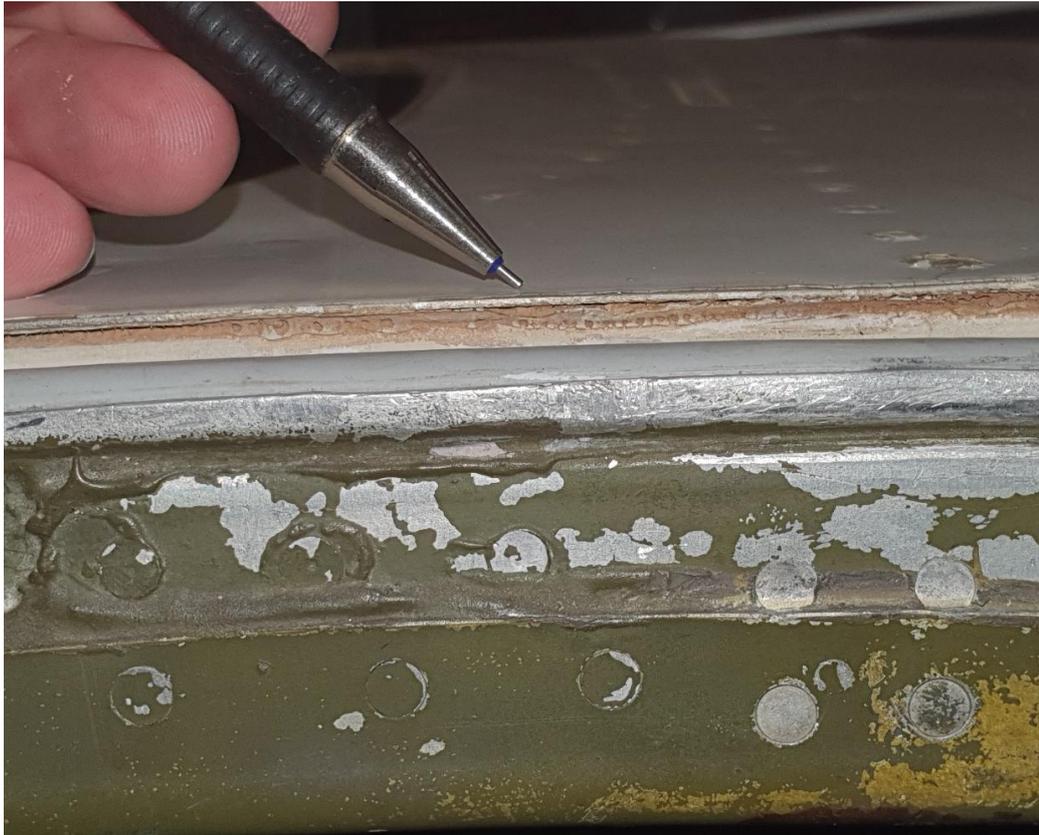
**Figure 4: Edge of skin, showing evidence of initial disbond – this can be very hard to see. Any lifting or voids are cause for further investigation of overall bond integrity.**

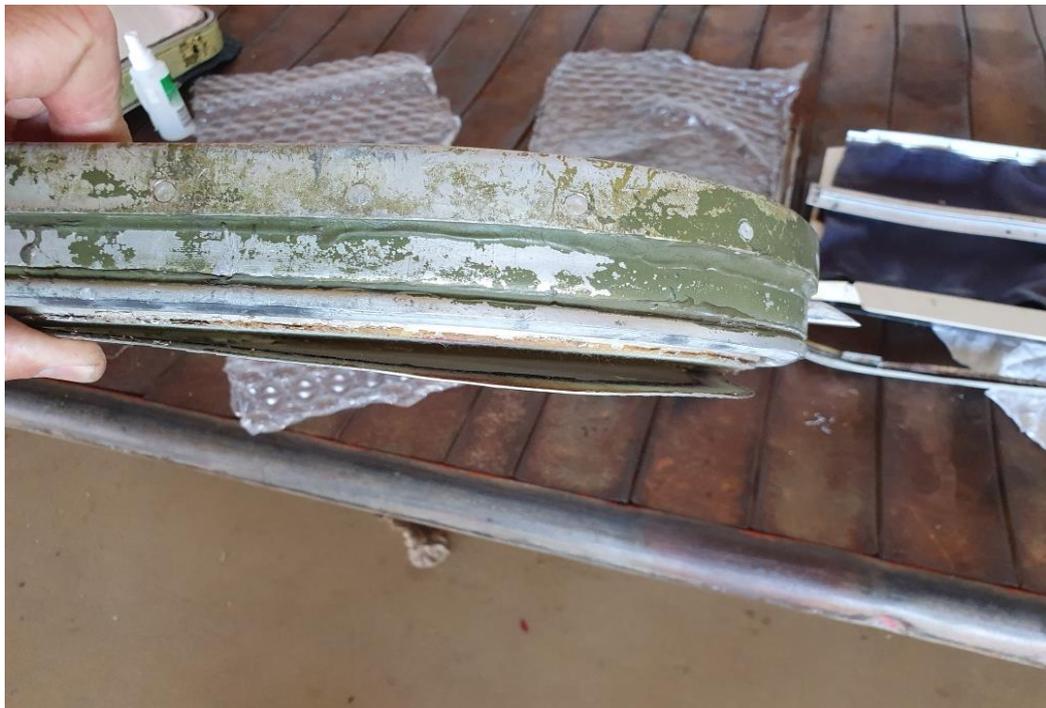
**Figure 5: View of external edge of door showing skin lifted after disbond**
