# AIRWORTHINESS BULLETIN

AWB 32-027 Issue 1 – 13 February 2018

## Cessna 441 Main Landing Gear Trunnion Fatigue Cracking

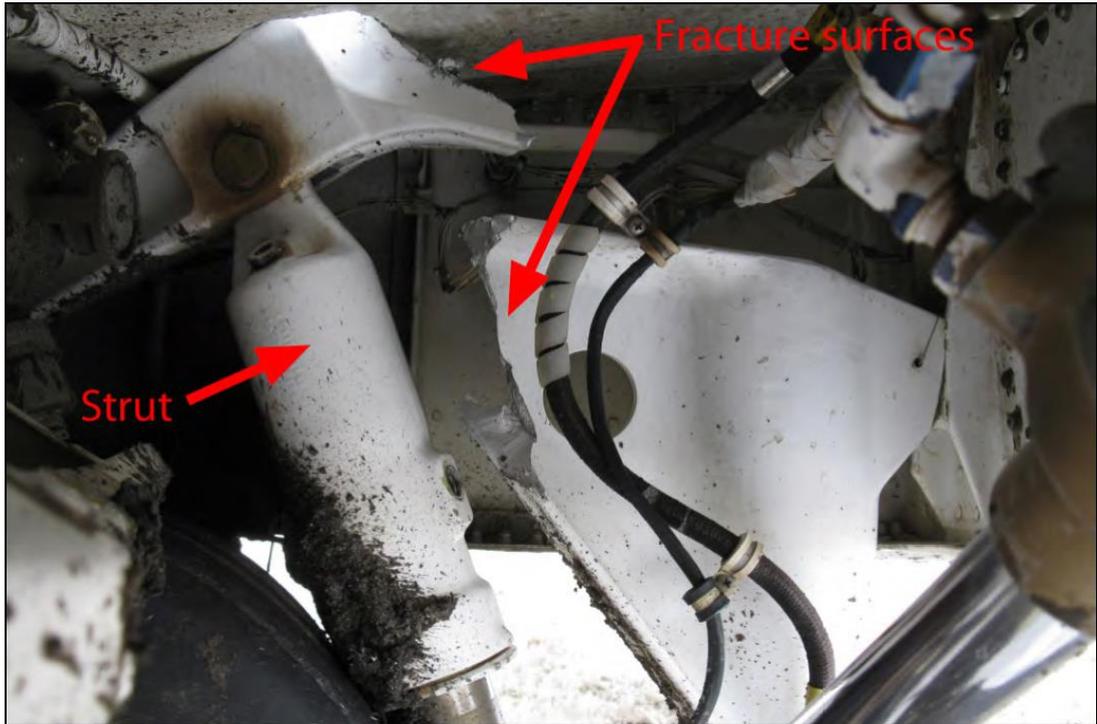
A previous ATSB report investigated a runway excursion incident on landing that resulted from a fracture failure of a P/N 5741115-13 left hand main landing gear trunnion.

Laboratory evaluation of both failures indicated that pre-existing cracking with associated fatigue crack growth was the likely cause of each failure.

Figure 2. Failed Left Hand Main Landing Gear Trunnion P/N 5741115-13  
Source: ATSB Report AO-2013-072

1. Ensure main landing gear trunnions are cleaned and carefully inspected per the applicable Supplemental Inspection Document (SID).
2. Carry out a targeted surface high frequency eddy current inspection of the trunnion gusset/web region for evidence of cracking concurrently with the aircraft manufacturer's specified periodic inspection.
3. If cracks are present, the affected trunnion should be replaced as a fracture failure during landing may cause significant damage to the aircraft and may cause injury to the occupants.

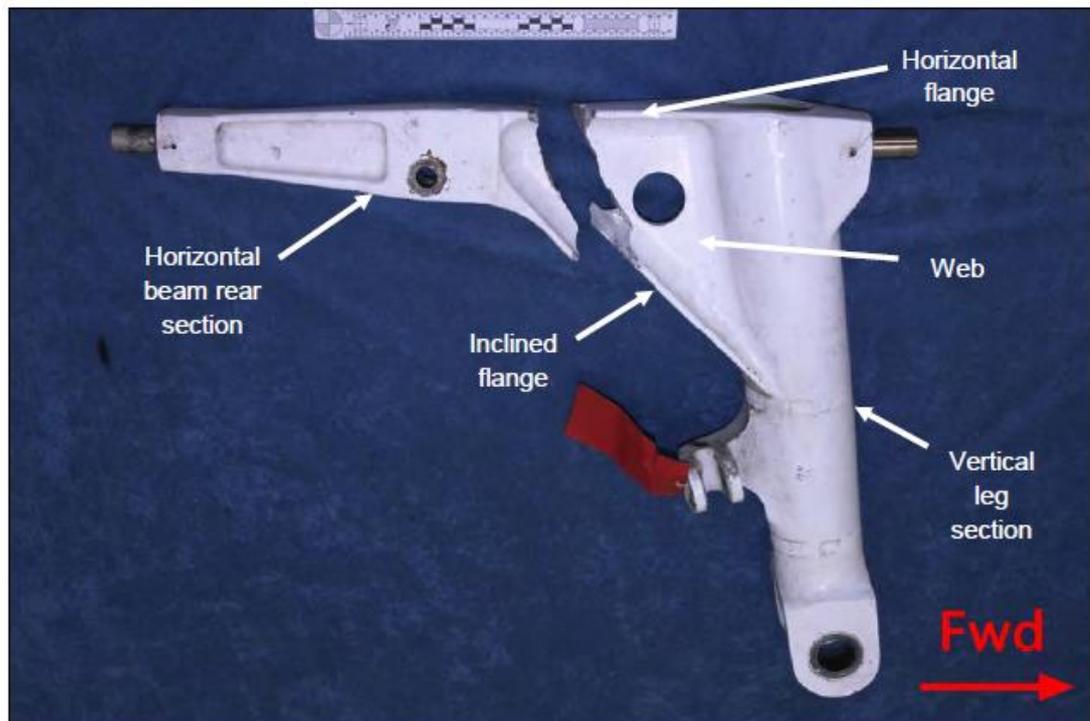
Figure 3. Trunnion removed from aircraft showing fracture location  
Source: ATSB Report AO-2013-072
