## Cessna 441 Wing Skin Inspection

AWB 57-003 Issue : 1  
Date : 1 February 2007

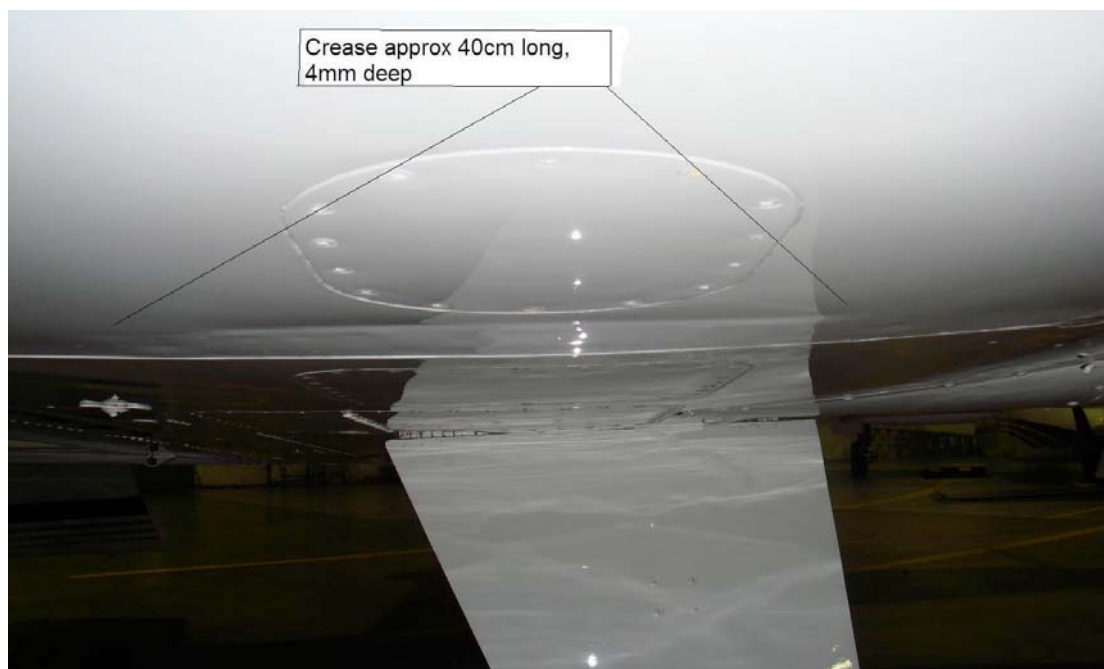
A crease in the underside wing skin of a Cessna 441 was recently observed (photo). The crease was just outboard of the centre wing section on the right hand wing at approximately wing station 12.

- the crease is suggestive of excessive downwards bending loads
- further investigation to check for under skin damage is warranted
- the skin deformation may eventually lead to cracks in the skin emanating from nearby fasteners
- even if no substructure damage is present, wing fatigue life may be expected to be shortened unless the damage is repaired
- delay in repair will probably result in the need for more extensive future repairs as damage propagates

It is recommended that owners/operators examine their aircraft for lower wing skin crease damage of the type described. If detected, it is strongly recommended that the wing be further examined for substructure damage and that any damage be repaired in accordance with manufacturer's recommendations.
