# Airworthiness Bulletin

## AWB 27-023 Issue 1 – 2 November 2021

### Cicare CH-7B Tail Rotor Pitch Control System

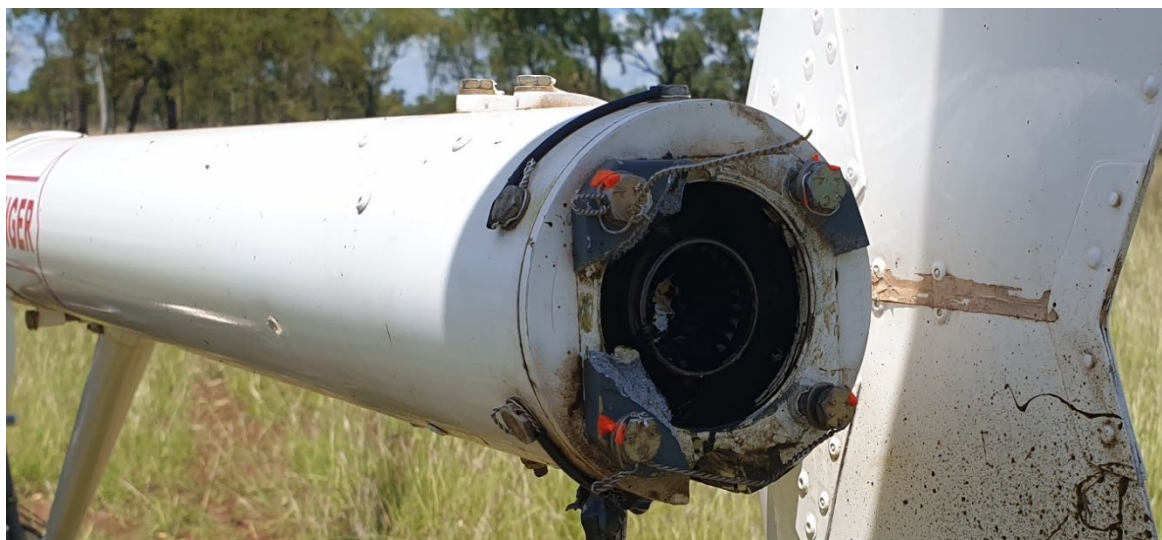
Two recent separate incidents have highlighted that Cicare' rotorcraft encountered increased vibrations at the tail rotor section of the rotorcraft. The two separate incidents have occurred in addition to two accidents that were investigated by the Australian Transport Safety Bureau (ATSB) investigations (ATSB Investigations AO-2014-086 and AO-2015-089). The recent incidents involved the Tail Rotor Gear Box (TRGB) departing the tail boom, the second with excessive vibrations following unapproved repairs to the pitch control mechanisms.

Figure 1. Tail Rotor Gearbox departed from CH7 tail boom section.

Operators and maintainers should follow manufacturer's maintenance instructions for continued airworthiness and be acutely aware of increases in vibrational feedback via the rotorcraft flight control inputs.

Similarly, all repairs outside of the manufacturer's maintenance instructions should be accomplished IAW manufactures approval or CASR 21 approved design data.

Finally, owners are to ensure that their rotorcraft have a CASA Experimental Certificate issued on completion of assembly, and that an approved CAR 30 maintenance organisation complete the appropriate track and balance of main and tail rotor systems prior to the rotorcraft's first flight.
