Plastic two-part detachable flight control column hand-grips installed in all aircraft.

To alert maintainers and operators to check for any detectable looseness between the control column and the grip. This may indicate failure of the plastic mating halves and/or attaching hardware.

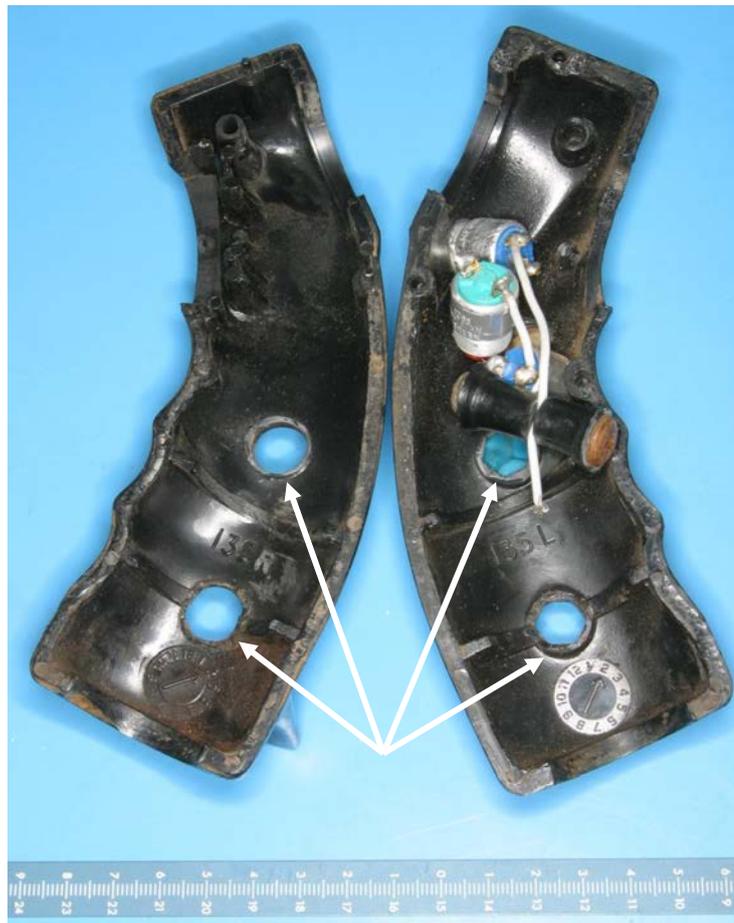
An accident resulted from loss of control at low altitude when the plastic control column grip suddenly separated from the control column. The grip was an approved STC part installed on an aircraft not listed by the STC. The grip consists of two halves clamped together with two through bolts. The lower through-bolt also attached the grip to the control column. Although the lower through-bolt remained in the column, the grip separated from the column because the lower and upper through-bolt boss areas had cracked and broken completely away from the grip.

Figure 1 – Mounting bolt bosses broken away (courtesy ATSB)

Check all detachable grips for looseness on the control column. Any detectable looseness between the grip and the control column may indicate loose or thread-bound through bolts, failure of the plastic through-bolt bosses, poor mating of the shell halves, improper installation and/or poor maintenance practices.

Carefully inspect the recessed areas of the grip around the thru-bolt bosses for signs of cracking and separation from the grip. If a grip remains loose on the control column after tightening, inspect for wear caused by chafing, check that electrical wiring in the grip assembly is not trapped between the grip halves preventing complete clamping and that the fasteners are not thread-bound.

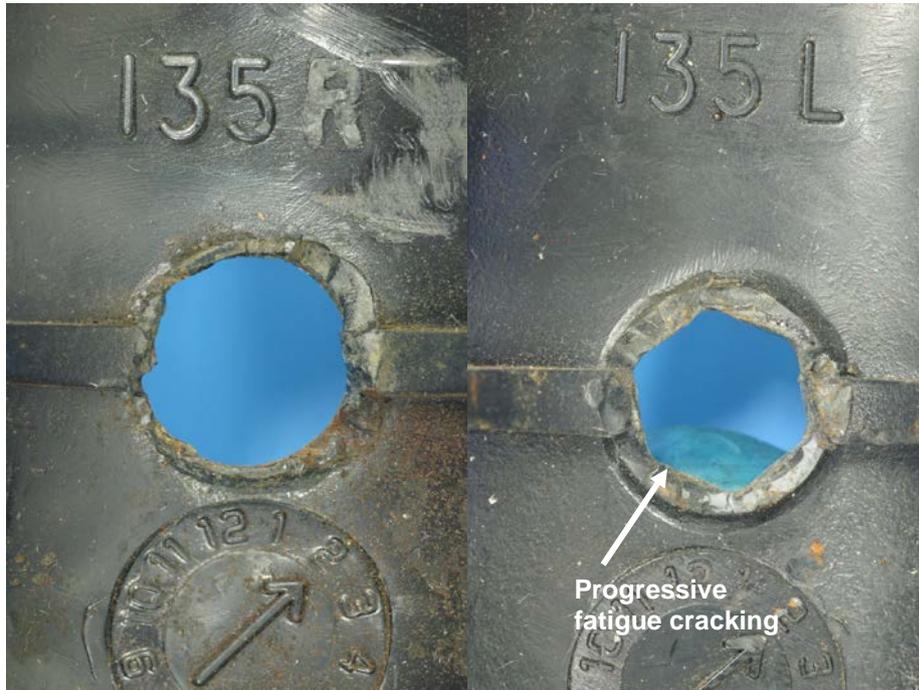
Figure 2 - Lower bolt boss fatigue cracking (courtesy ATSB)
