Cracking in Nose Landing Gear upper strut sections of Cirrus SR20 and SR22 aircraft **AWB** 32-015 **Issue :** 2
Date : 24 November 2009

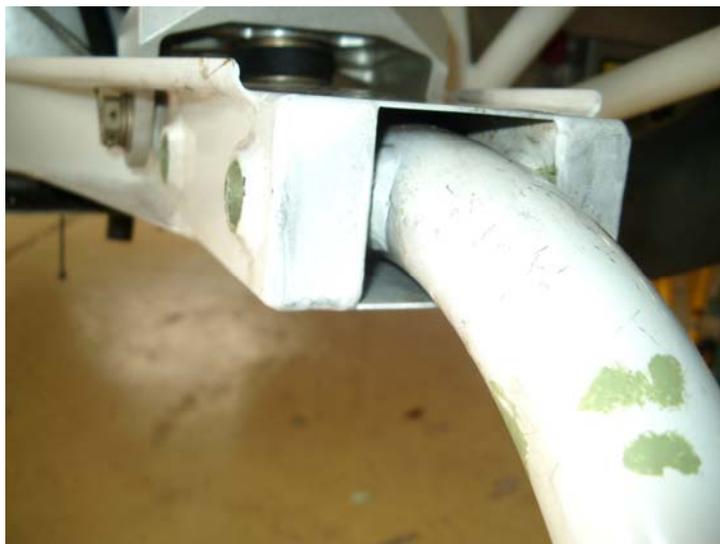
Recent defect reports have indicated that cracking has occurred around the Nose Landing Gear upper support gusset and strut attachment welds.

- Carry out a detailed inspection of the area around the fillet weld between the upper gusset plate and attach point arms in accordance with Cirrus Mandatory Service Bulletin 2X-32-18 R4 or later revision and instructions for inspection in Cirrus AMM Chapter 32-20.
- Continue to inspect at intervals determined in the service bulletin or replace gear with a Cirrus improved NLG strut when available.
