Airworthiness Bulletin

AWB 57-019 Issue 1 – 03 October 2023

CT/4B Wing Rear Spar Cracking

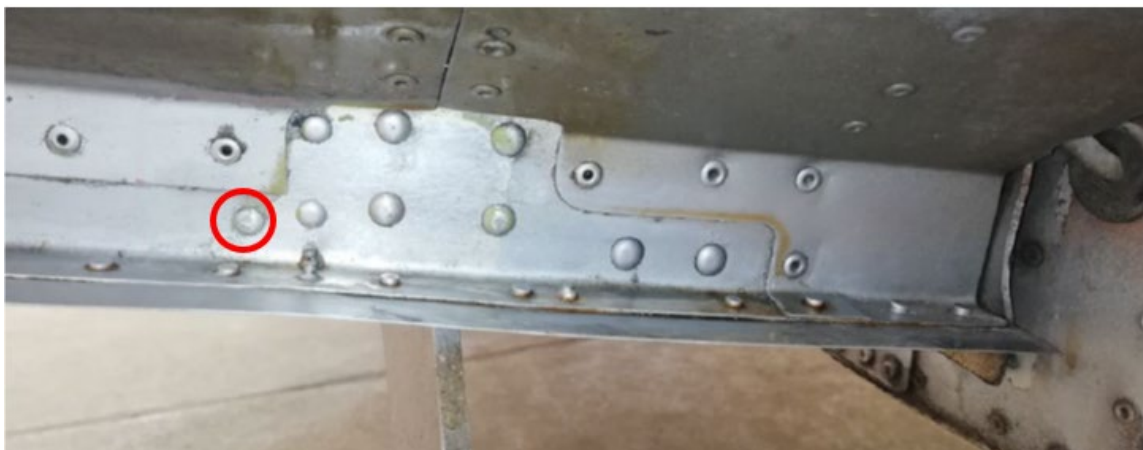
According to the ATSB findings and as shown in Figure 1 and Figure 2, the fastener where the cracking has been identified previously, has only a small distance around the fastener where the crack can be detected visually before it progresses under the flap close out panel.

Figure 1: CAA NZ AD DCA/CT4/9 Critical Fastener Location Near Rear Spar Wing Root

Whilst the mandated Detailed Visual Inspection (DVI) defined in CAA NZ AD DCA/CT4/9 is for the inboard area of the rear spar, CASA advise that the critical rivet identified in Figure 1 was where the subject aircraft was found to be cracked. There is just a small distance around the fastener where the crack can be detected visually. Otherwise the crack will progress under the flap close out panel where it is not detectable without removal.

A DVI is required per the CAA NZ AD DCA/CT4/9 with a 50 Hr inspection interval.

A DVI is required per the CAA NZ AD DCA/CT4/9 with a 50 Hr inspection interval. The inspection includes both LH and RH wings of the airplane.

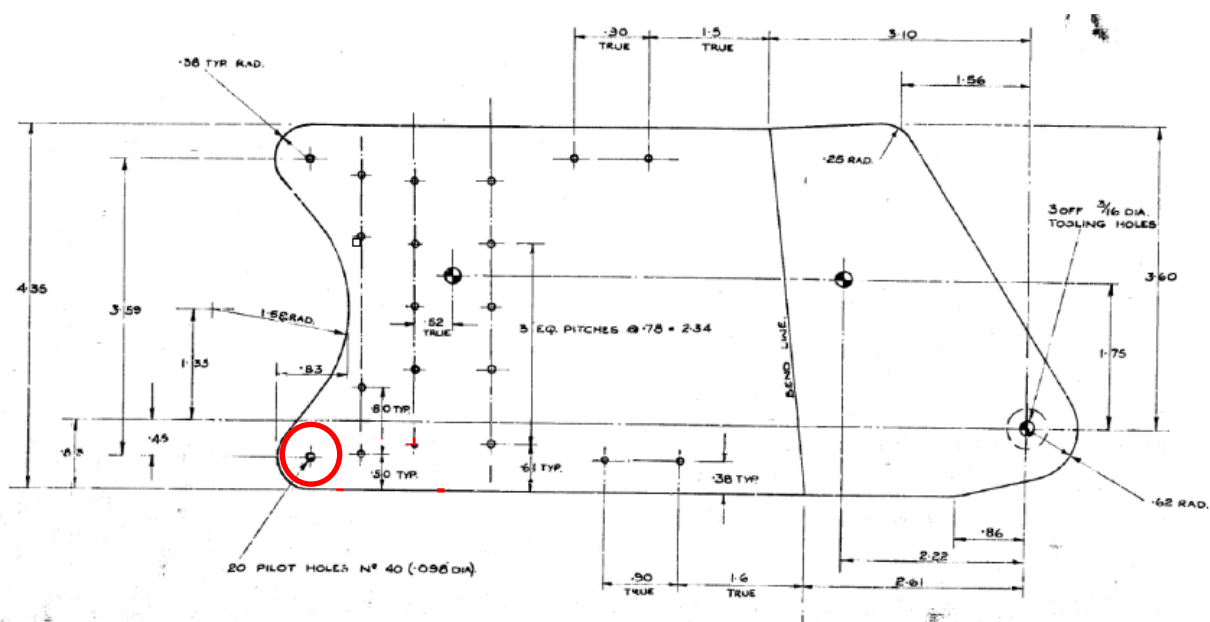
Figure 2: Critical Fastener Detail on Rear Leaf Pickup Bracket (Drawing 07-10019)

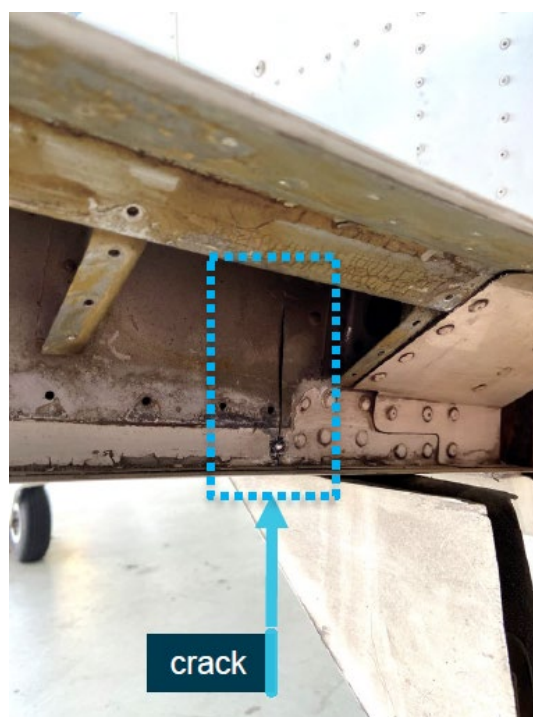
Figure 3: Cracks Emanating Above and Below the Critical Hole (Flap closeout panel removed in this photo)

CASA recommends looking for cracks emanating from the critical fastener hole in both directions, above and below the critical hole and as shown in Figure 3 and per the instructions in CAA NZ AD DCA/CT4/9.
