Airworthiness Bulletin

AWB 01-033 Issue 1 - 11 March 2021

DH82 Series Tiger Moth – Unapproved Joint H Structural Bolts

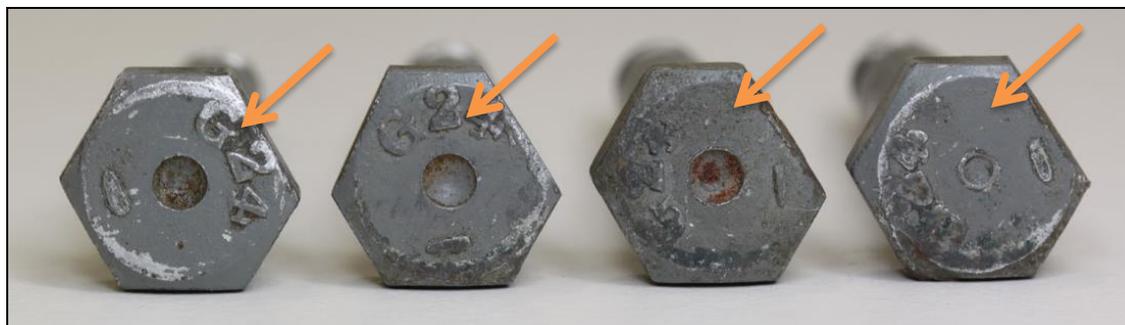
Figure 2. (Source: ATSB)

Also, one flat on the hexagonal head of each "G" bolt had been ground down to enable the larger diameter letter "G" bolt head to fit inside the flanged fitting of the main lateral compression tube. (Figure 2).

Confirm that the correct bolts are installed by gaining access to, and checking all H Joint upper bolt head markings (Figure 5b and 5c) to determine if the correct bolts are installed in all locations. The letter “G” (Figure 2) on the bolt head may indicate unapproved bolts have been installed. Some unapproved bolts may have no head markings (Figure 5a, b & c.).

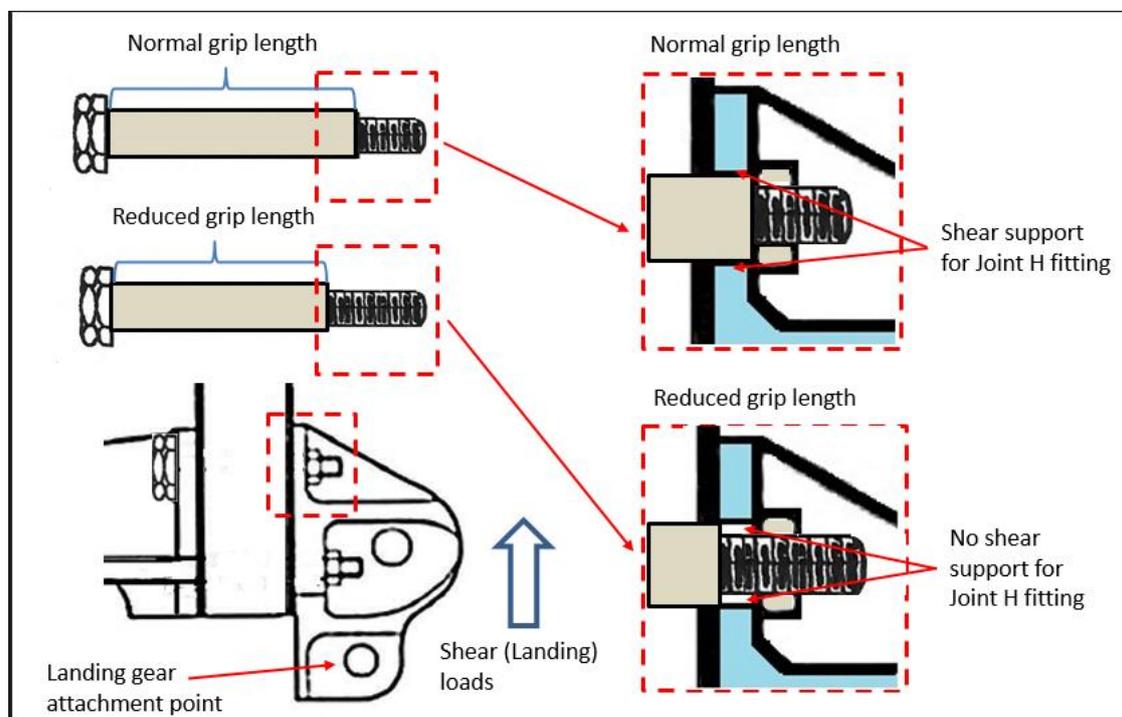
The H Joint upper attachment bolts are designed to work in conjunction with the lateral tie rods to transfer landing loads to the airframe. Unapproved, and typically short upper attachment bolts do not allow the shank of the bolt to properly engage with the fuselage structure and the Joint H fitting, and can allow the fitting to move up, and engage with the threads of the unapproved bolt, thereby subjecting the lateral tie rod to excessive shear loads, (Figure 3).

Figure 3. Correct and incorrect H Joint upper attachment bolt installation.
(Source: Adapted from ATSB Investigation AO-2013-226)
