# AIRWORTHINESS BULLETIN

AWB 51-011 Issue 1 – 2 September 2016

EC130 Cracking of Fenestron Cone Link Structure

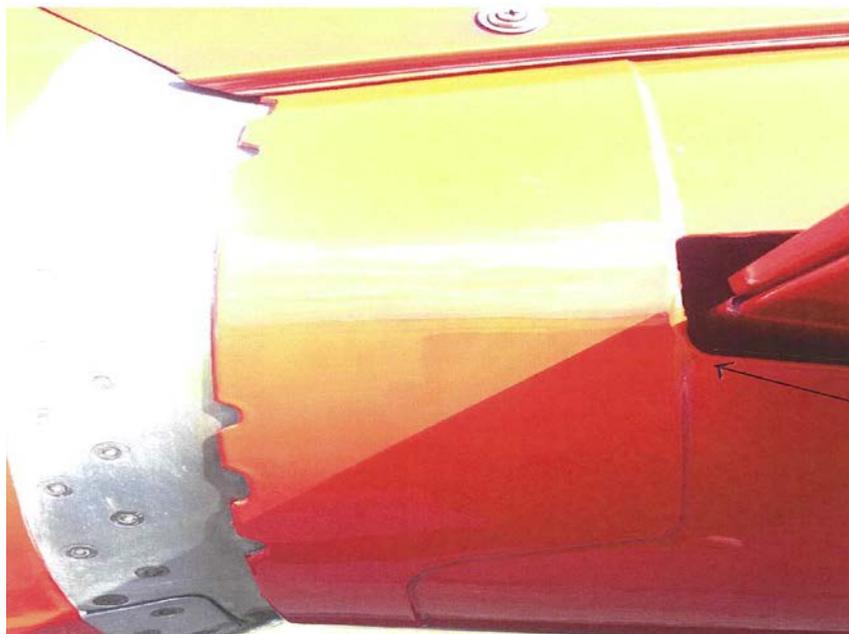
Figure 1

An operator of B4 rotorcraft has found three tail booms with cracking in the cone link area see figures below. Cracking appears to begin from the lower aft corner of the horizontal stabiliser cut out on the right hand side. These cracks were found whilst completing EASA emergency AD 2015-0033-E junction frame inspection.

Crack may be visible externally without use of tools, or disassembly. Crack has been found to be propagating beneath the external doubler.

CASA strongly recommends a visual inspection of both sides of the structure forward of the cone link doubler exterior and also internally with the use of a borescope at the earliest opportunity. Access of the borescope can be achieved through the horizontal stabiliser cut out from the opposite side.

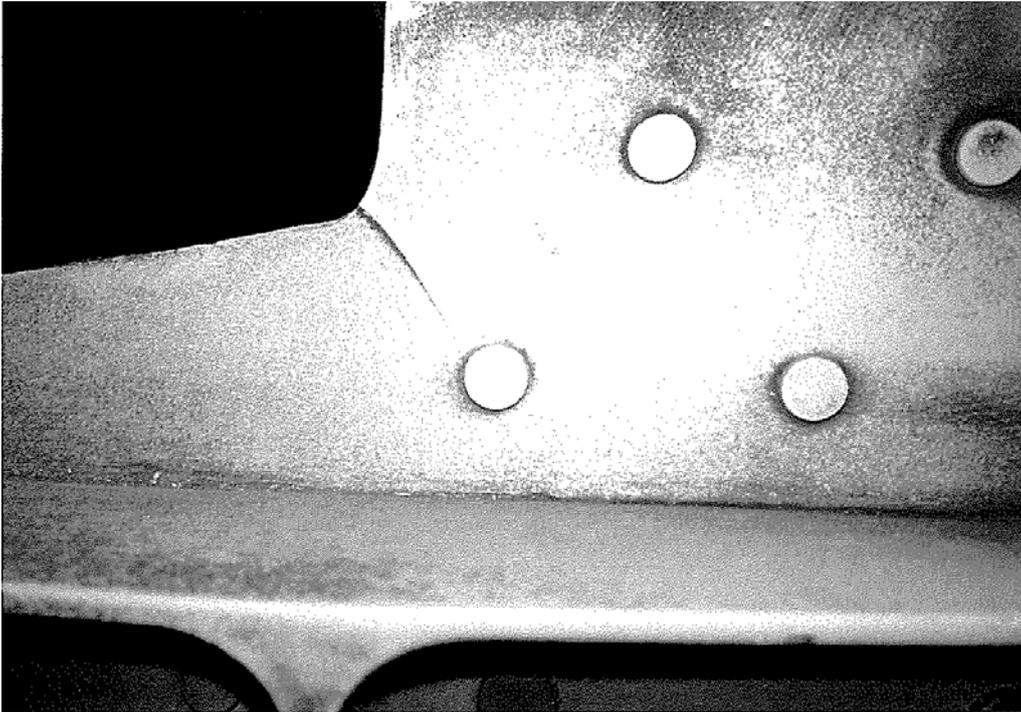
Figure 2

Cracks may be visible using a boroscope from the opposite side of the horizontal stabiliser cut out. Crack transits from the lower rear cut out radius downward to the rear typically through existing rivet holes and may continue behind the forging. The area to be inspected may need to be cleaned to allow detection of the crack.

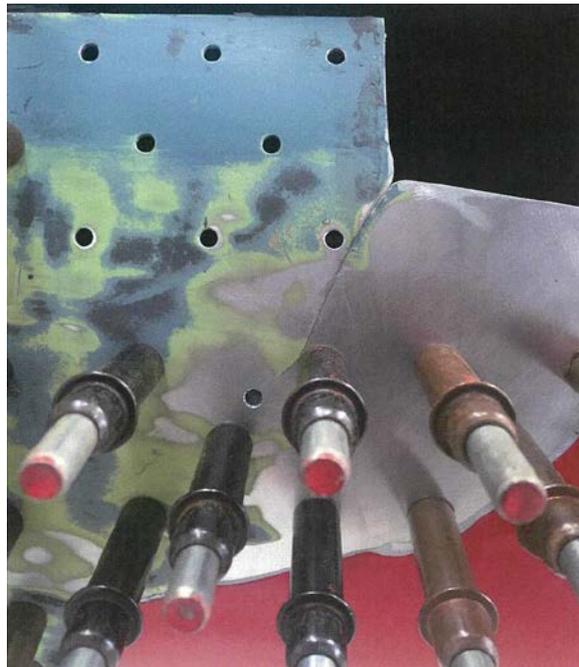
Figure 3

With the doubler removed cracks have been found at 60mm in length.
