All American Champion Aircraft (ACA)

To alert maintainers and operators to the in-flight failure of a primary flight control cable which occurred in an ACA 7GCBC 'Citabria' and to ensure that maintenance providers are made aware of the need to adequately inspect all flight control cables in ACA aircraft. This AWB is based on the preliminary findings of the ATSB investigation.

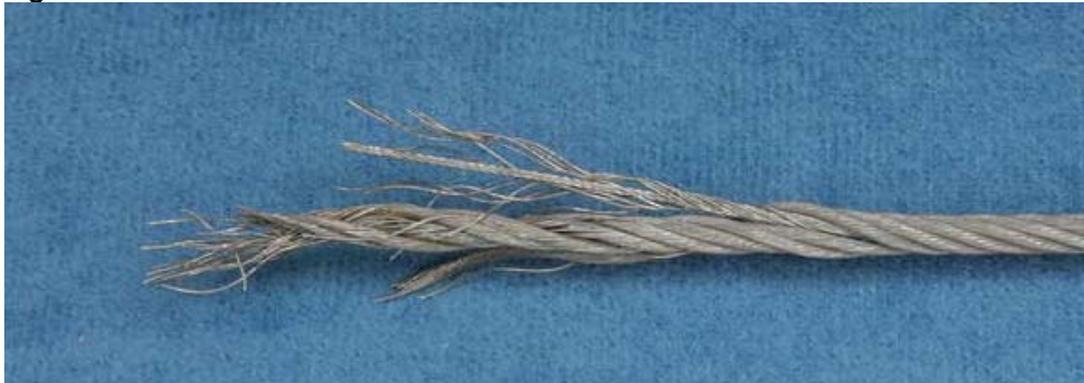
Figure 1.

The elevator "up" cable failed completely at the point where the cable ran over the first guide pulley forward of the elevator horn cable interconnection. (Fig.1). A second area of fraying was found in the same elevator cable, approximately 1.76 m further forward, at the next cable pulley location. (Fig. 2)

Aft section of failed elevator cable.

The cable failed due to the cumulative effects of fatigue cracking of the individual strand wires. The cable suffered multiple wire failures on the inside bend of the cable, specifically where it contacts the pulley during cruise flight. The cable did not show any other 'normal' signs of wear, such as flats or shiny sections in the areas where the cable contacted pulleys or fairleads. There was no obvious corrosion. The second area of cable degradation was also a fatigue cracking issue. See (Fig.2)

1. All flight control cables in all ACA aircraft be immediately subjected to a close inspection and frequent inspection thereafter, in accordance with FAA AC 43-13-1B, chapter 7, Section 8, paragraph 7-149(d), particularly in the areas of the cable at the specific points of contact with the pulleys and fairleads. This may require disconnecting the cable at one end in order to withdraw the cable from the aircraft and examine areas not normally visible with the system assembled.

2. Operators consider replacing all existing 1/8" 7x19 spiral-wound galvanised carbon steel cable which cannot be traced to MIL-DTL-83420 certification, with cables having verifiable certification to MIL- DTL- 83420 standard.

3. That all cable operated control systems are inspected for wear, broken wires and corrosion in accordance with FAA AC 43-13-1B, chapter 7, Section 8, paragraph 7-149(d) and in accordance with approved data and the manufacturers maintenance data as required at each 100 hourly or annual inspection.

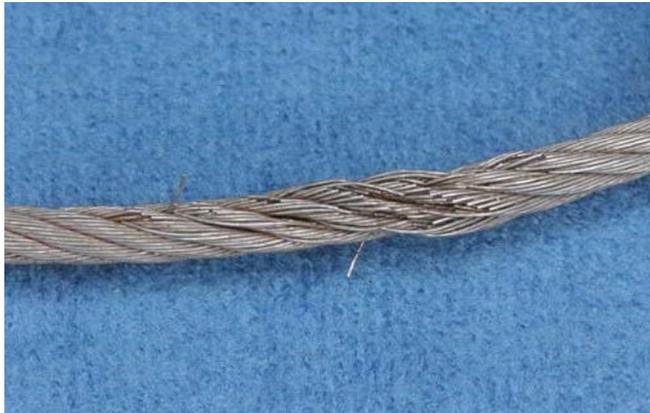
Figure 2.

The failed elevator cable was identified as a 1/8" diameter spiral-wound galvanised carbon steel cable, of 7 strands, each of 19 wire construction. (7X19).

The cable had been installed when the aircraft was manufactured in 2005 and had been in service for 2,904 Hours TSN.

Forward section of failed elevator cable.
