Airworthiness Bulletin

AWB 32-028 Issue 1 - 6 June 2023

Fokker F28 0070 and 0100 Landing Gear - Hydraulic Line Restrictor Check Valve / Screen Inspection

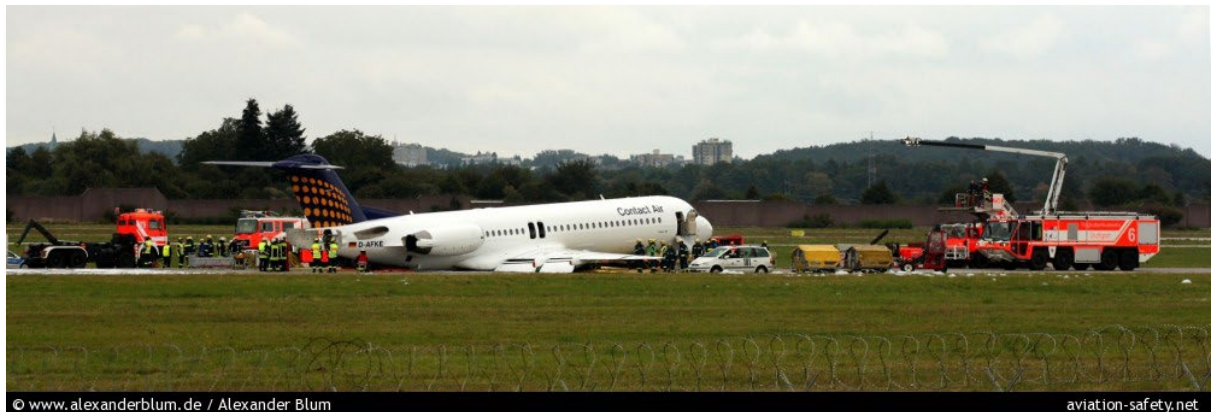
Figure 1:

- In 2009, during final approach, upon selecting the landing gear lever to the down position the LH and RH MLG failed to extend and lock. The crew initiated a go-around and flew past the control tower who visually confirmed that the LH MLG was not extended at all, whilst the RH MLG was partially extended. The crew made multiple attempts to extend the MLG with no success. These unsuccessful attempts included use of the alternate landing gear system, as well as flight manoeuvring to induce 2g forces. Ultimately, the crew were forced to make an emergency landing with only the NLG down and locked. Three passengers sustained minor injuries. The aircraft was severely damaged but was ultimately repaired. For further details, refer to the German BFU's Safety Bulletin 2009-09.

Aftermath of 2009 Mk0100 emergency, belly landing¹. The MLG failed to extend and lock, even after attempts with the alternate landing gear system as well as multiple '2g' manoeuvres. Please refer to the German Federal Bureau of Aircraft Accident Investigation (BFU) Safety Bulletin 2009-09 for details about the accident.

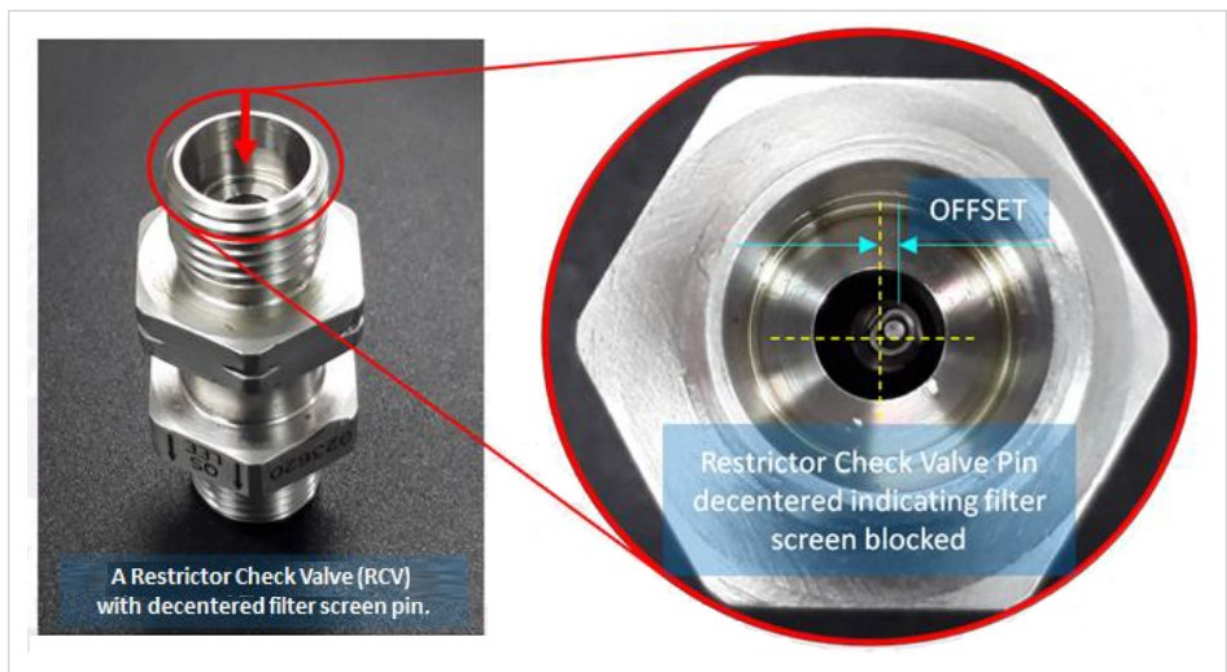
Figure 2:

Contamination of the fluid within hydraulic system 1 has been found to be clogging the filter screen of the restrictor check valve located in the hydraulic return line of the Parking Brake Shut-Off Valve (PBSOV). It is believed that this contamination can cause the filter to collapse, leading to a failure of the Landing Gear (LG) Hydraulic Control (Maintenance Significant Item (MSI) reference 323200).

This rapid onset could be that the contamination gradually builds up until it results in a pressure differential across the filter screen large enough to cause it to collapse. If this is the case, it is plausible that an inspection of the restrictor valve filter screen for signs of contamination and/or collapse could help reduce the likelihood of LG Hydraulic Control failures.

A decentred filter screen pin is indicative of a blocked or possibly even a collapsed filter screen.

1. Inspect the Hydraulic System Restrictor Check Valve in the return line of the Parking Brake Shut-Off Valve for contamination, and condition of the internal pin. Ref: IPC 29-13.-08-24, Item 160.
2. If found contaminated and/or has a bent internal pin:
 - a. Remove the check valve and O-ring in accordance with AMM 32-44-05-000-814-B and AMM 20-11-00-000-81-A. Seal in a bag in original (uncleaned) condition and route it to Technical Services.
 - b. Install a new valve and O-ring in accordance with AMM 32-44-05-400-814-B and AMM 20-14-06-910-822-A.
 - c. Flush and fill the hydraulic systems IAW AMM 12-12-01-610-813-A.
3. Carry out the Landing Gear Extension and Retraction Test for both Normal and Alternate Extension in accordance with AMM 32-00-00-720-815-A.
