Fokker B.V. F28 MK0100 aircraft.

AIRWORTHINESS BULLETIN

Fokker F28 Mk100 Fuel Pump Wiring

AWB 28-014 Issue : 3
Date : 20 November 2015

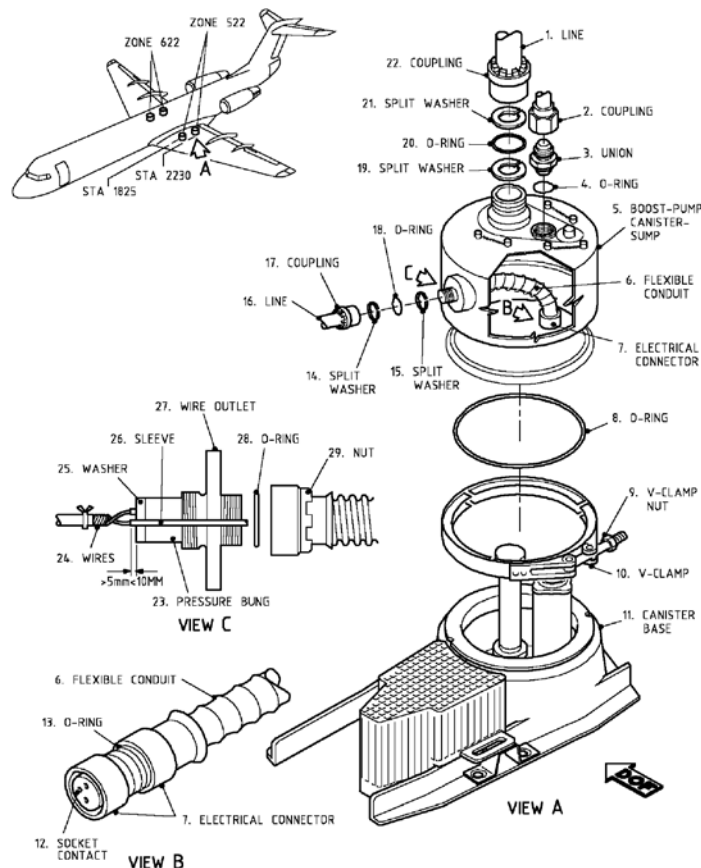
Figure 1 - Fuel boost pump

During scheduled maintenance, an operator identified burnt fuel boost-pump wiring. The wiring harness for the LH rear fuel boost pump canister was removed for access to allow defect rectification of a fuel leak (see Figure 1).

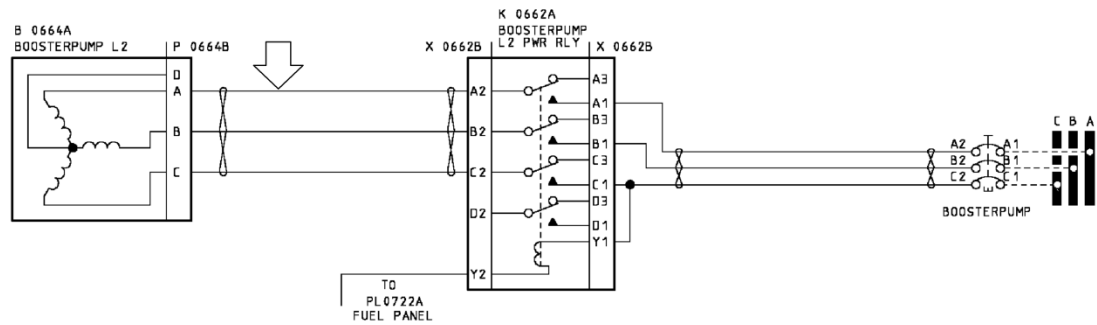
Figure 2 – Booster pump schematic

Wire number AWH0001 (red wire contact A) from Connector P 0664B (see Figure 2) was found with a burn mark on the insulation (see Figure 3).

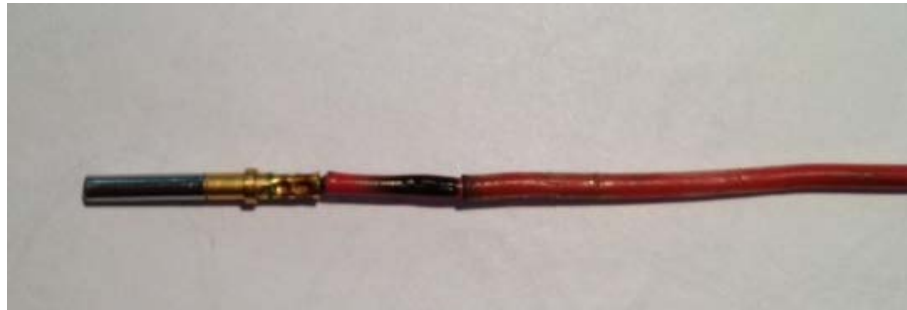
Figure 3 - Burnt A phase wiring

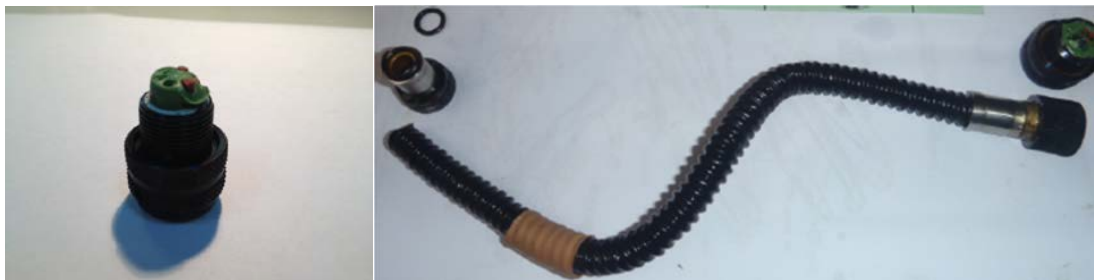
The wiring harness had fuel present within the harness conduit and the rubber insulation on the plug was found severely damaged (see Figure 4).

Figure 4 – Damaged Plug and broken flexible conduit

If the cable assembly conduit and the associated plug 8525-16R10B6SND071 is found damaged, it must be replaced with new components. However, if only the green grommet of the plug is found damaged you can replace the plug that includes the green grommet.

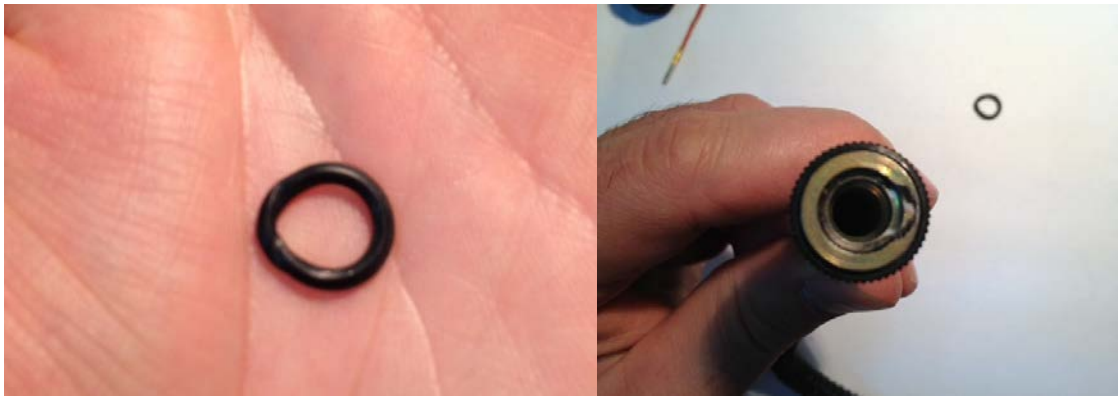
The harness attached to the canister end was found with a deformed O-ring as it was not seated correctly (see Figure 5). It was determined that the damage found was due to incorrect installation of the fuel canister harness backshell.

Figure 5 - Deformed O-ring

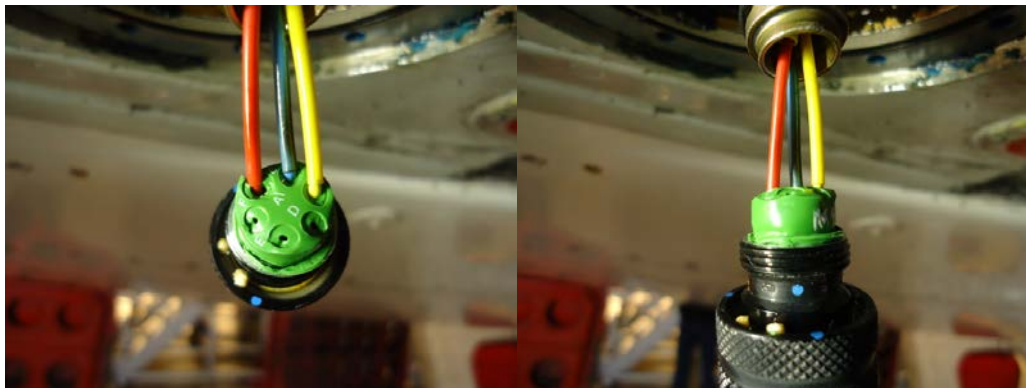
Figure 6 - Discolouration of the wire

One operator reported a case of discoloured (overheated) electrical wiring at the plug location (see Figure 6), which may have been caused by a conductivity issue (high resistance) between the contact on the pump receptacle and socket due to the presence of fuel. According to Fokker the heat build-up at the socket can be released through the plug but the heat build-up in the wire cannot be sufficiently released and leads to a colour change of the insulation material. Fokker indicates there is no immediate safety risk as long as the fuel pump remains submerged in fuel that prevents the presence of oxygen.

On October 21st 2013, Fokker Services issued a manual change notification MCNM F100-165 which stated “to reduce the risk associated with dry running of the boost-pumps during maintenance activities, **the circuit-breakers of the boost-pumps must be pulled** and tagged when the collector tanks are defueled to a remaining fuel quantity of 200 litres or less. In addition, to reduce the risk associated with dry-running of the centre-wing transfer-pumps, an

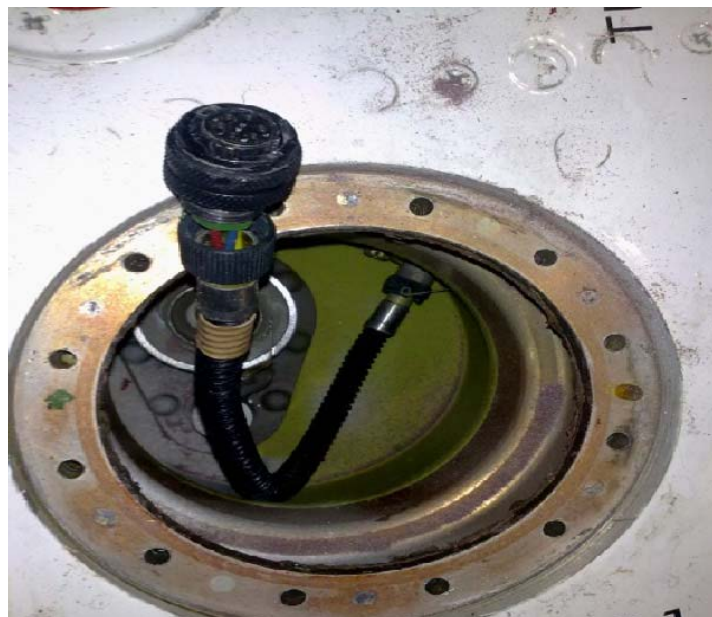
There is no requirement to seal the booster pump cable assembly to prevent fuel leaks into the cable assembly flexible conduit see Figure 7. The coupling nut, which is part of the flexible conduit, can untwist slightly from the plug due to booster pump vibration or during maintenance when replacing a booster pump; therefore allowing some fuel to enter the flexible conduit. The coupling nut is not self-locking and does not need to be safety-wired. The observed damage to the plug part number 8525-16R10B6SND071, may be the result of poor maintenance practice when replacement of a booster pump is carried out. Whenever a booster pump is replaced or installed the LAME should ensure that the coupling nut is sufficiently tightened to minimize the chance for untwisting while over tightening can lead to fractures. Furthermore, the LAME should ensure that the strain acting on the flexible conduit following the installation of the booster pump is minimal to avoid damage due to stresses developing over time.

Figure 7 - Booster pump canister. Flexible conduit and plug

All materials used in the design should have sufficient resistance to fuel; therefore degradation as a result of contact with fuel is normally not expected. However, based on the feedback Fokker has received from operators so far, degradation of the green grommet (see Figure 7) due to fuel saturation cannot fully be excluded. The AMM boost pump canister installation task 28-13-01-400-814-A and boost pump installation task 28-22-02-400-814-A are currently under review by Fokker to eliminate any possible misunderstandings as to the inspection requirements during removal and installation.

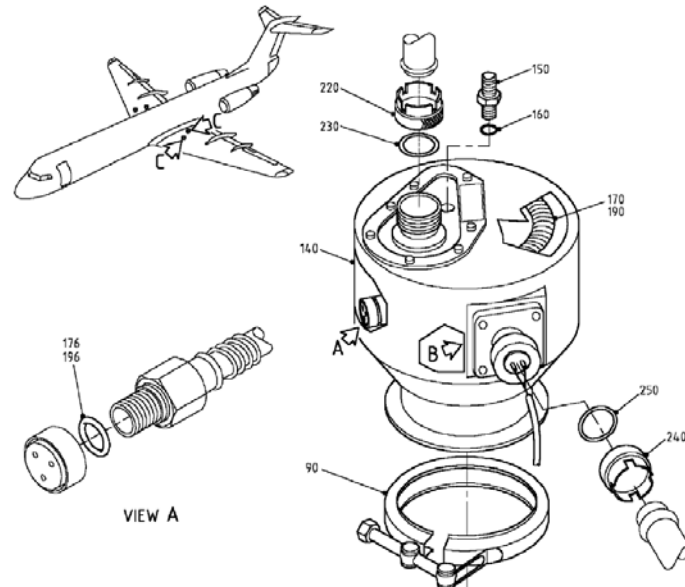
Figure 9 – O-ring installation

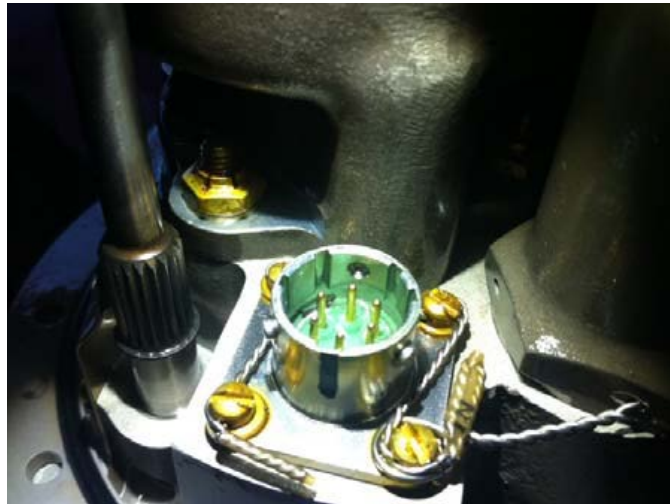
problem provided the assembly is not taken apart. Exposure to fuel can be expected over time because the parts used in the cable assembly are not designed to be hermetically sealed. The ambient pressure differences between ground and cruise level then will be enough to allow minute quantities of fuel to enter the conduit each time the conduit is at a lower pressure see Figure 10.

Figure 10 - Fuel in receptacle
