AIRWORTHINESS BULLETIN

AWB 25-035 Issue 1 – 28 April 2020

Fokker F28 Mk70 and MK100 Flight Crew Seat Cracking and Repairs

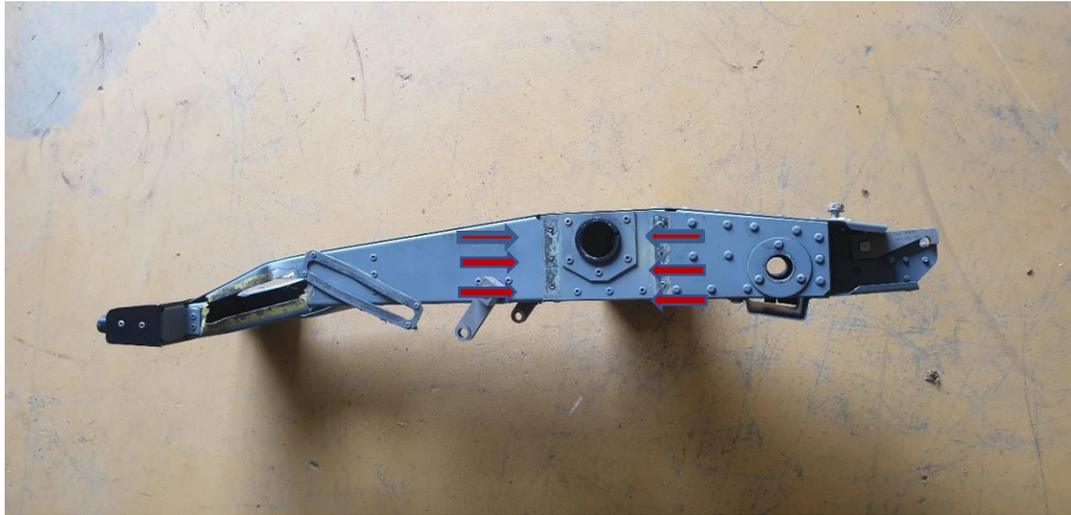
Figure 1: Seat spine, as removed, showing rivet failure as indicated. These rivets attach part of the armrest structure. Refer to relevant CMM for details.

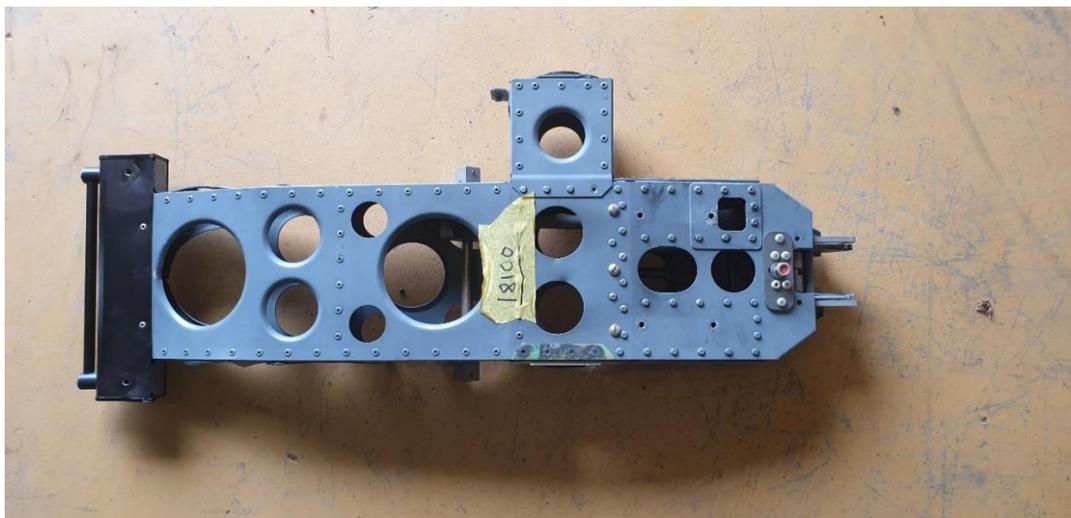
Figure 2: Crack location indicated by tape.

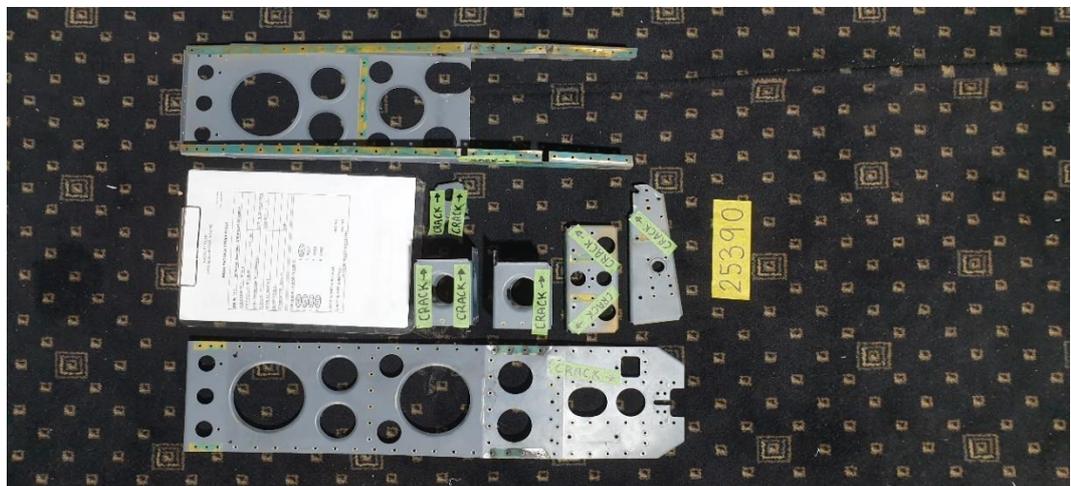
Figure 3: After the seat spine was disassembled, these defects were found

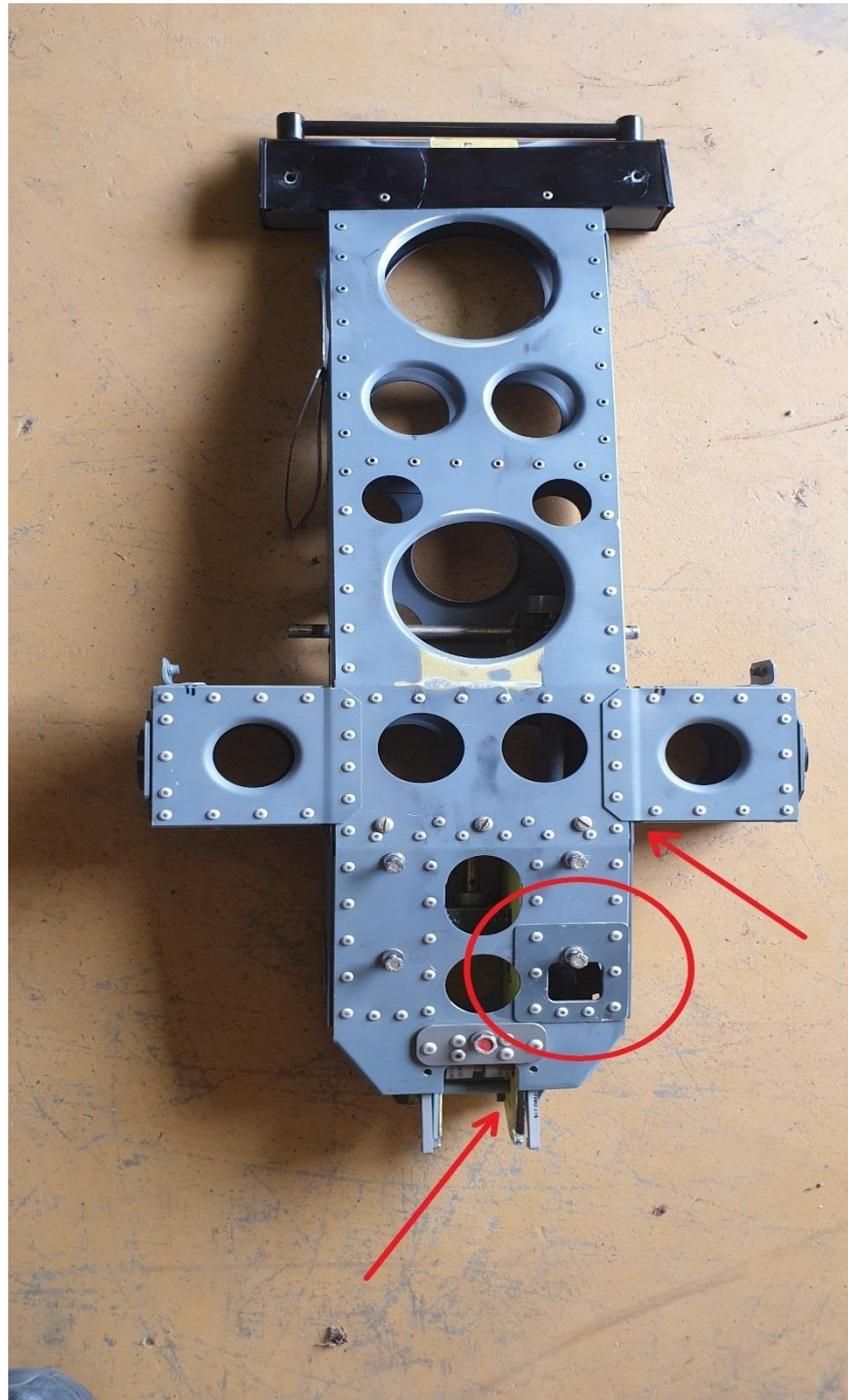
Figure 4: Circled area showing doubler repair which appears to be undocumented/unapproved. Arrows indicate areas where cracks are known to occur.

3. Review the aircraft maintenance records to determine the approval basis for any repairs that appear to be AC43 type repairs. If there is doubt, a person authorised under Part 21M/21J may need to review and approve any rectification to such a repair.

4. Advise CASA or an Authorised person if any repair is found to be undocumented.
5. If the OEM is unable to provide a repair scheme or replacement parts, then CASR Part 21M/21J approval should be sought for any repair.
