Helicopter Rotor Blade Stainless Steel
Tension/Torsion (TT) Strap Failures

AWB 63-009 **Issue :** 1
Date : 2 December 2013

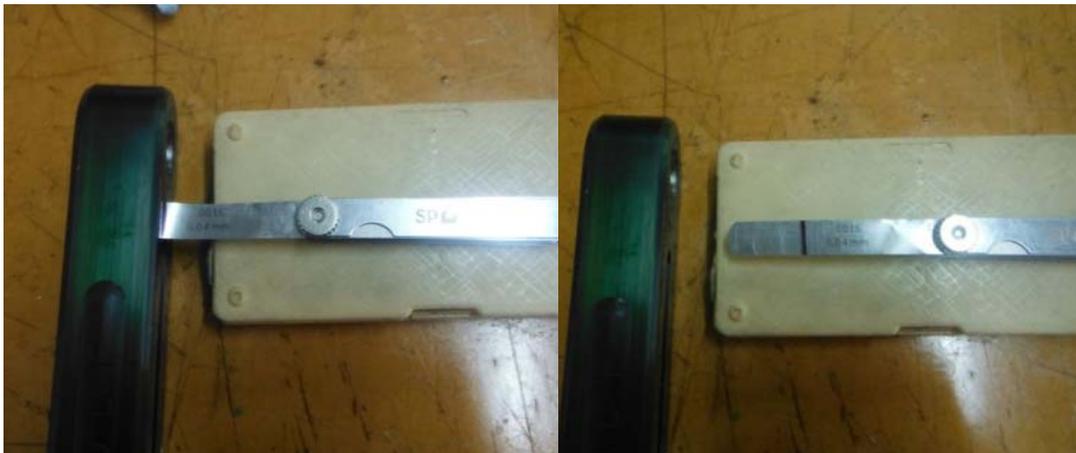
CASA has received defect reports describing cracks in the urethane casing of two brand new Airwolf Aerospace P/N AA-206-011-154-107 Rev B, S/N AA10856 (PMA) TT straps (see Fig. 1a and 1b) and an additional report of an unidentified brown paste in a time-expired Airwolf Aerospace TT strap which did not appear to be cracked.

Fig. 1a and 1b Showing penetration of a .015" Feeler gauge in the urethane casing of an Airwolf TT strap.

Because stainless steel must be in continual contact with the oxygen in the atmosphere in order to develop and maintain the integrity of the chromic oxide film, lack of oxygen will cause breakdown in any area of the oxide film and allow localised corrosion cells to form in the presence of contamination which will enter the urethane case via cracks or leaks.

Inspect TT strap casings for cracks, or other evidence that the protective casing may be compromised, and

Withdraw from service any TT strap assembly which has cracks or other evidence that the protective coating has been breached.
