Cessna 150/152 Series Aircraft Horizontal
Stabiliser Spar Cracking

AWB 25-003 **Issue :** 2
Date : 8 February 2012

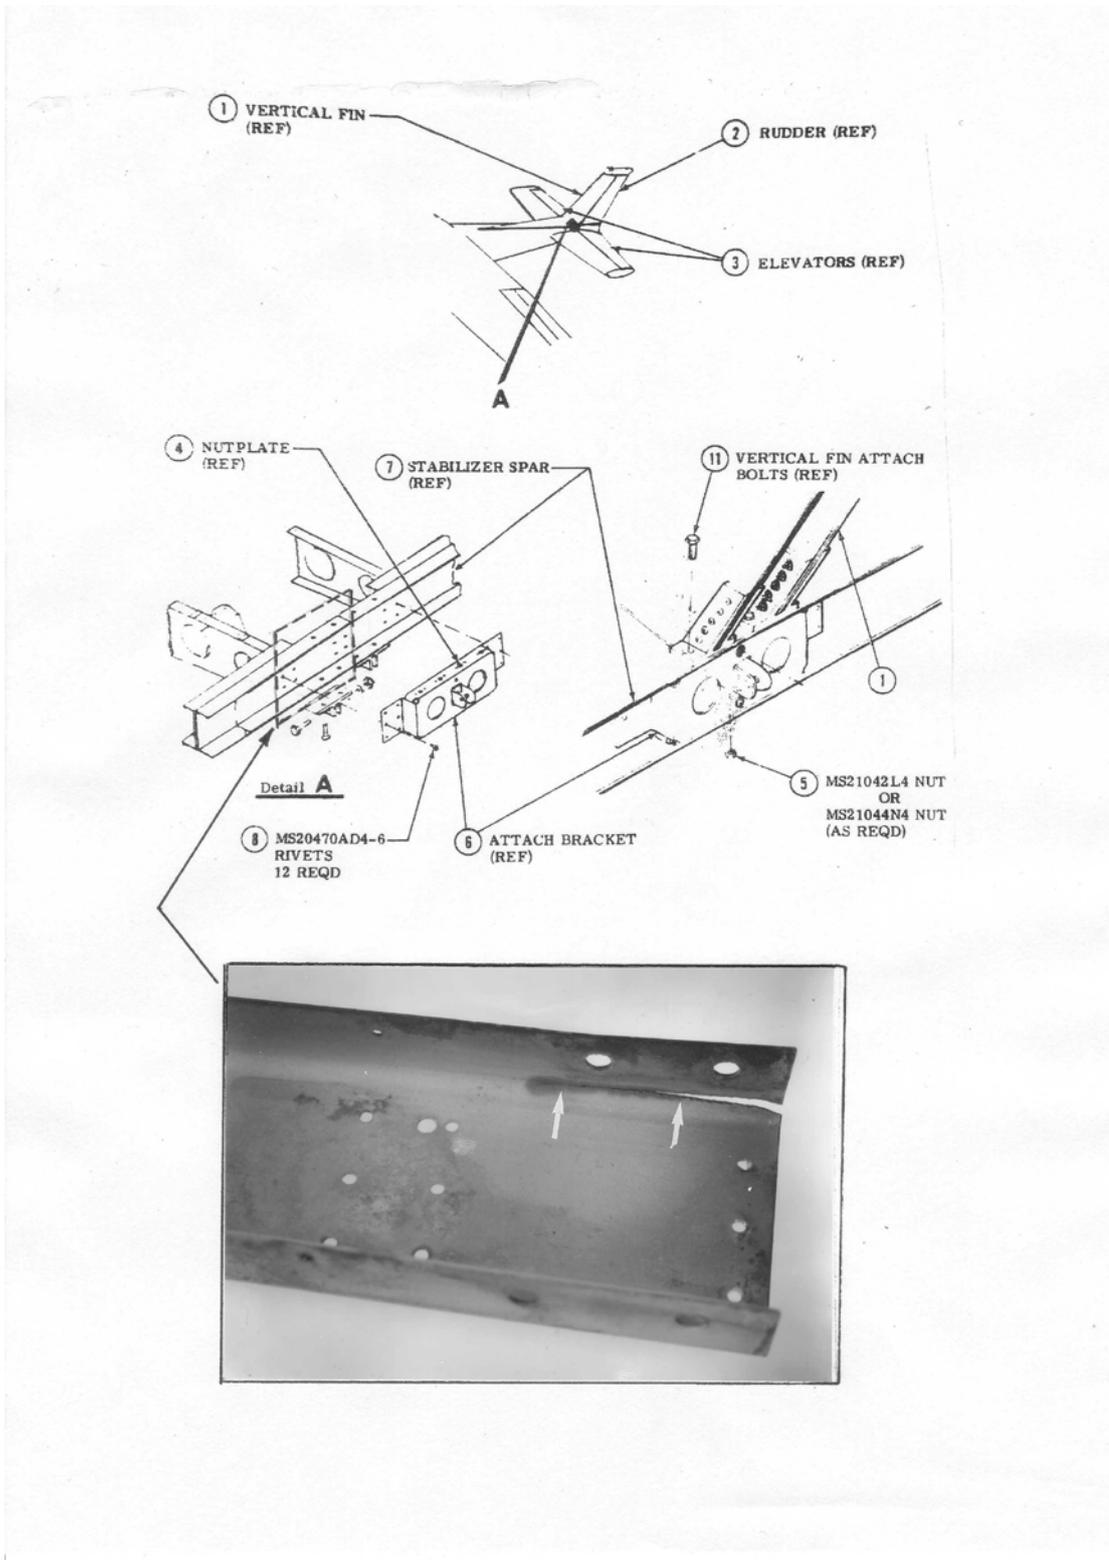
The purpose of this bulletin is to advise operators and maintenance organisations that cracks may exist in the vertical fin attachment bracket P/N 0432004-9, horizontal stabiliser spar P/N 0432001-56 and/or its reinforcement P/N 0432001-15 and to provide a method for a visual inspection to detect these cracks if they exist.

During inspections for the cracking in the vertical fin attachment bracket nut plates in accordance with AD/CESSNA 150/31 Amendment 4, several operators have noticed cracking along the edge of the plate welded to the forward face of the fin attach bracket. On very rare occasions, this cracking may extend into the horizontal stabiliser spar and its reinforcement. The vertical fin attach bracket is attached to this spar by twelve fasteners (6 each side) and when the bracket cracks, the additional loads are transferred directly into the spar, causing cracking. The cracking in the vertical fin attachment bracket is a slow, progressive failure during which time the tailplane assembly is still capable of withstanding the original design loads. Once the crack has extended into the stabiliser spar, the tailplane structural strength may be reduced below the original design strength.

Previous experience has shown that the cracking in the spar is a fatigue phenomenon, driven by in-flight cyclic loads on the tailplane structure. There have been no reported cases of in-flight horizontal stabiliser failure due to these cracks and only seven reported incidents of cracking in the type's history.

attention should be paid to the weld at the top, forward corner of the fin attachment bracket and the corresponding sections of the spar and reinforcement doubler.

2. Visually inspect the horizontal stabiliser spar and reinforcement for cracks using a bright light source, removing protective coating where necessary. See figure 1 for inspection location.
3. Re-protect the subject area with an approved protective treatment and return the aircraft to its original condition per the Cessna maintenance manual.
4. Report any cracks found in the stabiliser spar or reinforcement to CASA via a Defect Report form.
