AIRWORTHINESS BULLETIN

AWB 25-020 Issue 3 – 1 May 2018

Lifejacket Survivor Light Battery Failures

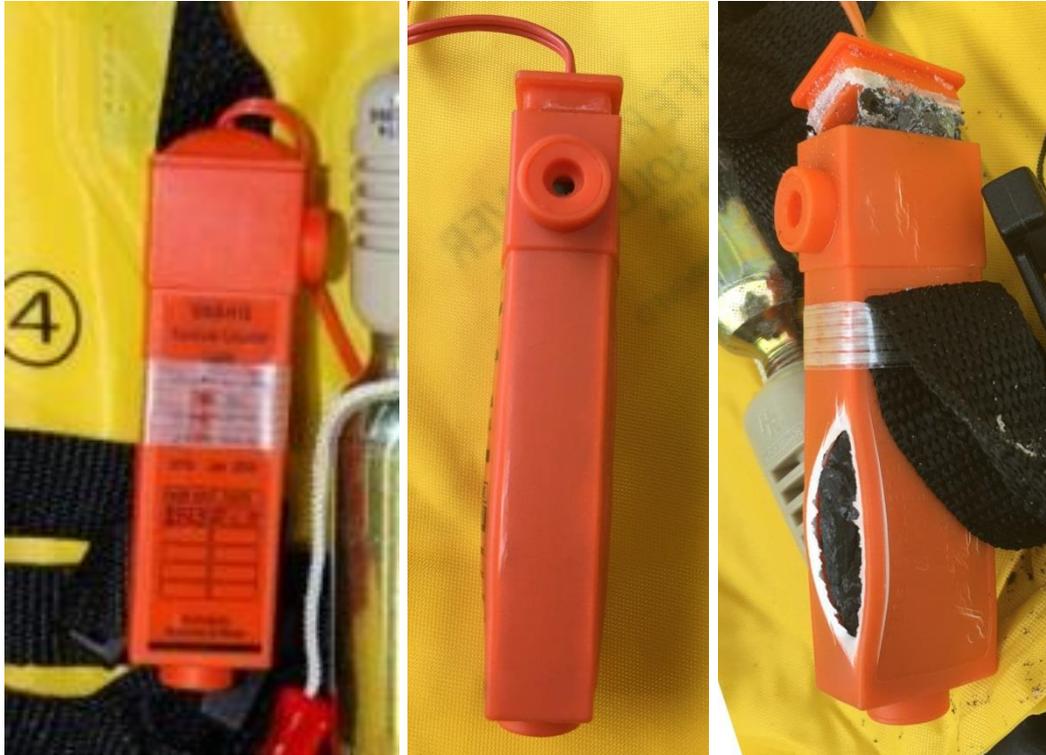
Since the initial issue of this AWB, CASA has received three separate defect reports on Survivor Light Batteries on EAM Lifejackets and one on Regent Lifejackets that contain Epsilon – Electric Fuel WAB-H18 Survivor Locator Light Batteries. In all cases, the batteries of multiple lifejackets were swollen beyond limits and had split cases or endcap pushed off due to swelling of internal components.

These Lifejackets can be packaged in a sealed valise, non-sealed valise or a pouch. As the battery is packaged in the centre of the folded lifejacket contained within the valise, the failed batteries show little externally visible evidence of their

loss of integrity. Failure of the battery can only be confirmed by opening the valise.

Figure 1: Left to right – Serviceable battery, unserviceable battery (note swelling of main body and endcap pushing off), failed battery.

CASA recommends all operators with Regent RSS-301(XX) type and EAM KSE-35L8 (P0723E105PW) lifejackets be aware of the following attributes that may indicate a failed battery inside:

1. Visually inspect every lifejacket valise. Look for any tears or pin holes in the packaging, and for any visible moisture inside the packaging.
2. For Regent RSS-301WT, the valise should be sealed and evacuated ('sucked down'). Note if it is 'inflated' or pressurised.

CASA recommends lifejacket packages that contain:

- a. any tears in the valise,
- b. visible moisture inside the valise, and
- c. for Regent RSS-301WT lifejackets - the valise appears to be inflated,

be considered suspect in their integrity and the lifejacket should be returned for servicing.
