AIRWORTHINESS BULLETIN

Lycoming Engines Model L-TIO540-J2BD Engine **AWB** 83-001 **Issue :** 1
Crankcase and Accessory Gear Housing Reliability **Date :** 7 April 2006

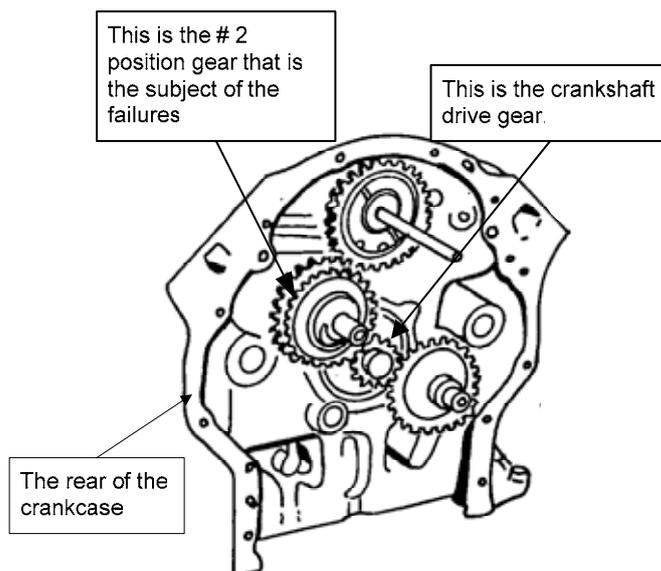
These failures occurred around the magneto idler gear position (#2 gear position) and had active failure modes that included failure of the magneto idler gear (LW-10292 & LW -10297) and failure of the gear supporting bosses on the crankcase and accessory gear housing.

Figure 1. #2 Gear position & Crankshaft drive gear position

- A. The magneto idler gear be replaced with a new item at overhaul. Engine build-specification should also be reviewed with a view to replacing all accessory gears at overhaul and to specify the maximum life of crankcases. For those engines with extended manufacturers TBO or with engines 'on condition' the Registered Operator should also review the timing for replacement of these gears.
- B. Where crankcase halves have undergone any machining process or modification: In order to maintain in-service reliability, particular attention should be paid to manufacturer's crankcase dimensional tolerances, and should be checked for accuracy as a part of the machining process. This should be reflected in the relevant EO or modification documentation.

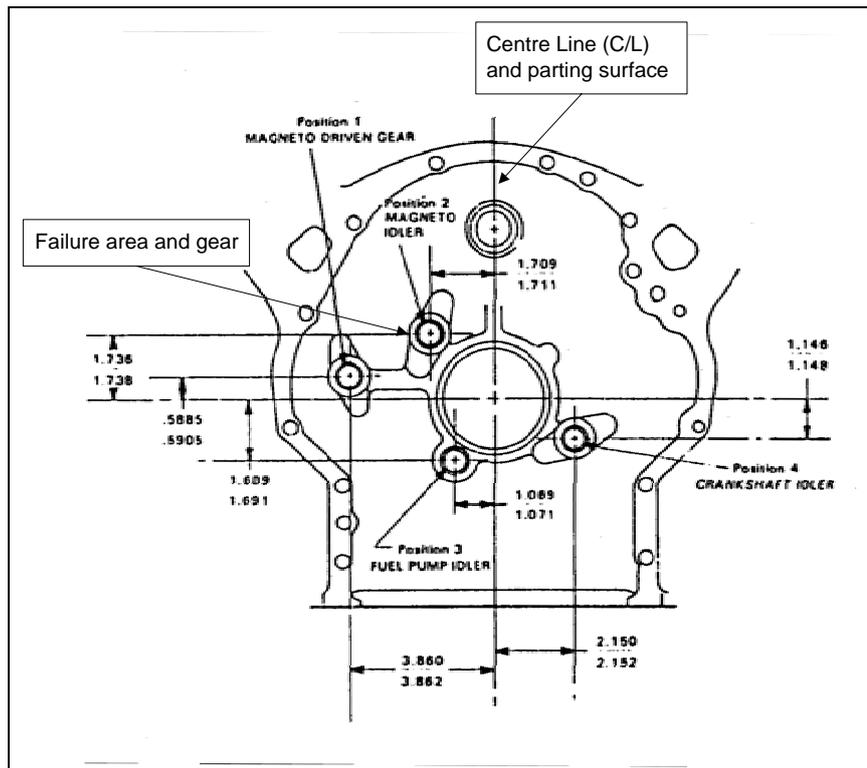
Figure 2. Gear boss positions and dimension.

For accessory drive gear case bosses, as shown in figure 2 and Lycoming Service Instruction, SI 1417, the accuracy of all dimensions should be determined as part of the machining process before going for assembly. The gear drive backlash check is for assembly purposes only, and not intended to be a measurement of accuracy of prior machining processes, it is simply not an accurate enough indication for that purpose.

Additionally the deck height of the crankcase halves should be checked. The CASA recommends that the deck height should be as close to nominal (4.500") as possible with a minimum deck height of 4.480", representing a maximum 0.020" reduction.

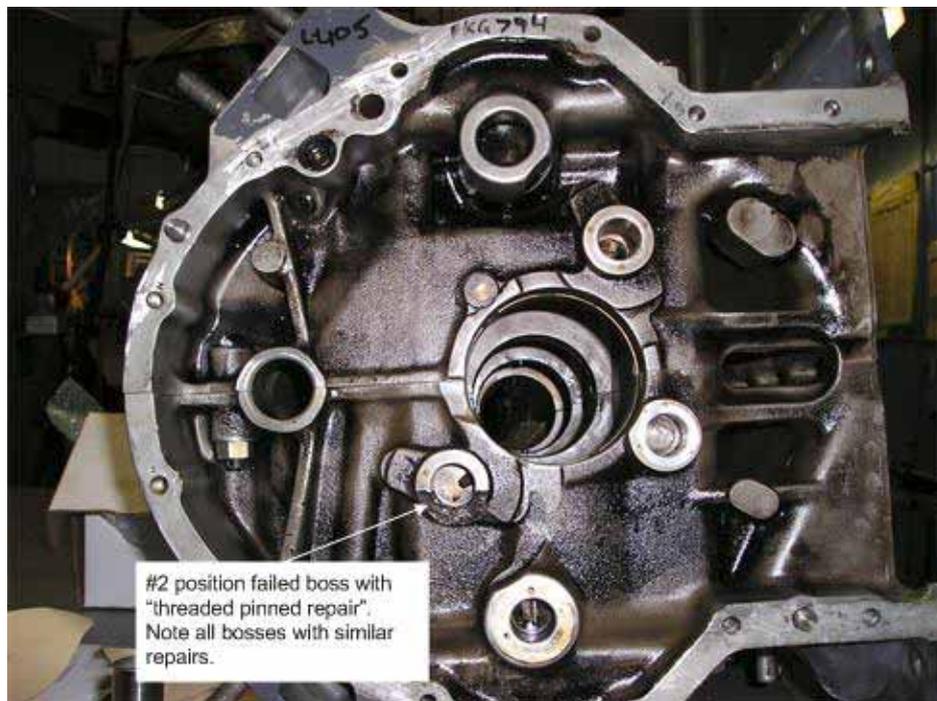
- E. A number of the failed engines had unusual repairs in the accessory gear area. Figure 3 shows one of the unusual repairs which are identified by the threaded brass pins locking a machined sleeve inserted into the gear boss areas. It is recommended that any crankcases discovered with the repairs as shown in Figure 3 be removed from service.

For example, the repair shown in figure 3 is very different from Lycoming SI 1417 repair (refer also to figure 4). Referring to the extract from SI 1417 (figure 4), the dowel (pin) is singular, non threaded and positioned radially in the bush. On the contrary, the repair scheme depicted in figure 3 reveals three (3), threaded, vertical, brass pins. If the Lycoming repair is properly incorporated, the observer will not see any pins unless one views inside the bushing while in figure 3, three dowel pins are clearly visible.

Figure 3. Threaded Pin Repair (not recommended).

Lycoming SI1417 repairs are acceptable while repairs such as depicted in figure 3 are not.]

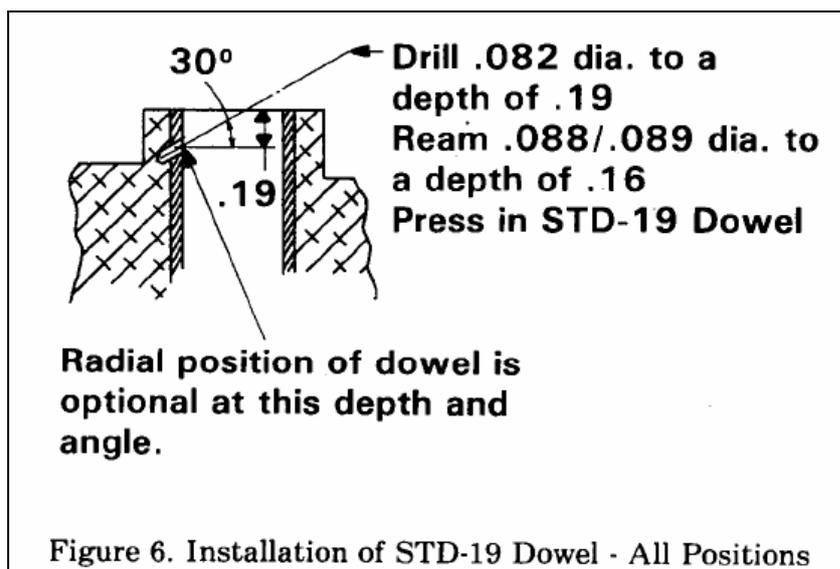
Figure 4. Extract from SI 1417 regarding pinning bush repairs.
