Lycoming O-235 Engine Accessory Housings

AWB 83-002 Issue : 1
Date : 11 December 2006

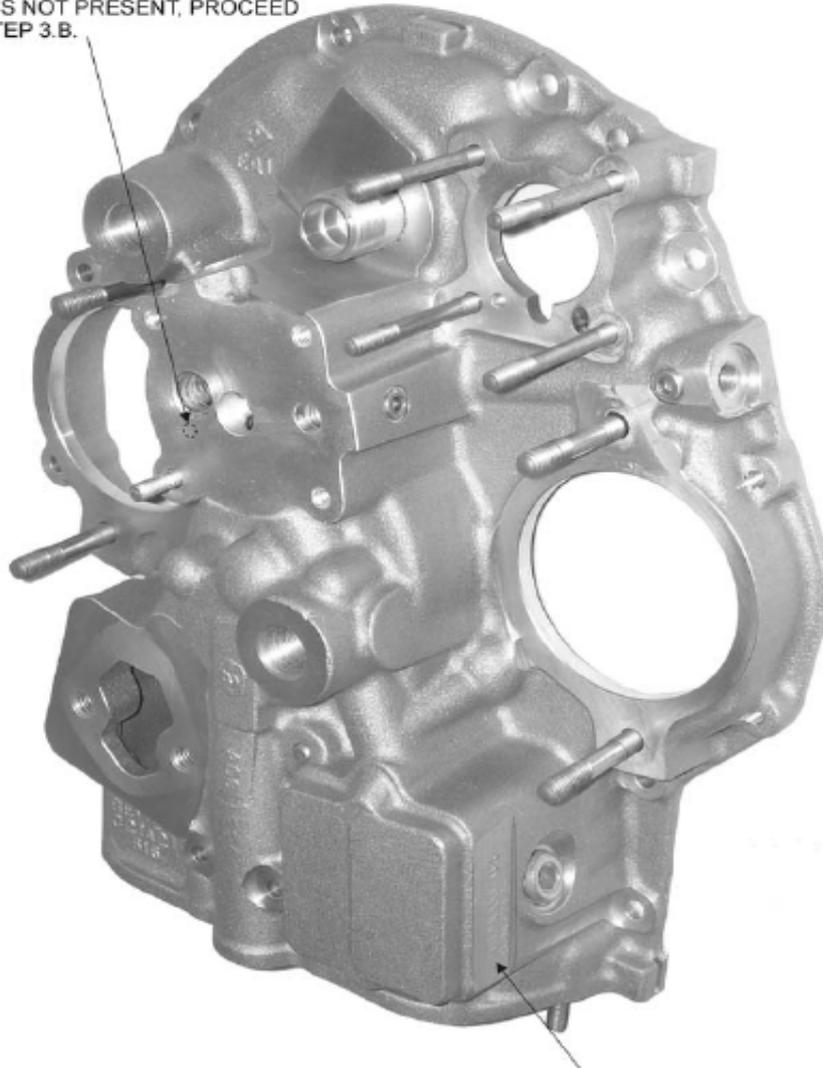
Certain accessory housings, P/N 21A23000, either installed on Lycoming O-235 engines or received in an accessory housing kit, P/N 05K21678 between 01 September 2003 and 01 June 2006 may not have an oil passage hole to the idler gear shaft. If the idler gear shaft is not lubricated, wear damage to the idler gear shaft and subsequent damage to the engine by metal contamination may occur.

THE OIL PASSAGE HOLE CAN BE FOUND NEAR THIS LOCATION. IF THIS IS NOT PRESENT, PROCEED WITH STEP 3.B.

THE ACCESSORY HOUSING SERIAL NUMBER WILL BE STAMPED HERE. IF THE SERIAL NUMBER DOES NOT CONTAIN "7212" THEN NO FURTHER ACTION IS REQUIRED. IF IT DOES CONTAIN "7212" THEN PROCEED WITH STEP 3.

1. Remove the oil filter base or pressure screen housing and inspect for the presence of a 3/16-inch hole at the location shown in Figure 1 of Lycoming MSB 572.
2. If the 3/16-inch hole is not present, contact the manufacturer for further instructions.
3. If the 3/16-inch hole is present, verify that it passes through to the interior of the accessory housing by using compressed air or probing with a thin piece of wire.

If the passage hole is obstructed, contact the manufacturer for further instructions.
