This Airworthiness Bulletin (AWB) is a compilation of information contained in Airworthiness Advisory Circulars (AAC), Service Bulletins (SB), Service Difficulty Reports (SDR) and Advisory Circulars (AC) and will be revised from time to time to incorporate new magneto defects.

## Magneto Defects

AWB 74-005 Issue : 3  
Date : 20 October 2014

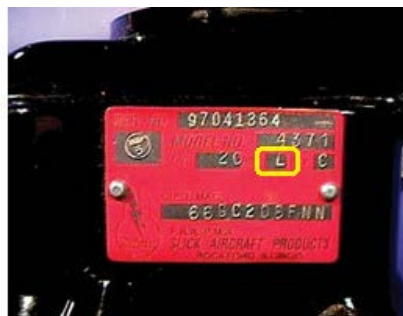
In one instance, a left hand rotation magneto was installed in the position where a right hand rotation was specified. This resulted in a rough running engine with reduced power and the associated possibility of destructive detonation.

Figure 2 - Data plate showing typical code for direction of magneto rotation

Care needs to be taken to ensure the correct model magneto is fitted that will suit the direction of rotation of the engine. This is typically marked on the magneto data plate with either “L” or “R”. The L or R text does not refer to the position on the engine. Check with the approved technical data for the correct magneto and installation instructions. See Figure 2.

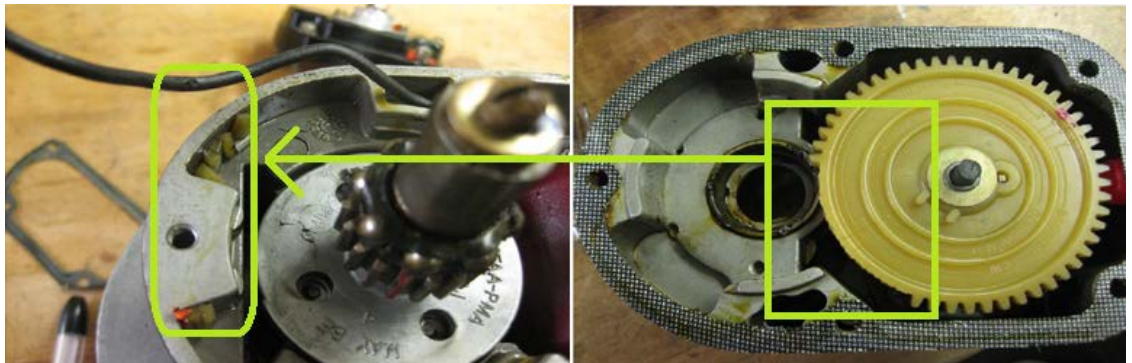
The magneto in Figure 3 (below) suffered teeth failure approximately 150 hours after the magneto was inspected in accordance with the 500 hour Continental Motors System Support Manual inspection. This issue was found when a magneto failed a dead cut test. When the magneto was opened - the

distributor gear was found with several gear teeth broken away from the gear. The teeth were retained inside the magneto case. No other parts were found out of place inside the magneto case. This magneto was documented to have approximately 1000 hours TSO (total since overhaul); however, overhauled magnetos may contain components which have been in service for many years.

Figure 3 - Broken Distributor Gear Teeth (Sourced from FAA Alert 401, December 2011)

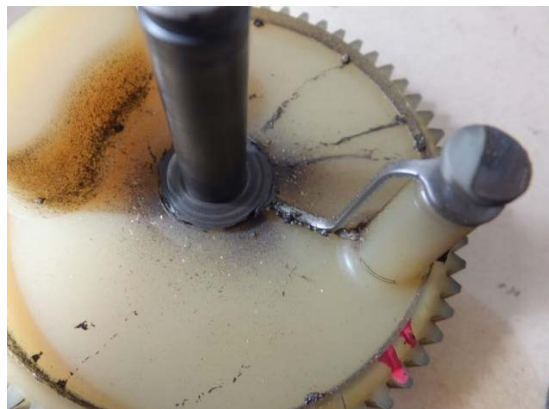
A distributor gear which either rotate sporadically or does not rotate due to broken teeth, may also result in additional internal arcing damage to other electrical components, such as tracking burns on the distributor cap and burnt high tension coils. See Figure 4.

Figure 4 - Arcing damage on distributor gear wheel

This is because the high tension electricity is still being generated as the magneto continues to operate and if the electrical energy cannot discharge at the spark plug, it seeks alternate paths to earth.

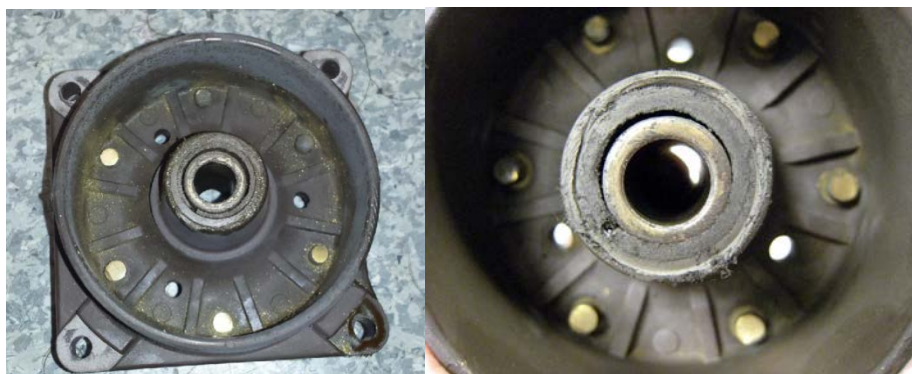
Magneto miss-firing and dead-cuts have been traced to the distributor wheel shaft bearing spinning and moving in the bearing block. 30 SDRs have been reported regarding this type of failure. On one occasion this problem caused an engine failure on take-off.

Figure 5 – Distributor Bearing block

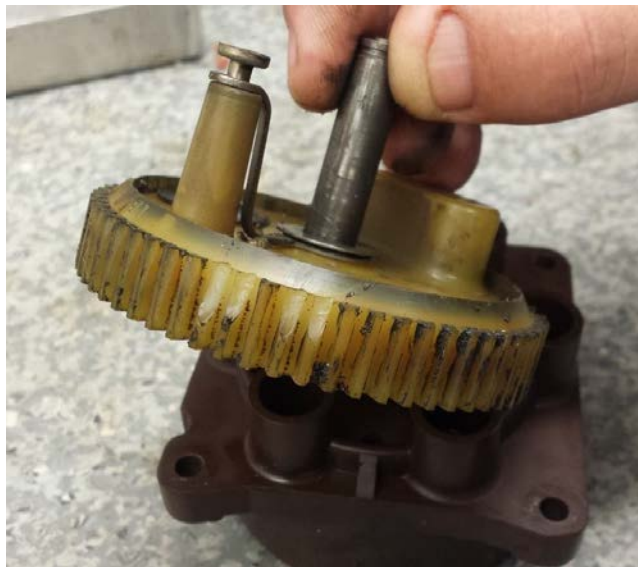
When distributor block bearing failures occur, the nylon distributor gear can become intermittently disengaged from the pinion gear and this problem may be first apparent by engine rough running, loss of engine power, and as the failure progresses, complete loss of timing and no output due to distributor gear wheel teeth being sheared off the nylon gear. On inspection because of the play from the bushing it was found that the internal timing had skipped teeth on distributor gear wheel and was 180 degrees out of timing. See Figure 6.

Figure 6 - SDR 510019629 Broken teeth

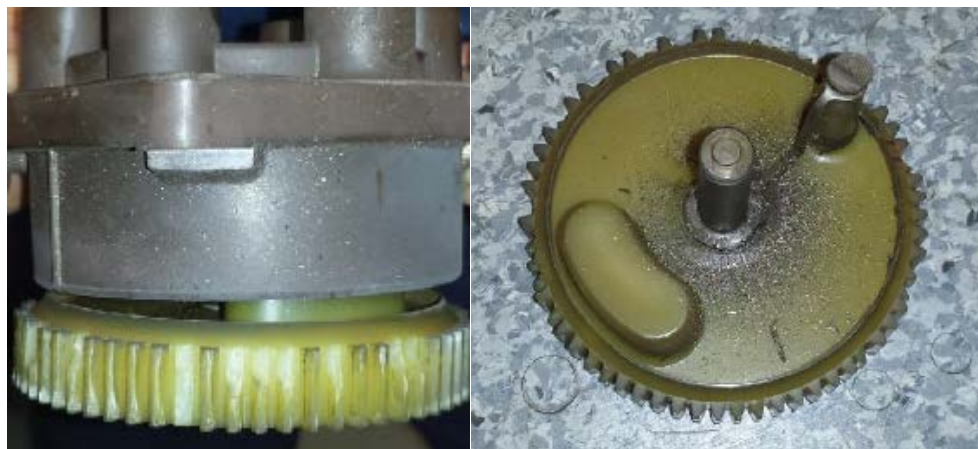
Lower bearings have been found loose in the cap has also allowed the electrode on the rotor finger to contact the high tension terminals in the cap (see Figure 7). This type of failure could cause premature magneto failure.

Figure 7 - Sheared teeth and debris from electrode contacting high tension terminals

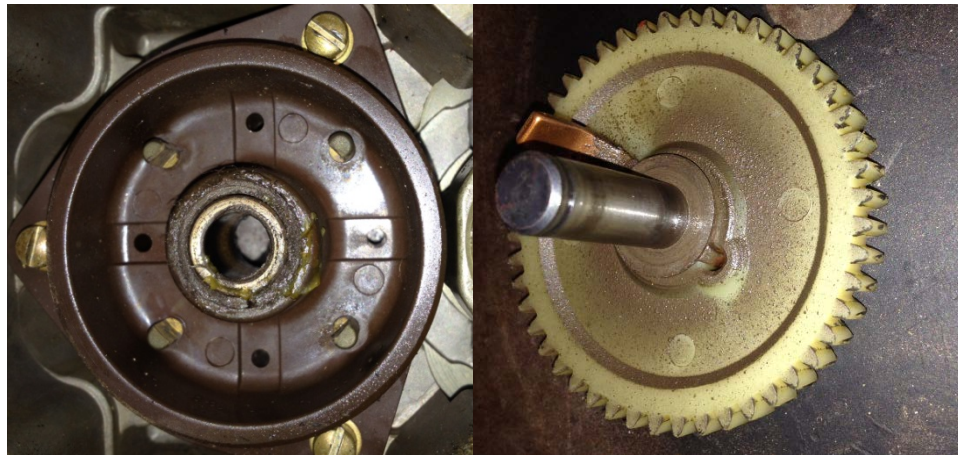
It is reported by magneto overhaul shops that despite close inspection of new distributor blocks, there is no way to determine if a new distributor block will prove to be reliable in service. This is currently the matter of an active on-going investigation in conjunction with manufacturers. In the CASA SDR database, there has been an approximately 70% increase in loose distributor block bearings in rotorcraft installations.

Figure 8 - Bushing failure

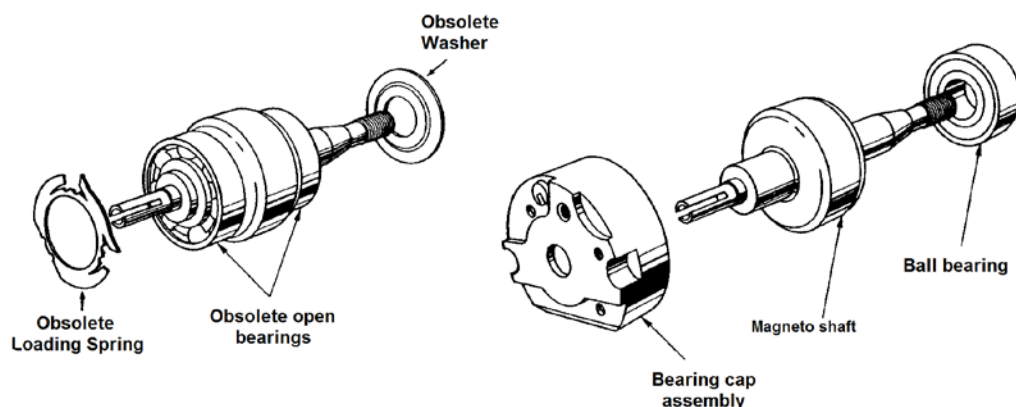
CASA AAC 1-81 - Magneto Maintenance - General 6/95 documented bearings spinning in the end cap. This has occurred in Slick 4200 and 6200 series magnetos and AD/ELECT/46 was issued to address this problem. The AD has been cancelled and the content of which is now incorporated into manufacturers Service Bulletins see Figure 9 below.

Figure 9 - Old and new slick bearing end cap designs

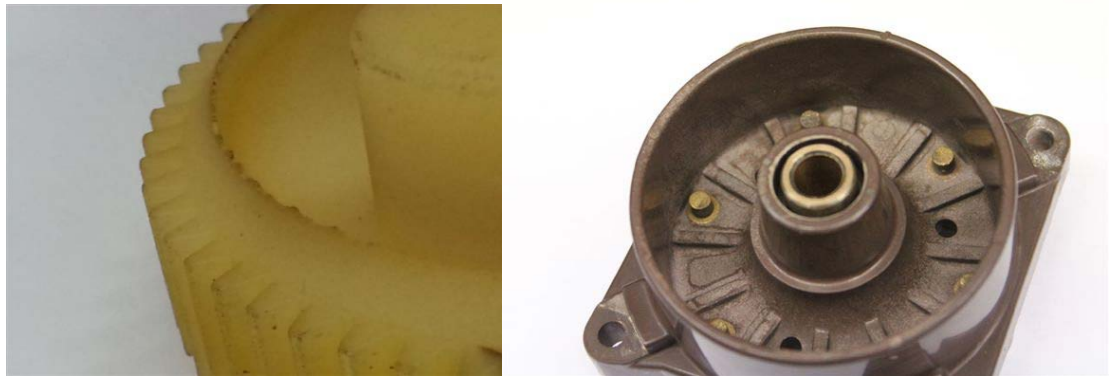
In one instance a magneto was inspected after an overhaul from an FAA approved overhaul facility (see Figure 10). The distributor gear and block were sandblasted during the previous overhaul, causing erosion to the parts.

Figure 10 - Eroded gear and block

Figure 10 shows sand blast beads were found in the block bushing. This issue was identified during an overhaul of the magneto.

Sandblasting is not an approved process during overhaul and this information was provided to the FAA to aid in their inquiries.

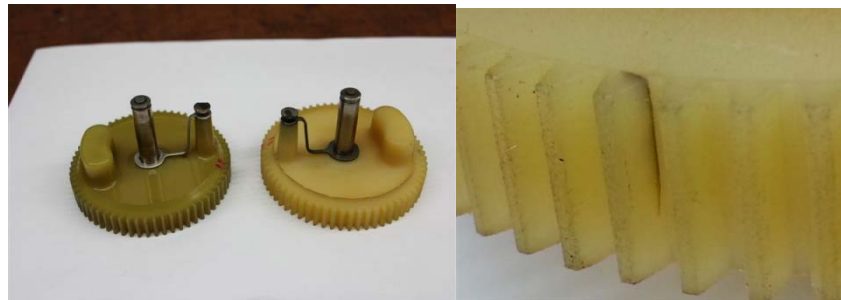
Figure 11 - Original gear compared to sandblasted gear and cracked gear tooth

A closer inspection of the sand-blasted gear tooth revealed cracks, which would have caused an eventual premature failure of the gear.

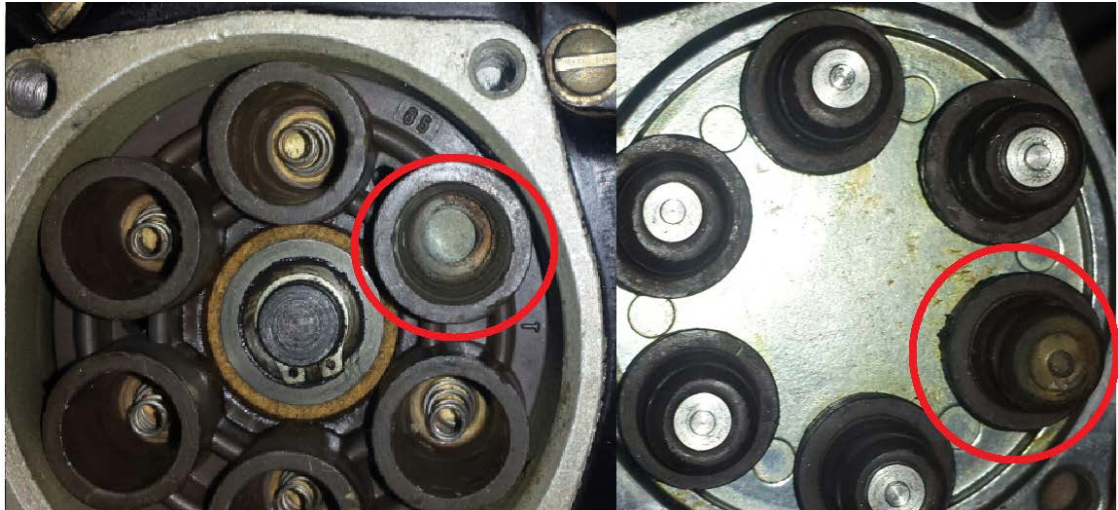
Figure 12 shows both sides of the magneto distributor block where a distributor block spring was missing in the assembly of the magneto.

Figure 12 - Missing block spring

This magneto in the engine of rotorcraft, failed in service because a missing spring caused misfiring which lead to an autorotation landing. If the spring is missing it causes intermittent cross firing in the distributor and loss of power. It is important to check the springs are serviceable whenever an opportunity presents itself.

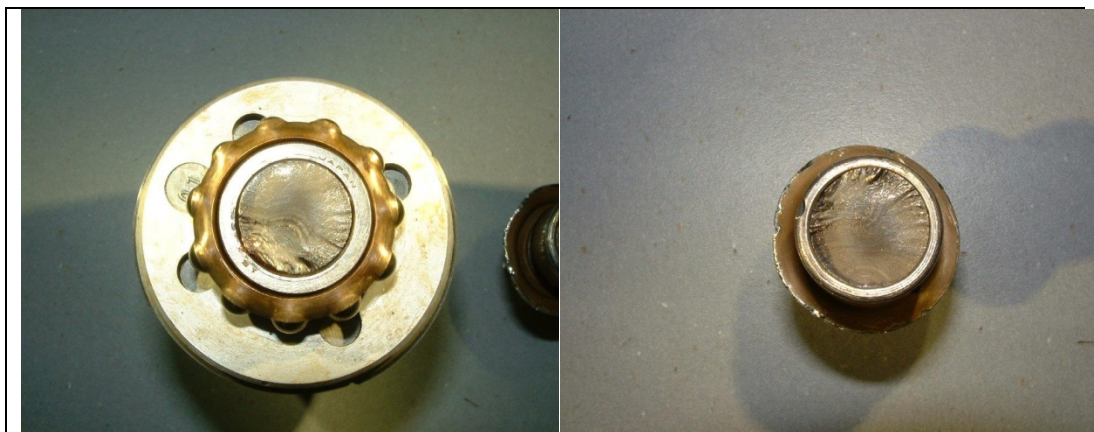
Failures of the type indicated in Figure 13 appear to be a result of high cycle fatigue cracking which initiates from small corrosion pits in the shaft or in the area of the Woodruff key. This shaft can also respond to engine vibration which, under certain conditions may induce a bending or wave motion response typical of shafts rotating at critical whirl speed, making the shafts vulnerable to any surface defect.

Figure 13 - Sheared shaft

Failures of this kind may also be linked to the same possible causal factors listed in as detailed in paragraph on Broken Distributor Gear Teeth.

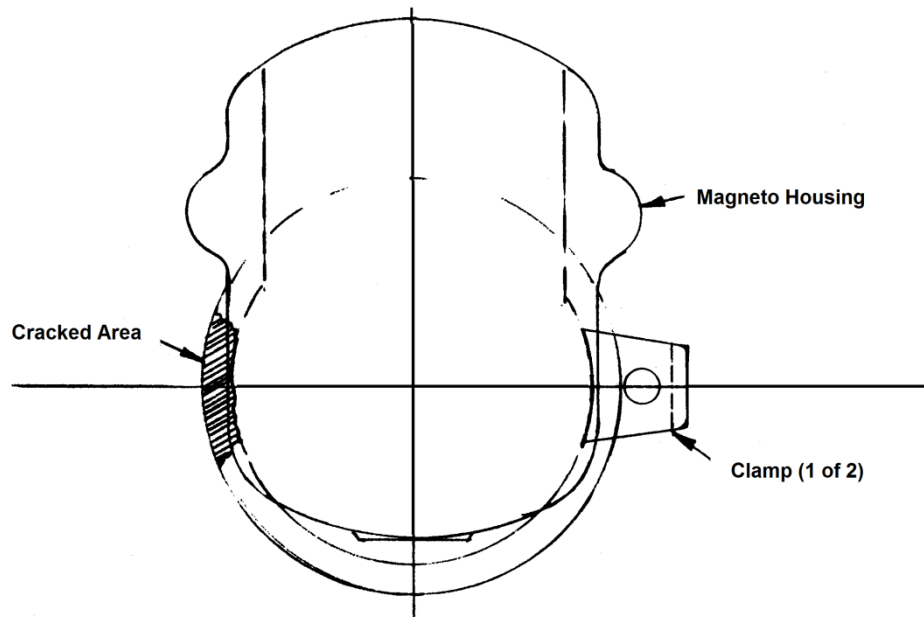
Figure 15 - From Slick SB 3-80B Broken Magneto flanges

An SDR was submitted to CASA where a manufacturing defect was identified in the housing casting. Failure occurred at the point of contact with the hardware. This caused the separation of a large portion of the flange from the housing.

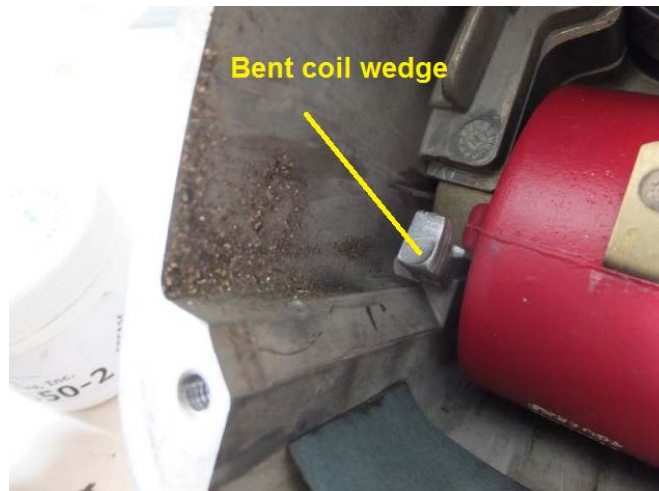
Wedges securing the coil core inside the magneto case were found bent. A bent wedge is unserviceable and will not perform its intended function of securing the coil.

Figure 21 – Bent coil wedge

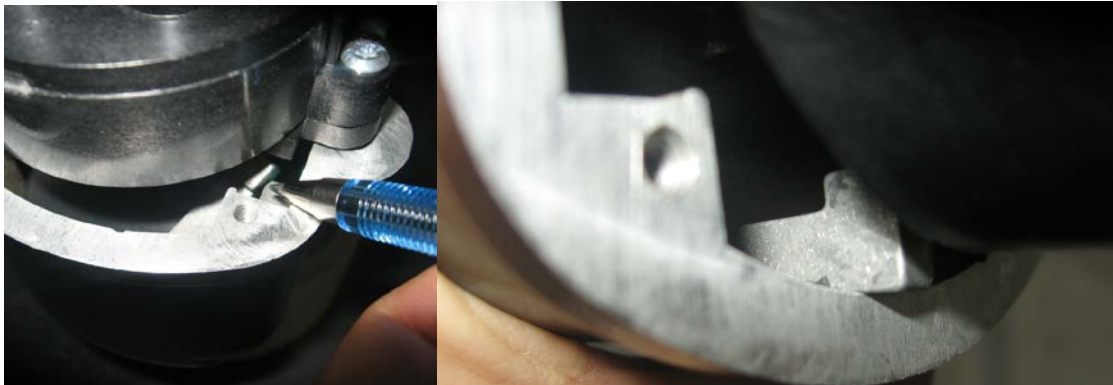
Instances of loose coil wedges have been reported to CASA. Loose wedges have could cause the coil to become dislodged and cause premature magneto failure.

Figure 22 - Magneto wedge loose inside case.

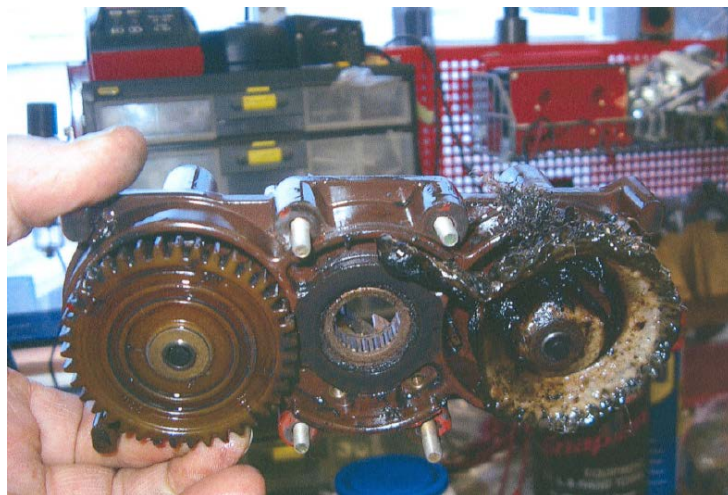
An SDR has identified missing bearing retainer plate screws. The magneto below in Figure 23, became heavily contaminated with engine oil which had entered the magneto via the missing retainer plate screws. The right hand distribution gear had suffered severe burning and melting. The gear was severely distorted and no longer in mesh with the drive gear.

Figure 23 - Missing bearing retainer plate screws

of the seal wears against a rotating surface. Oil seals should be changed during magneto overhaul.

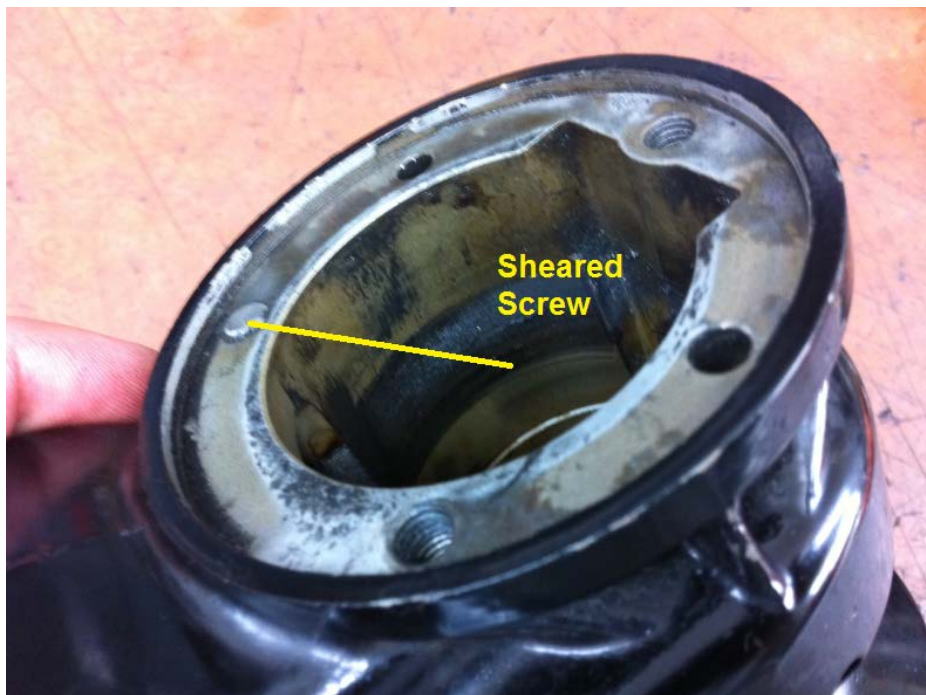
Incorrectly torqued magneto flange screws have caused the screws to shear. The stator below in Figure 24 was damaged by the magneto rotor as a result.

Figure 24 – Sheared screw

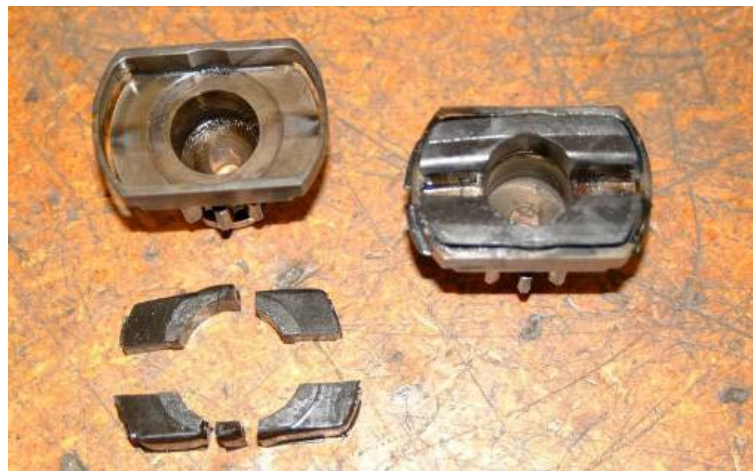
Although the magneto drive rubbers or cushions become hard and brittle during normal operation, it has been found that abnormal torsional engine vibration may cause magneto drive rubbers to fragment.

Figure 25 - Failed magneto drive rubbers

The study found that torsional vibration from the engine crankshaft was transmitted through the accessory gears to the EDFP coupling and to the magneto coupling. Torsional vibration caused the left hand magneto drive damper within the coupling to fail as illustrated in Figure 25(above). Similar failures of both EDFP couplings and magneto drive rubbers have also been reported in Australia. In the resulting post-study engine overhaul, the cause of EDFP coupling failure was attributed to worn crankshaft counterweight damper rollers and bushes.
