Maintenance of External Tubes and Lines    **AWB**    02-024    **Issue :** 1  
- Small Gas Turbine Engines                    **Date :**    15 August 2007

This AWB highlights the importance of proper installation of engine tubing and provides general advice on their maintenance. In all cases, maintenance data provided by the engine or aircraft OEM supersedes any guidelines contained in this AWB.

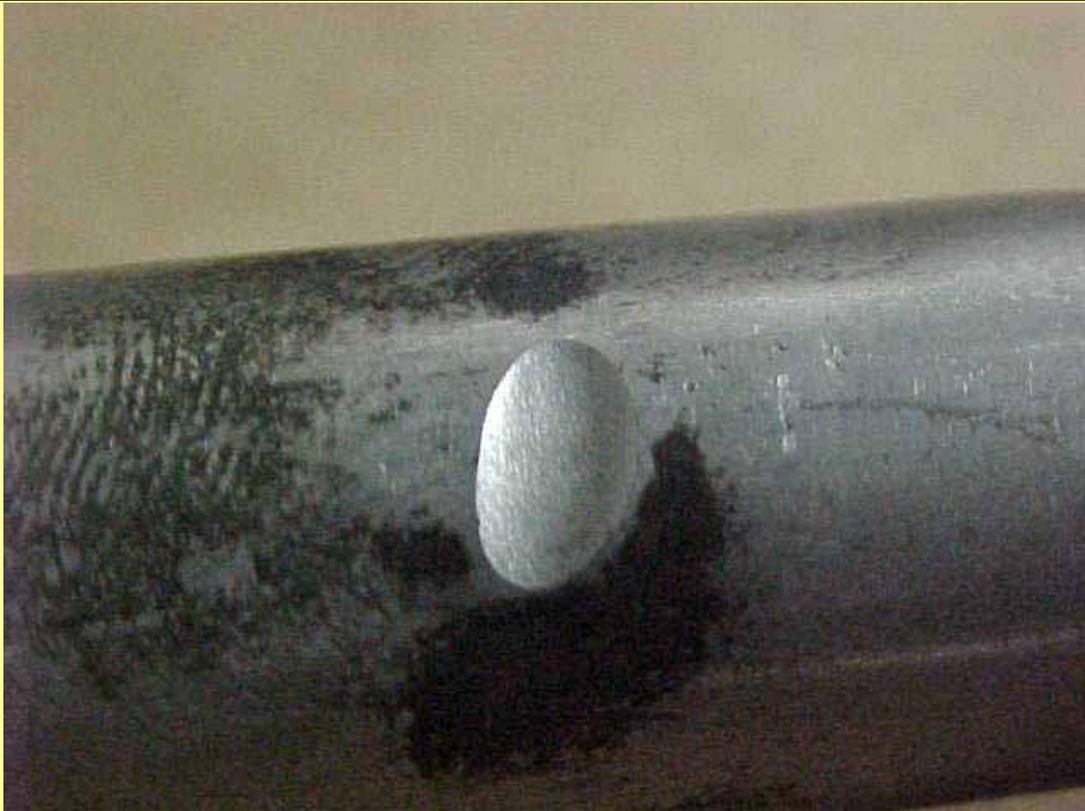
**Figure 1 - Tube Assembly - chafing marks and signs of corrosion**

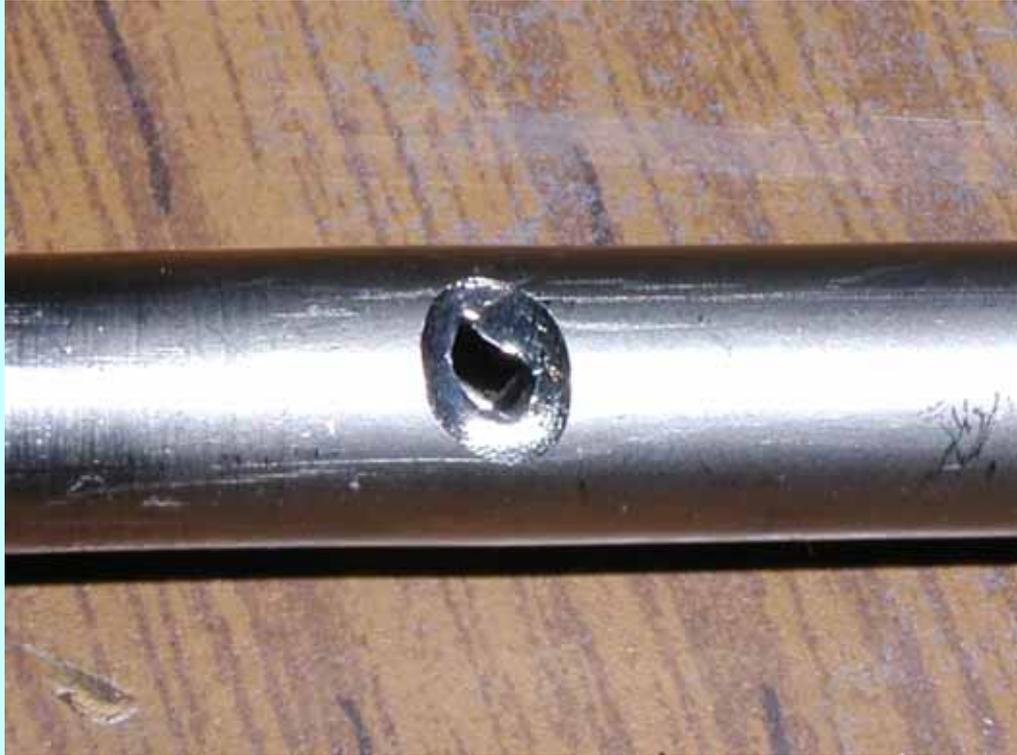
**Figure 2 - Tube Assembly - chafing led to holing and fluid leakage**

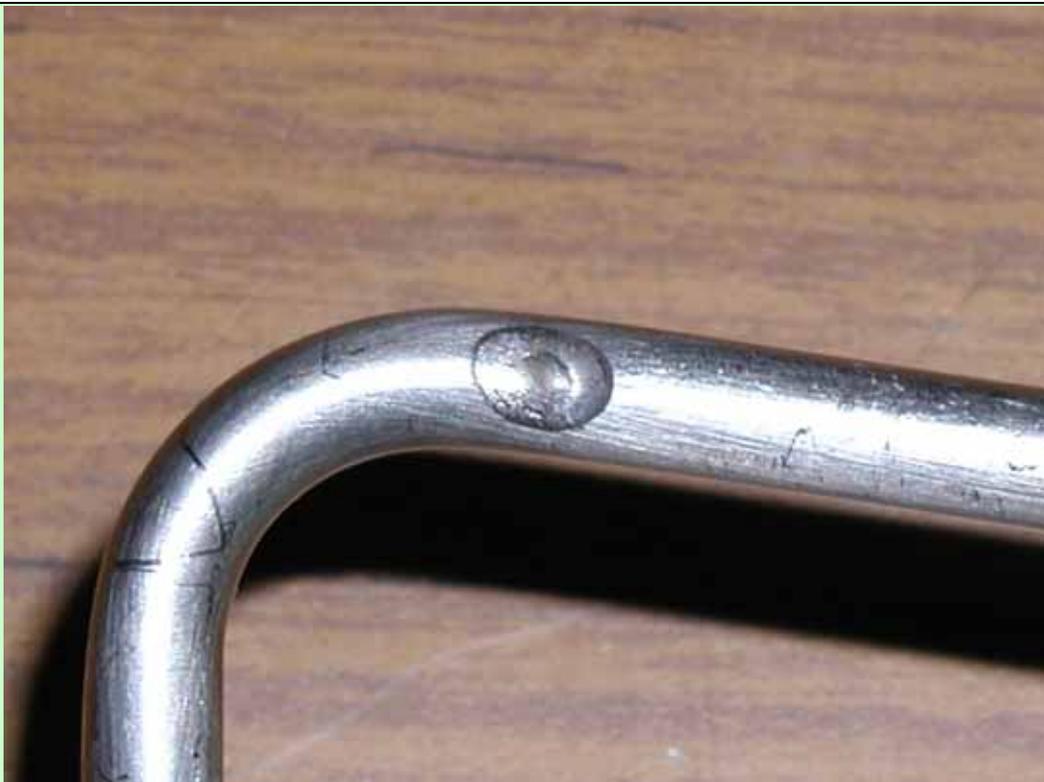
**Figure 3 - Tube Assembly - Chafing**

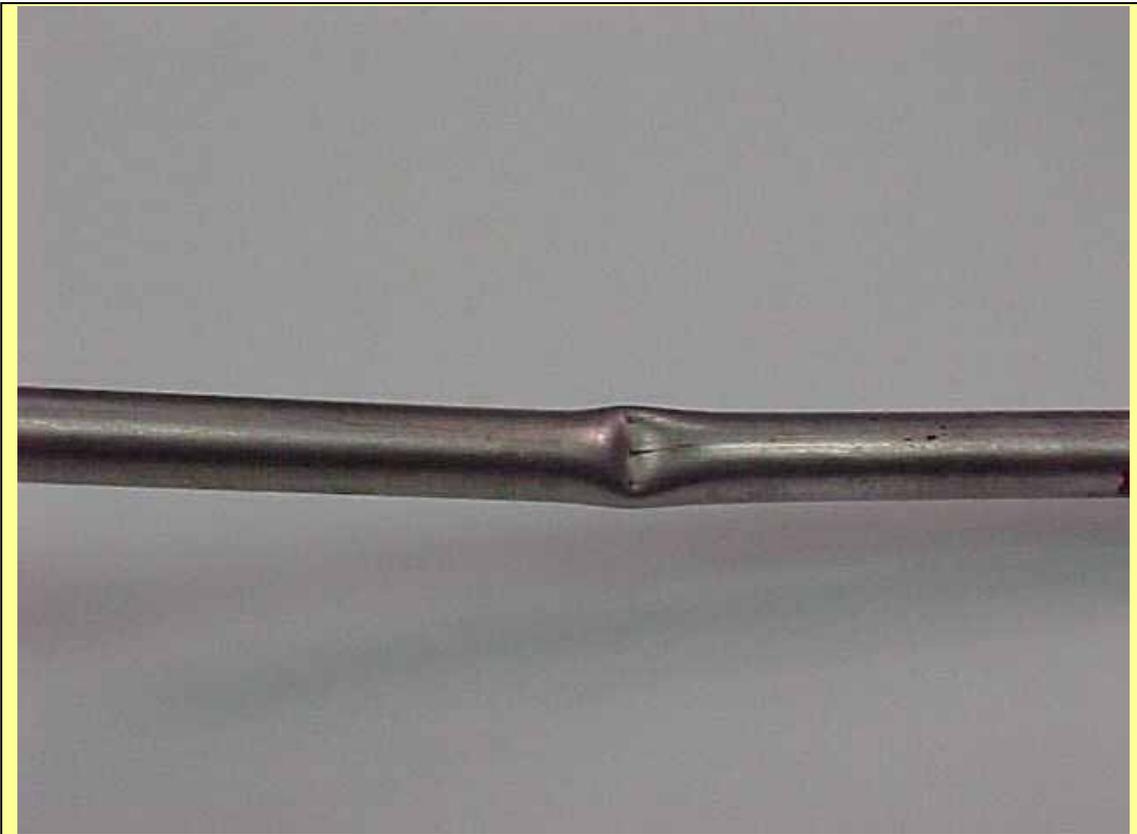
**Figure 4 - Tube Assembly, Rolls Royce P/N 23033896**

P/N 23033896 tube assembly was removed from a Rolls Royce Model 250-C20R Series engine. Photographs were taken of the deformations in the tube assembly and are indicated in Figure 4. The following discrepancies were noted during the examination of the tube assembly:

- A. The deformations were caused by attempting to use Model C2OR Series single engine designated clamping on a multi-engine configuration tube.
- B. The previously mentioned clamp hid the large dent. Only removal of the tube assembly allowed discovery of the extent of damage to the tube.

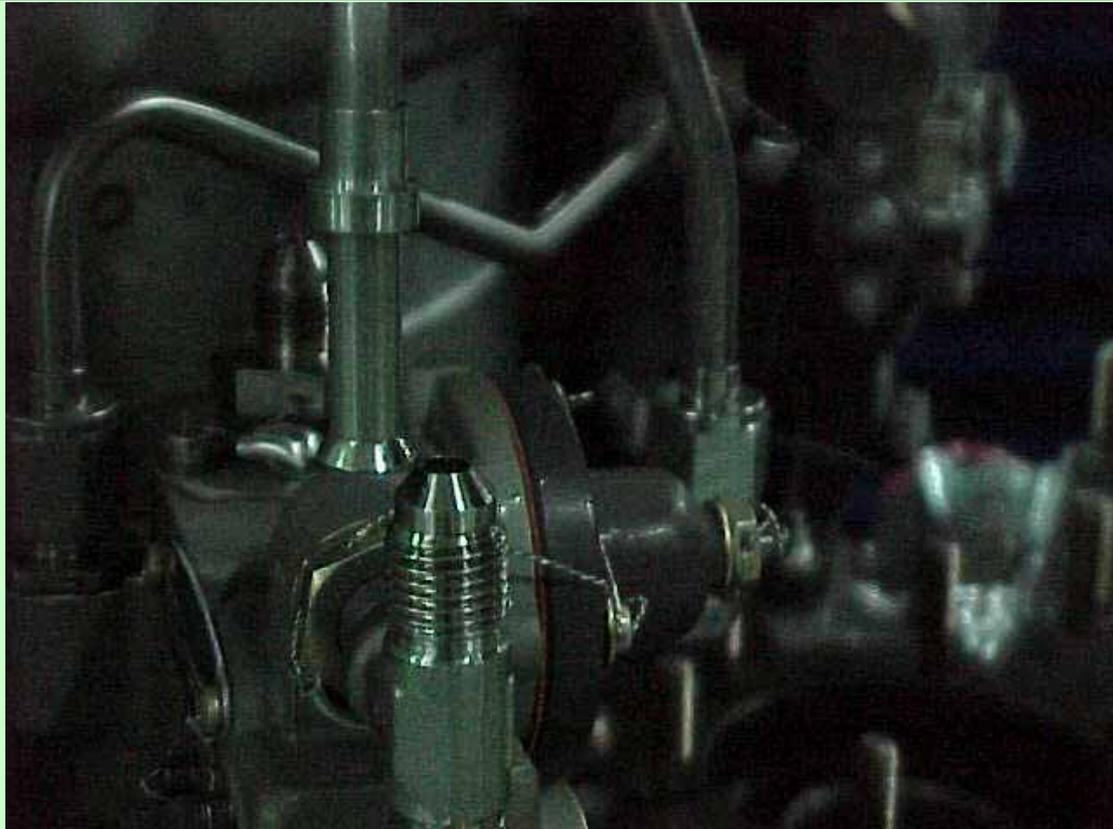
**Figure 5 - Misaligned Tube**

- C. Always use a torque reaction wrench when tightening tube assembly B-nuts.
- D. Tube assemblies must fit and be aligned with the mating flare tube fittings to the degree that at both ends of the assembly, the flares shall be uniformly seated in a free state on the cones of the mating fittings. The fitting shall be without distortions or stretching of the tube assembly, and to the degree that the nuts can be fully engaged up to the final one-half turn with light finger pressure. (See Figures 5 and 6).

- E. In the event that a tube does not align with the mating fittings, re-position the mating fittings to the degree that proper alignment may be achieved. Final tightening of these fitting lock nuts must be accomplished before the tube assembly is torqued.

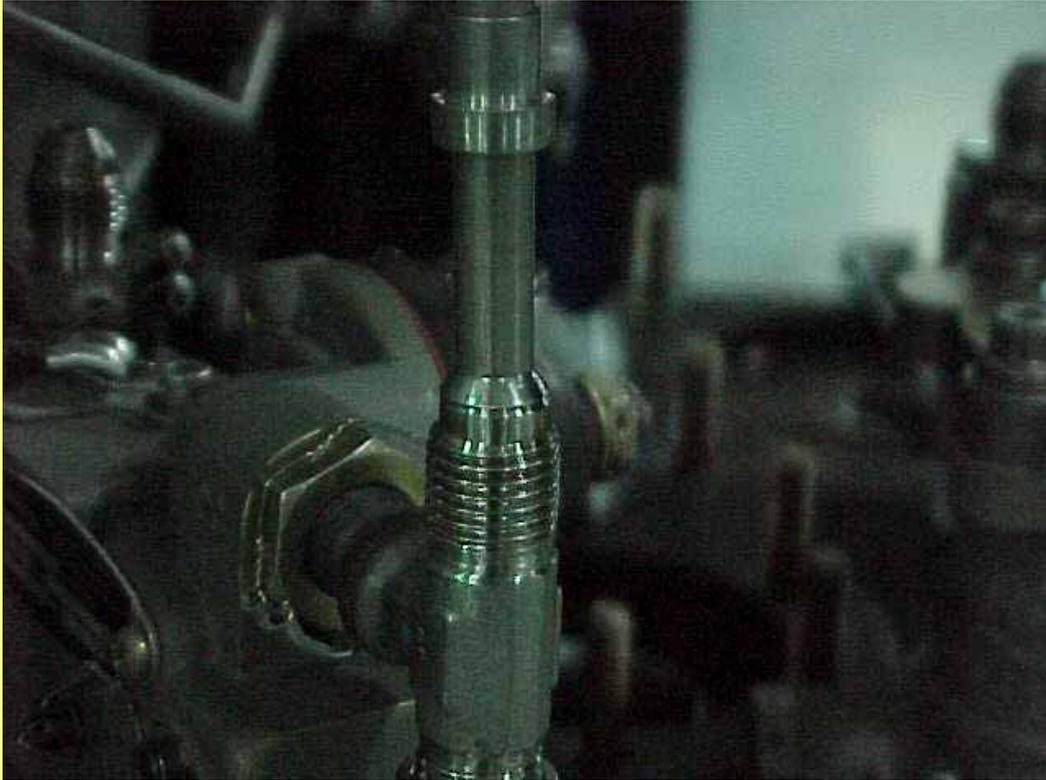
**Figure 6 - Properly Aligned Tube**

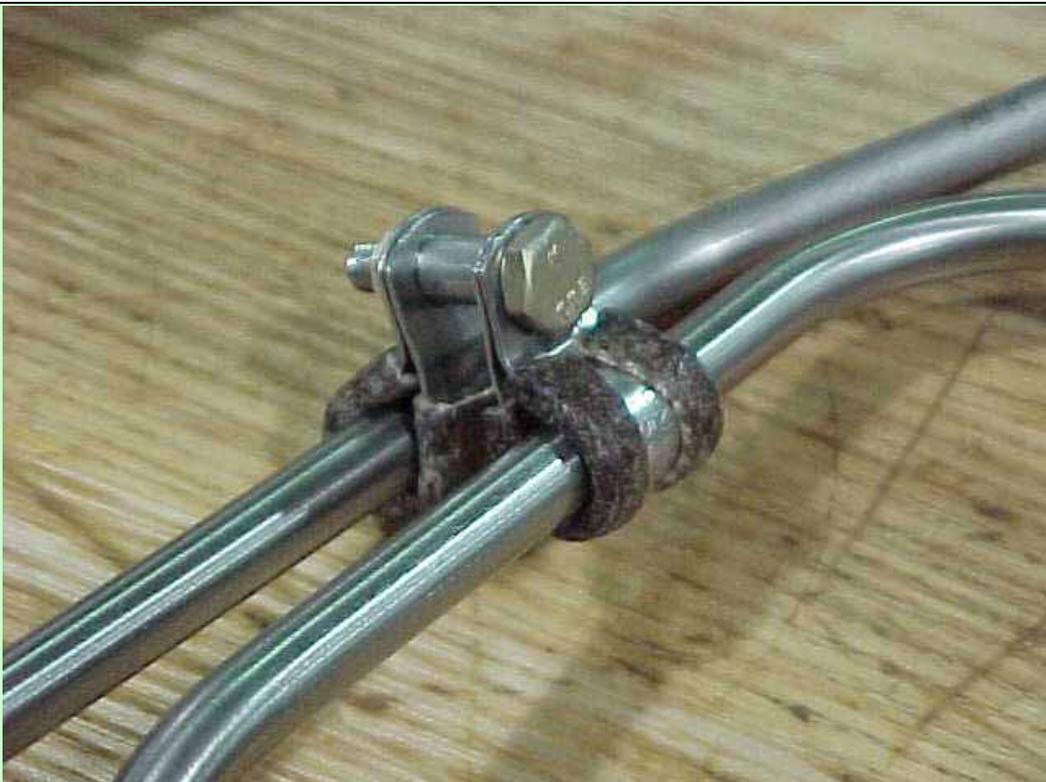
**Figure 7 - Correct Cushion Material**

- M. Do not install unapproved clamps, hardware, fittings, chafe-material, etc., on the engine tube assemblies. See Figure 7 for a correct cushion material example.
