Pacific Scientific Reel-O-Matic  
Inertia Reel - Correct Installation

**AWB** 20-003 **Issue :** 1  
**Date :** 27 November 2013

NOTICE NO. N-194  
DATE 1/9/85  
PAGE 1 OF 5

**SUBJECT:** ONE-TIME INSPECTION AND REWORK OF 269A4262 INERTIA REEL SHOULDER HARNESS ASSEMBLIES AND INSTALLATION.

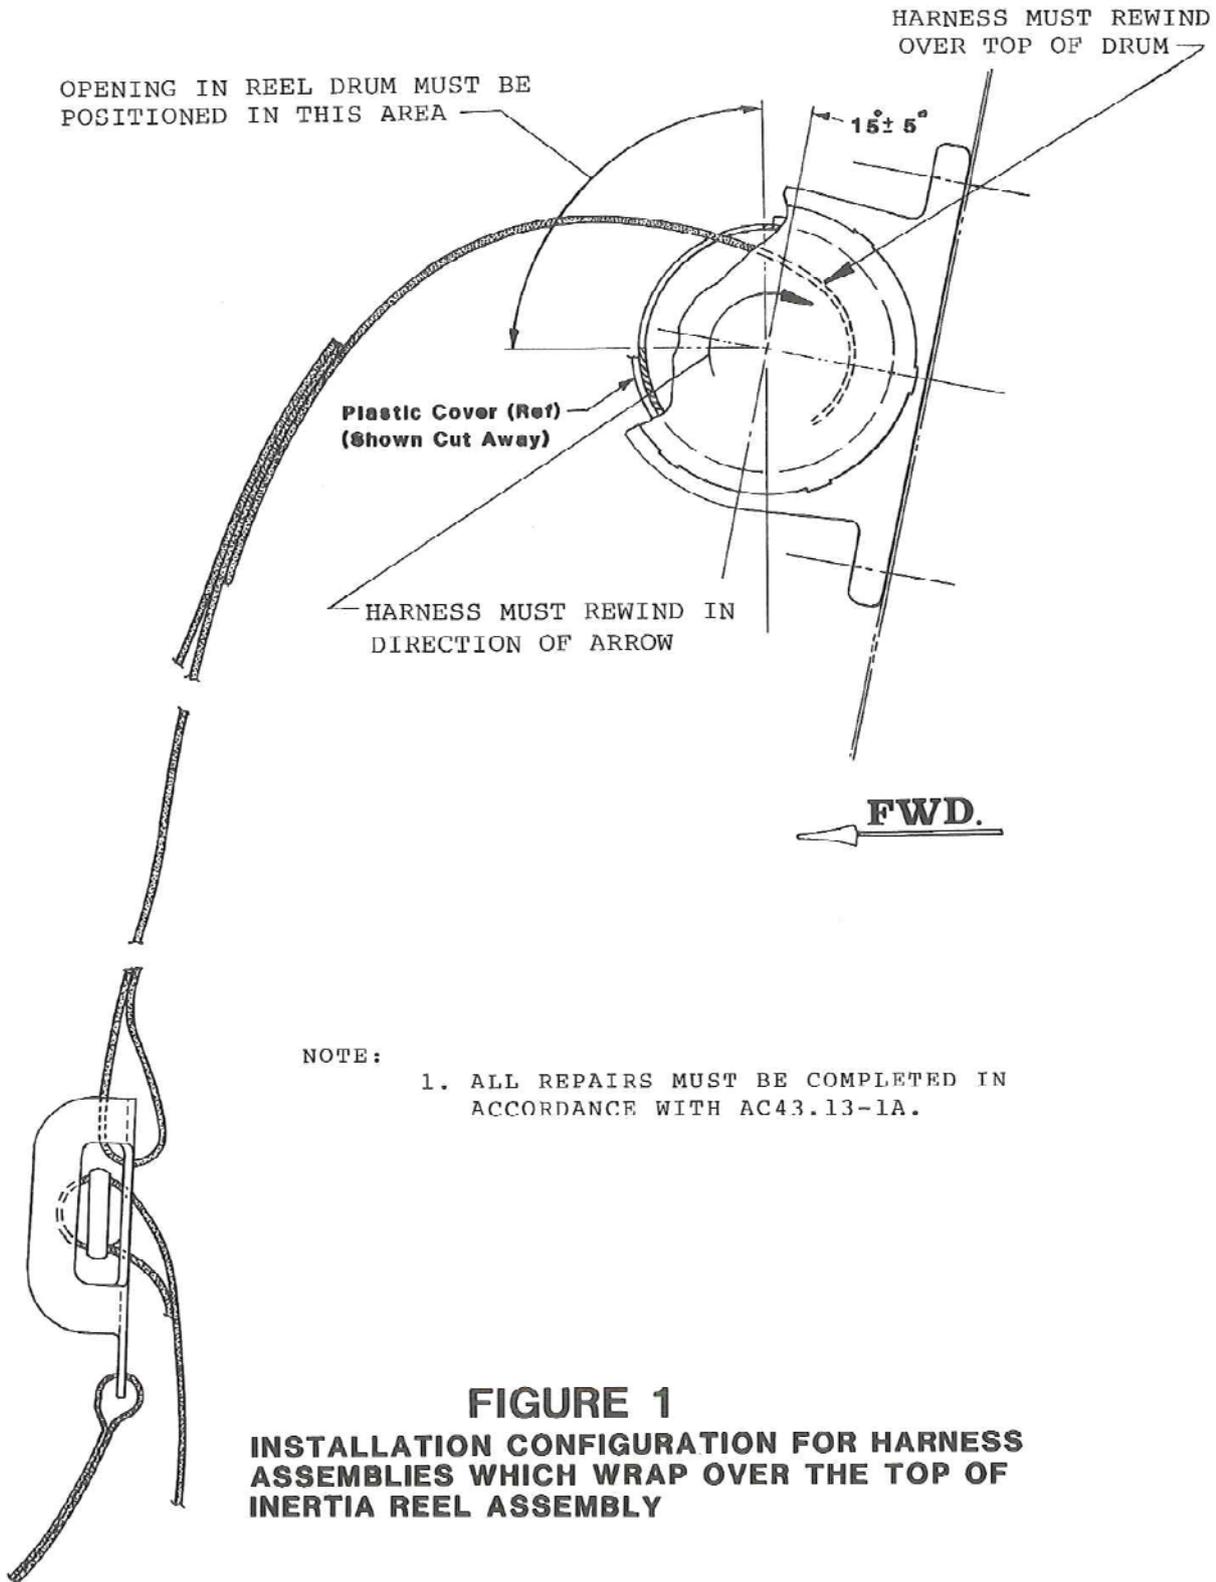
1. The reel may be installed with the harness strap coming off the top or bottom of the reel, whichever will allow correct positioning of the harness on the wearer.
2. With the harness strap coming off the top of the inertia reel the slotted opening in the metal reel housing is to be positioned facing forward with the top of the opening at an angle of  $15^{\circ} \pm 5^{\circ}$  relative to the 269A2103 panel. See figure 1.

1. If harness assembly cannot be properly positioned on user, i.e. tensioning buckles press against users chest, reverse inertia reel installation so strap comes off the top or bottom, (whichever is opposite the installed reel).
2. To position the slotted opening correctly, remove mounting feet from reel assembly and reindex to proper position.

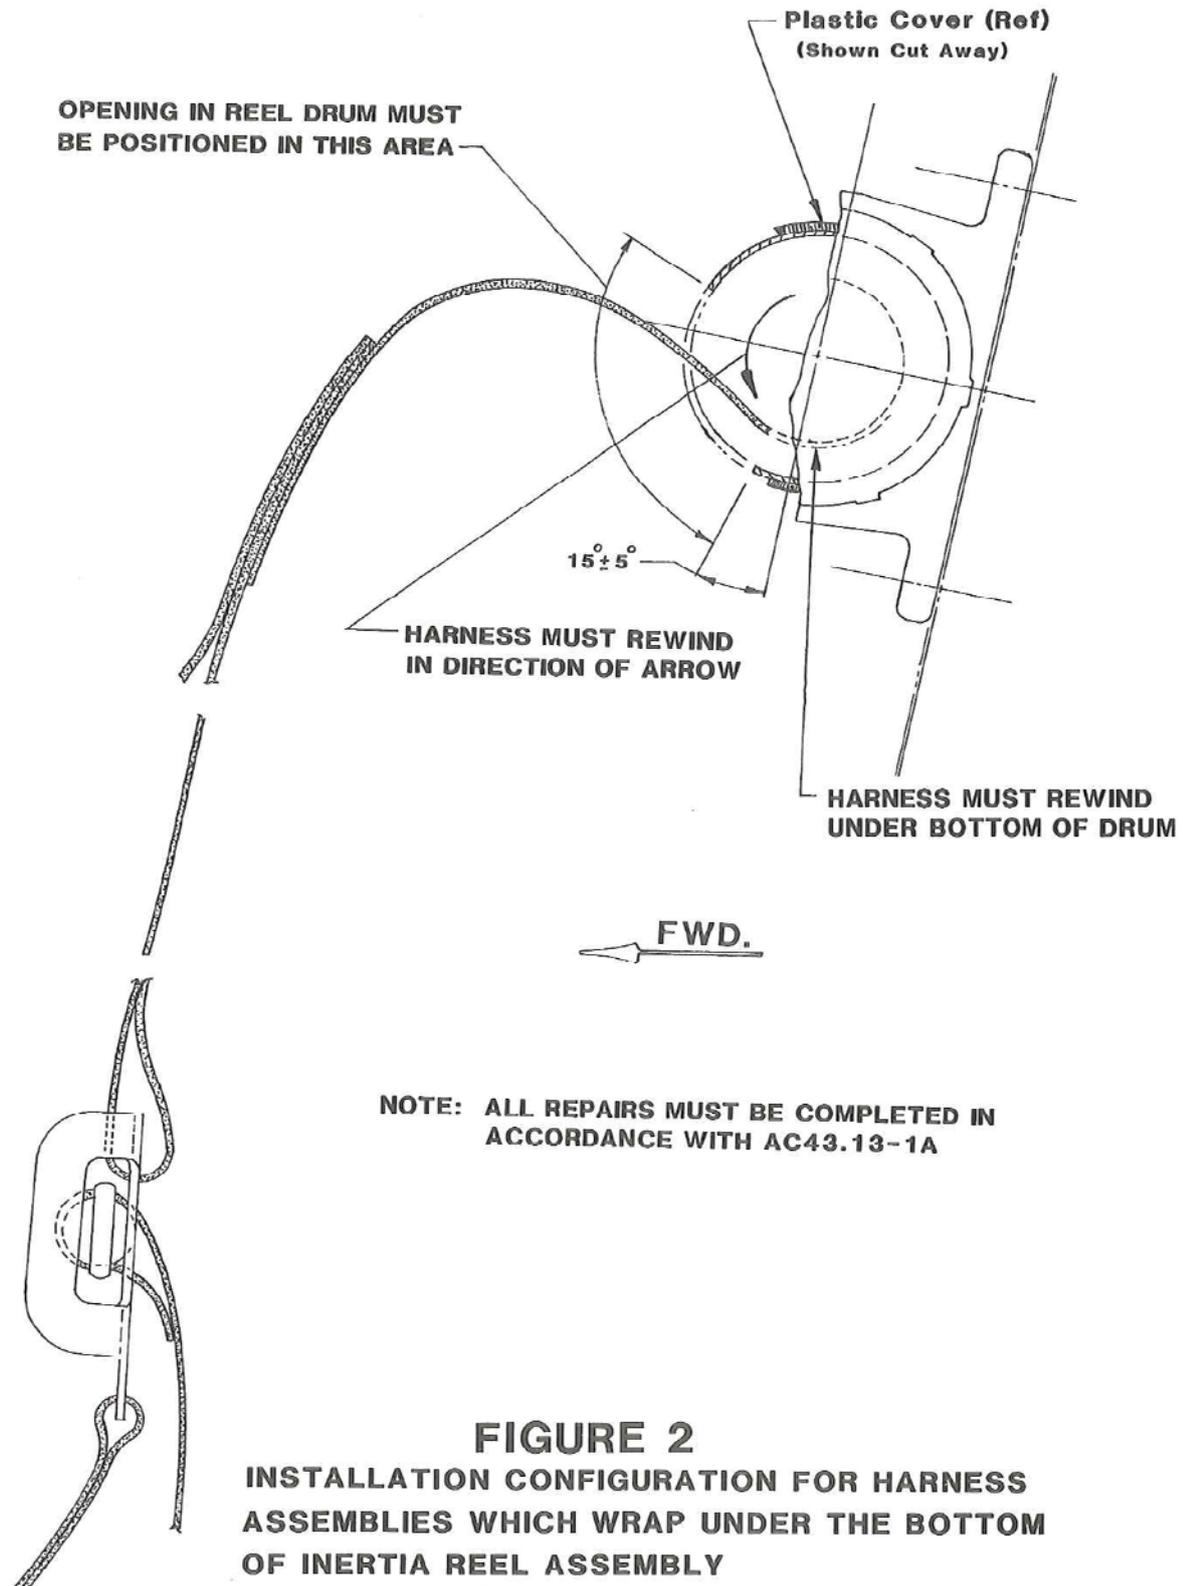
With the harness strap coming off the bottom of the inertia reel, the slotted opening in the metal reel housing is to be positioned facing forward with the bottom at the opening at an angle of  $15^{\circ} \pm 5^{\circ}$  relative to the 269A2103 panel. See figure 2.
