AWB 25-10 Issue 1 - Pacific Scientific rotary seatbelt buckles

Pacific Scientific rotary seatbelt buckles

AWB 25-10 Issue 1, 3 April 2006

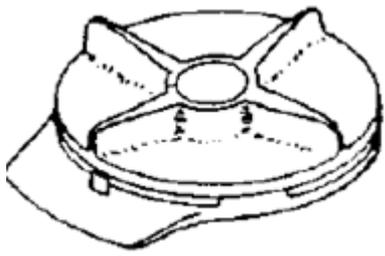
Investigation of a fatal aircraft accident in 2003 showed that the captain had been ejected from her seat upon impact as a result of uncommanded release of a rotary seatbelt buckle which was made by Pacific Scientific. Other uncommanded releases of the same type of rotary seatbelt buckle have been reported.

The following figure depicts the Pacific Scientific rotary seatbelt buckle:

If so, in each instance it should be determined whether the new guarded seatbelt buckle, as specified in Pacific Scientific Service Bulletin 1117032-25-02 (which was issued specifically in respect to Boeing aircraft) is fitted. If not, it is strongly recommended that the guarded rotary seatbelt buckle, as specified in the above Service Bulletin, be fitted in each instance.
