AIRWORTHINESS BULLETIN

Pacific Scientific shoulder harness retraction reels **AWB** 25-008 **Issue :** 1
Date : 21 October 2005

ALERT SERVICE BULLETIN

RESTRAINT SYSTEMS - OPERATORS OF AIRCRAFT WITH PACIFIC
SCIENTIFIC COMPANY, HTL/KIN-TECH DIVISION
RESTRAINTS INSTALLED

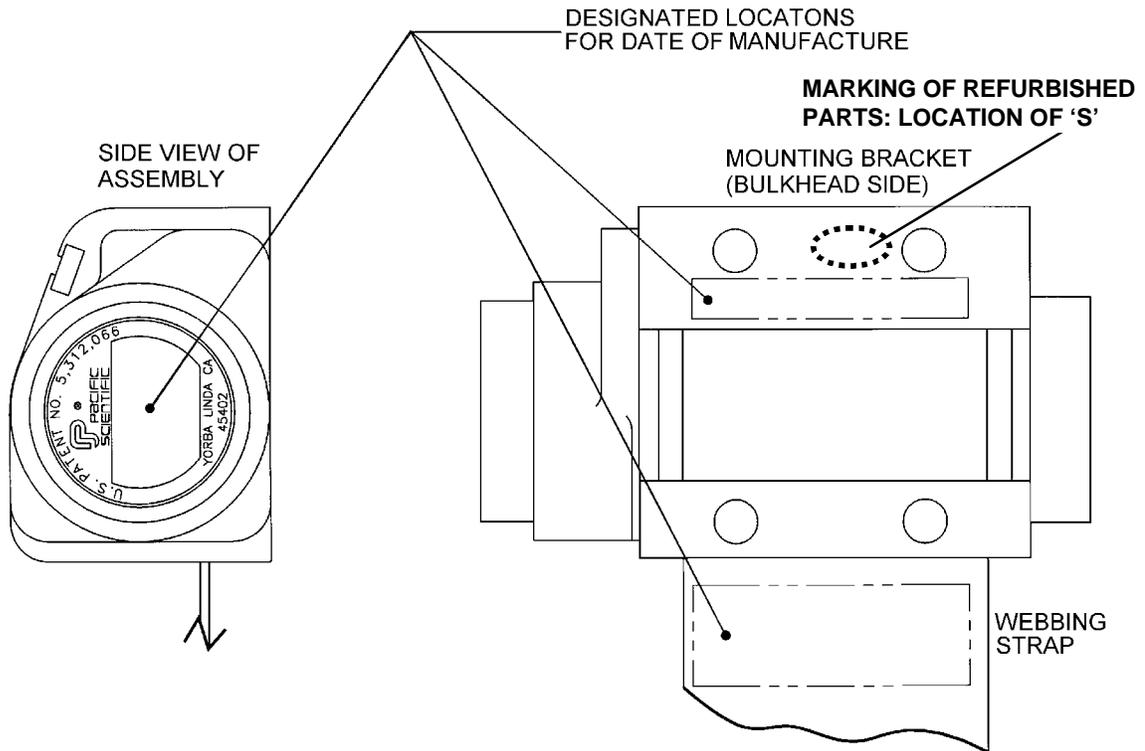
Figure 1. Location of Manufacturer's Date and Marking of Refurbished Parts

Parts serviced or refurbished will be ink stamped with the date and an “S” on the back of the frame. This stamp will indicate the Aluminum shaft has been replaced with the Steel shaft. (See Figure 1.)
