Piper PA-28 Series - Nose Landing Gear
Fork Failures

AWB 32-019 **Issue :** 1
Date : 16 April 2009

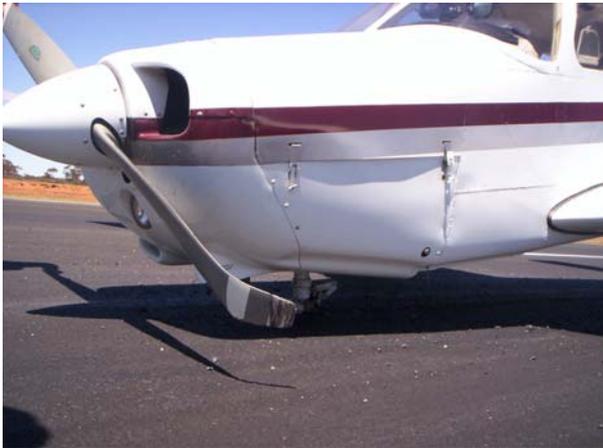
CASA continues to receive Service Difficulty Reports describing the catastrophic failure of the nose landing gear fork assembly. Investigations conducted by operators report one or more of the following as contributing factors.

1. Loose or broken bolts where the fork attaches to the steering block.
2. Cracking on the inside surface of the fork in the region of the attaching nuts and washers.
3. Unresolved shimmy dampener problems.
4. Corrosion in various locations between the steering block and the upper surface of the nose landing gear fork.
5. Heavy landings and / or high side loadings induced during cross wind operations
6. High time in service.

Operators and maintainers should consider inspecting the fork and steering block assembly for looseness and periodically unbolting the fork from the steering block to inspect the fork structure and attaching hardware, particularly after a heavy landing and if the aeroplane has been engaged in training operations.
