AWB 51-4 Issue 1, Piper PA30/39 Wing Spar Cap Corrosion

AWB 51-4 Issue 1, 27 September 2002

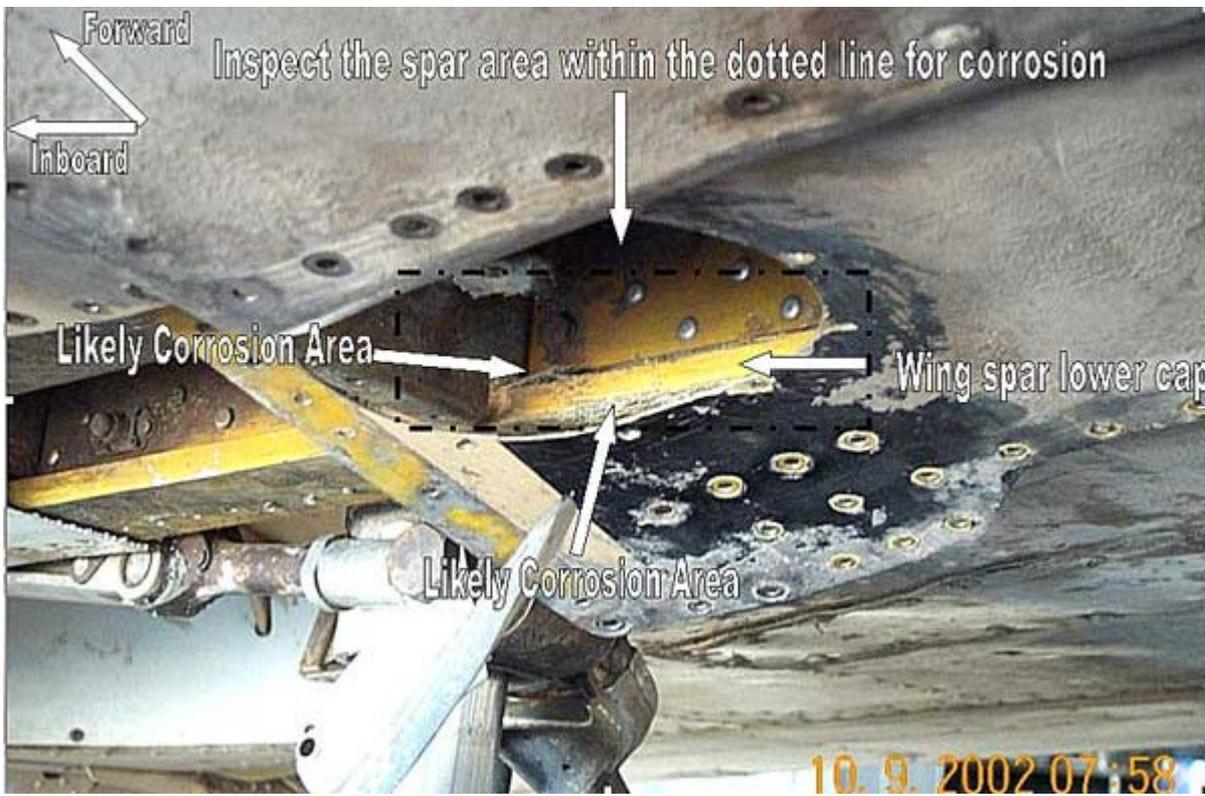
Corrosion has been observed on the forward flange leading edge of the left and right wing lower spar caps due to the ingress of corrosive exhaust gases through the inspection access panel number 12. (See the Piper Twin Comanche Service Manual, figure 2-8 for the panel location). The inspection access panel number 12 incorporates a fuel drain fitting in some earlier models. Corrosion caused by exhaust gas inside the wing cavity is a known problem in the PA-30 and PA-39, evidenced by the fact that there is a specific inspection for it in the Piper Service Manual. Whilst the requirement to inspect the internal wing structure for corrosion is already contained in the manual, more detail is required to direct attention to specific sites of likely corrosion, including the wing spar caps. Additionally, some Australian PA-30/39's are being maintained to CASA Schedule 5, which contains a requirement to "inspect the internal structures and spars" of the wing (Refer CASA Schedule 5 - Section 1 - The Airframe, part 2 (c)), rather than the manufacturers maintenance schedule. Irrespective of which maintenance schedule the aircraft is on, the inspection for corrosion in the wing cavity must be carried out in accordance with the aircraft's approved maintenance data (CAR 42V) which is the manufacturers maintenance or service manual. In this case, the service manual does not provide enough detail on where or how to look for corrosion that is caused by exhaust gas. The recommendations below will provide more detail on where and how to perform the inspection for corrosion.

The cavity covered by panel 12 allows access to the wing spar, which is easily visible and may exhibit corrosion, especially on the lower spar cap. Pay particular attention to the spar cap forward flange leading edge, upper and lower surfaces (See Figure 1 which shows the area of likely corrosion). Use of a mirror and bright light will be necessary to see clearly, the upper and lower surface of the spar cap. If any corrosion is detected, report it to CASA via a Major Defect Report (MDR) form (as required by CAR 52). In the MDR form, the following additional information should be provided. Include the information on a separate page if there is insufficient space on the MDR report form.

Figure 1: Inspection Area - Left wing with inspection access panel number 12 removed.

Perform an inspection of the left and right wing spar caps at each scheduled aeroplane inspection (100 hourly inspection) as per the following procedure:

Remove the number 12 inspection access panels on the left and right wings (See the Piper Twin Comanche Service Manual, figure 2-8 for the panel location). It may be necessary to clean the area to be inspected so that any corrosion can be seen.
