Piston Engine Overhaul - Dangers of
Replating Engine Hardware - Hydrogen
Embrittlement

AWB 85-011 **Issue :** 1
Date : 10 June 2009

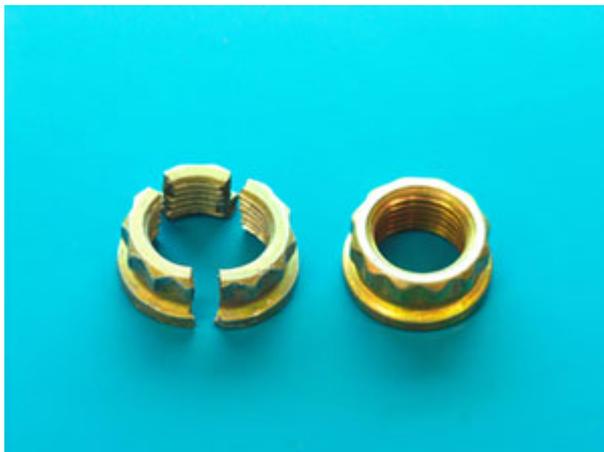
“...The fracture of the failed nut occurred on several longitudinal planes. Fracture initiated from regions of intergranular cracking in the increased section created by the nut flange. Final fracture occurred in a ductile manner.

These features are typical of hydrogen-induced delayed cracking (hydrogen embrittlement), a condition resulting from the presence of hydrogen in the steel and a sustained tensile stress. The effect of thread shape creates a sustained tensile hoop (circumferential) stress in a tightened nut. A particular hazard of cadmium plating high strength steels is the absorption of hydrogen into the base metal. This hazard is countered by baking the parts after plating.

FIGURE 1: Fractured nut as received with an intact nut for comparison.

CASA recommends that engine manufacturing and overhaul facilities review current plating practices, to determine if the cadmium plating and baking process and process controls employed by the plating facility prevent the occurrence of hydrogen-induced delayed cracking in high-strength steel engine hardware, including through-bolts and nuts.

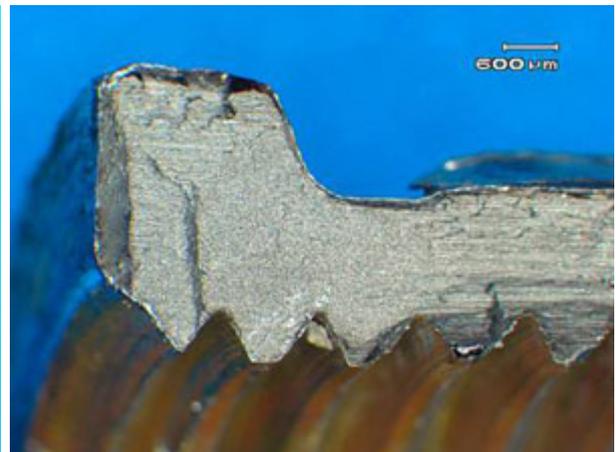
FIGURE 2: Fracture surface showing the brittle cracking region in the centre of the photograph and the surrounding ductile fracture features.

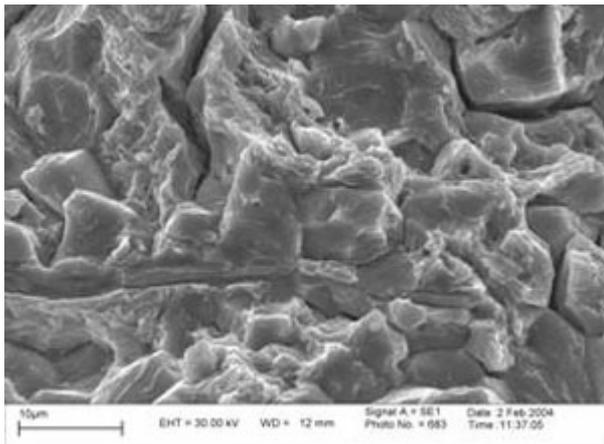
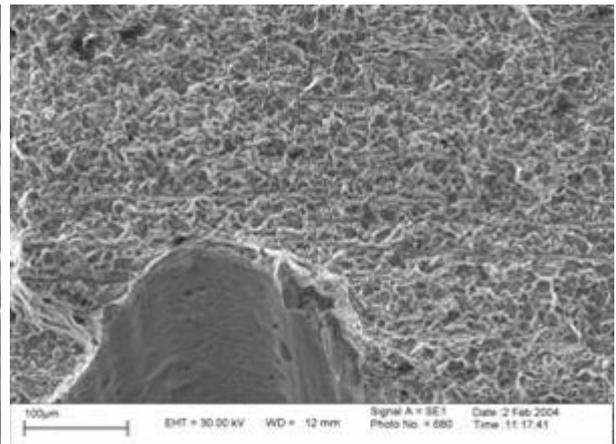
FIGURE 3,4: Scanning electron micrographs of the brittle cracking region.

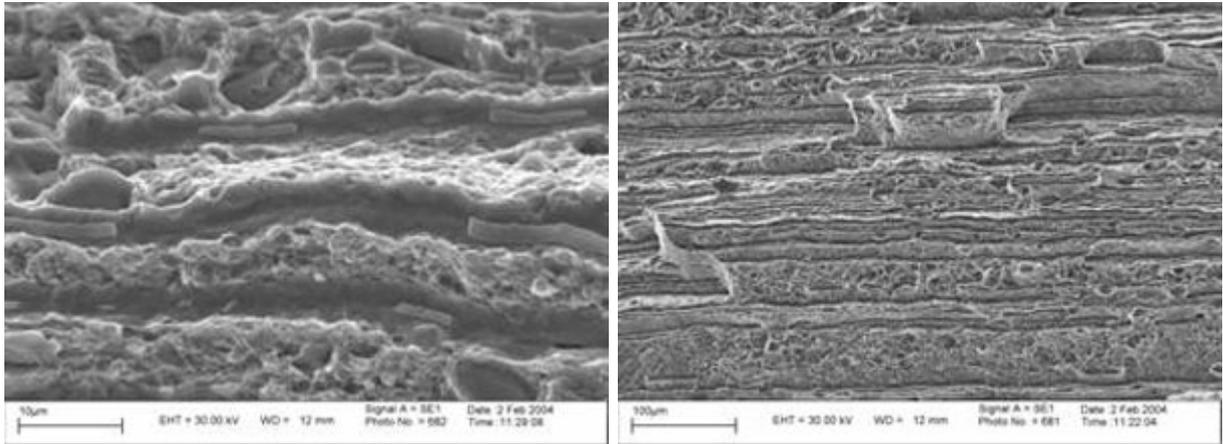
FIGURE 5.6: Scanning electron micrographs showing the features of the ductile fracture region.
