Piston Engine Valve Tappet Body
& Camshaft Lobe Wear

AWB 85-014 **Issue** : 1
Date : 23 November 2012

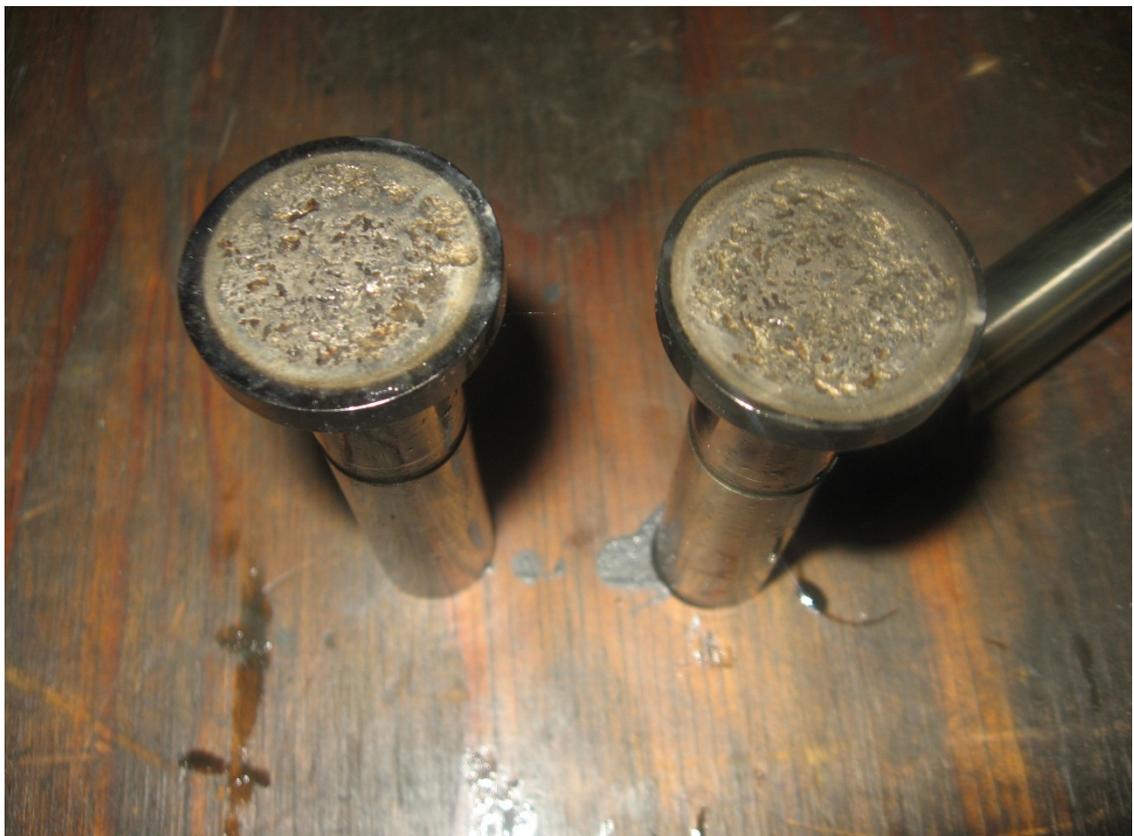
Investigations by various Lycoming engine overhaulers have found that in the majority of cases the filter contamination was directly attributed to severe spalling of the now superseded Lycoming tappet body P/N 15B26064. These tappet bodies were supplied from late 2009 until mid 2012.

Figure 1 - Advanced spalling of Lycoming tappet body P/N 15B26064.

For example, Lycoming Service Instruction (SI) No. 1543 Dated: February 23, 2012 - "Notification of Approved Tappet P/N 15B26262", advises that tappet P/N 15B26262 is the approved replacement for Tappet P/N 15B26064 with compliance at next overhaul, whenever tappet replacement is necessary, or earlier at owner's discretion.

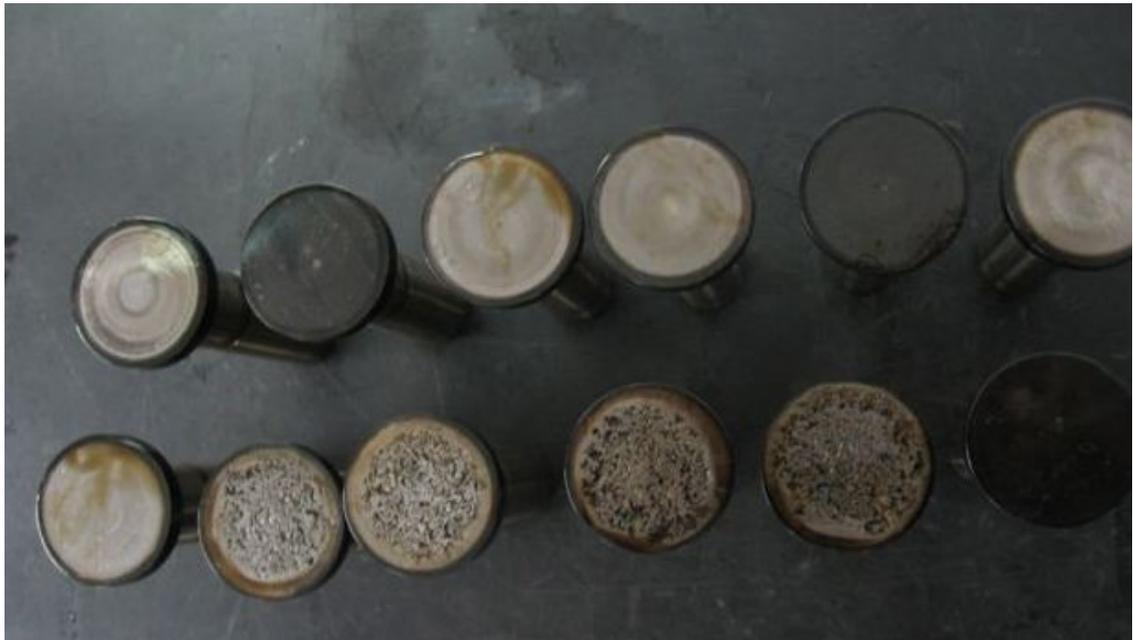
Figure 2 - Spalled P/N 15B26064 tappets showing the various stages of deterioration that can exist between tappet bodies in one engine.

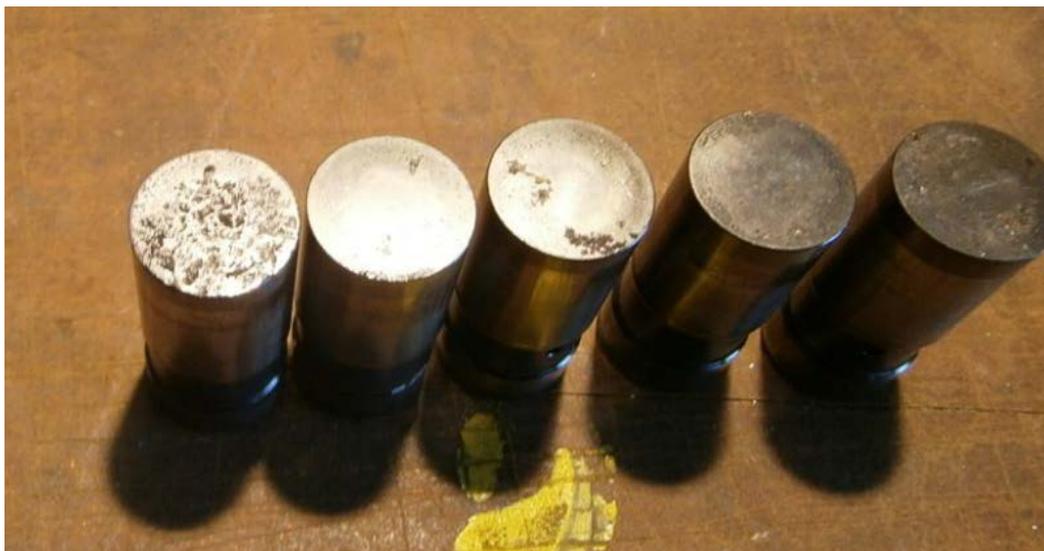
Figure 3 - Spalled TCM Continental hydraulic valve lifters P/N 653877, Note that P/N 653877 is not currently identified as a mandatory replacement in TCM MSB09-8A which states that lifter failures can present a safety of flight issue.

The FAA have issued AD 2010-11-04 mandating TCM Continental Mandatory Service Bulletin (MSB) No. MSB09-8A, which provides similar information, and may require the replacement of certain part number hydraulic lifters before further flight.

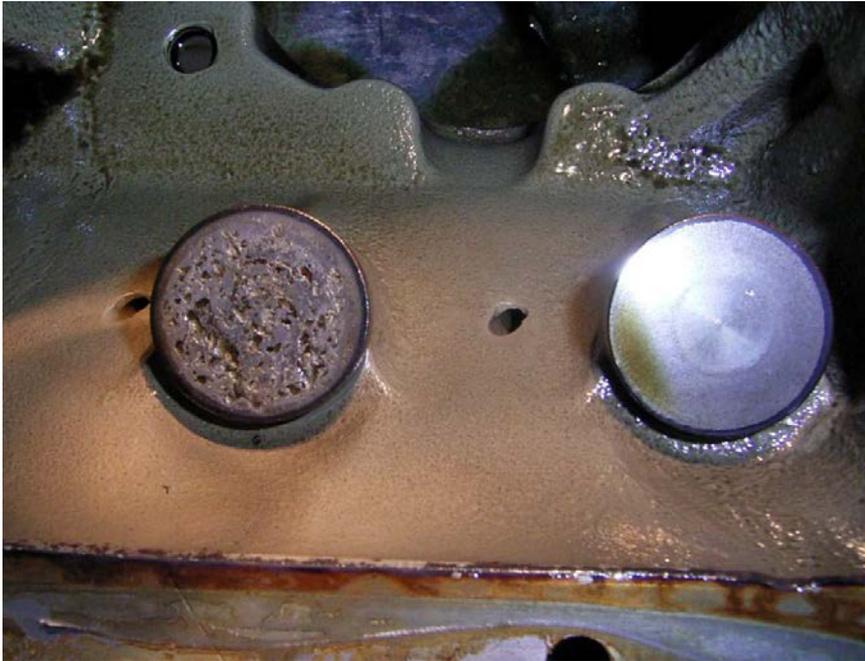
Figure 4 - Tappet Body P/N SL72877 - Variation in the condition of adjacent tappet body faces

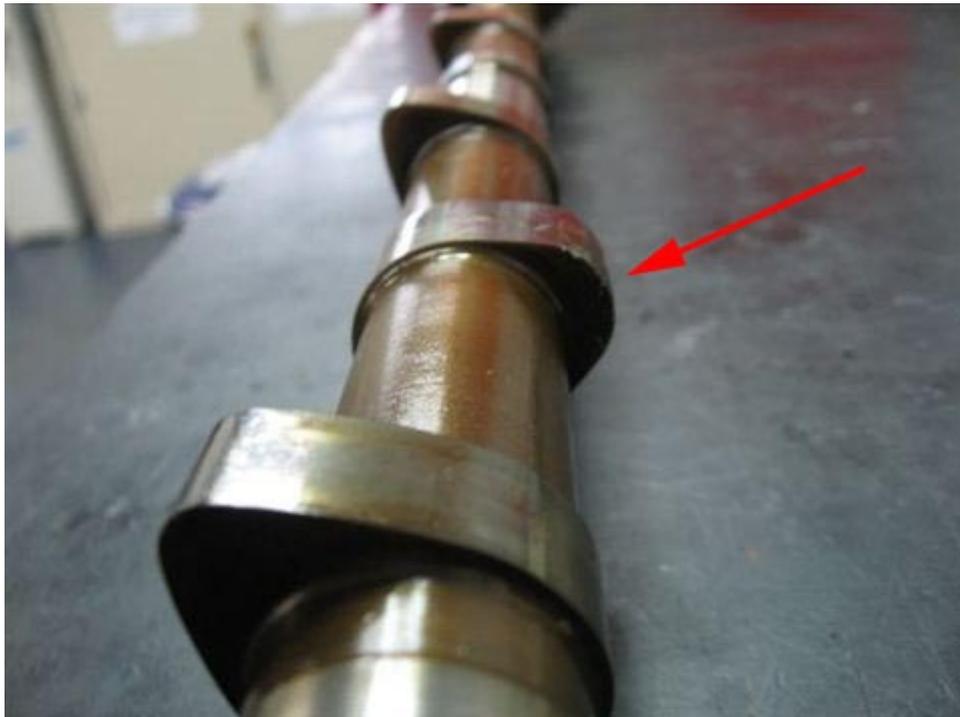
To reduce the costs of overhaul, some maintainers have installed reground camshafts and tappets into engines. Although camshafts may be reground, there is a very strict limit on the amount of grinding which can be tolerated. If the hardened surface of the cam lobe is removed, the softer material is exposed and the rapid wear that follows provides an increasing volume of metal in the engine oil and filter.

Camshaft wear will result in loss of engine performance due to loss of volumetric efficiency and subtle changes in valve timing. Cam lobe wear may be most pronounced where two valve tappet bodies share the same cam lobe, (e.g. intake valve train).

Figure 5 - Worn Lycoming camshaft lobe which was operating with a spalled tappet body P/N15B26064.

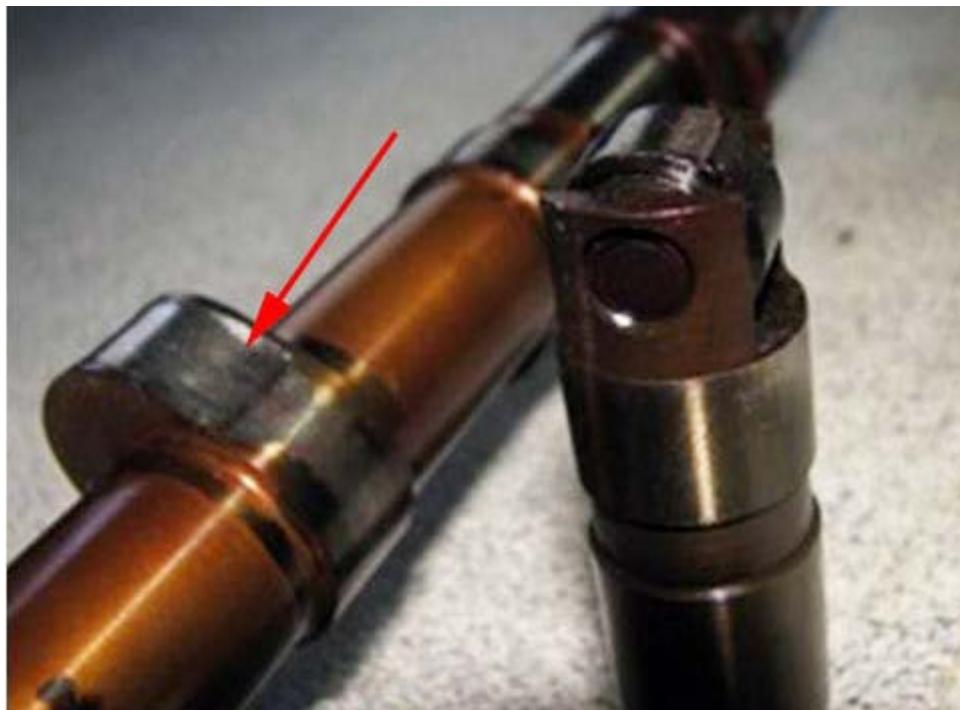
Figure 6 - Lycoming roller cam follower and worn cam lobe.

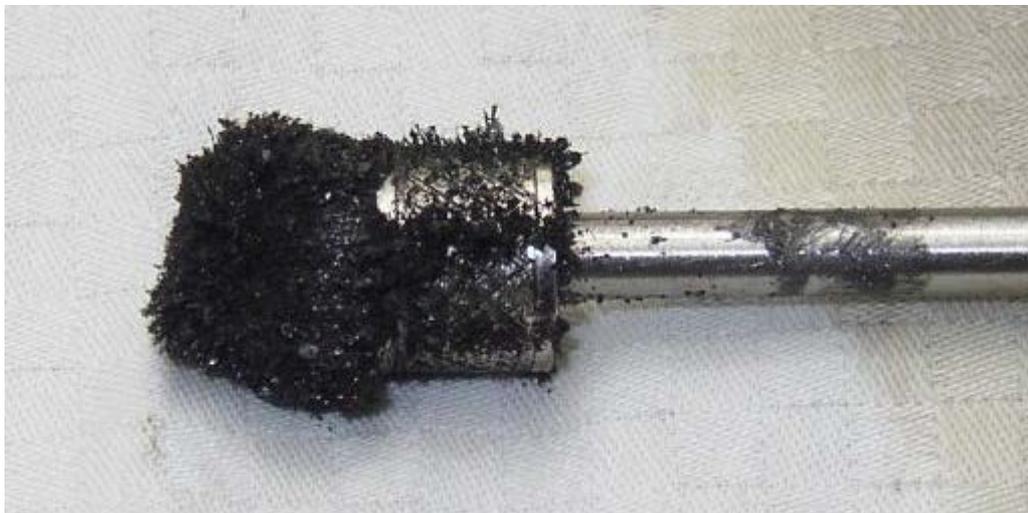
The first indications of abnormal tappet face wear are commonly reported to be very fine magnetic particles in the engine oil pressure filter element. Metallic contamination of the engine oil supply may result in a wide range of problems including; propeller and turbocharger control malfunction, gear tooth wear and a reduction of oil pressure due to wear in engine bearings.

Figure 7 - Very fine magnetic particles, typically eroded from tappet bodies / lifters and camshaft lobes, extracted from an engine oil filter element.

Whenever metallic debris is detected in the filter or the volume of engine oil filter debris remains at a high level or exceeds the manufacturer's limits, the source of the debris should be identified and any problems corrected prior to further engine operation. Due to the difficulty in detecting the early stages of adverse tappet body wear, the periodic removal of a cylinder and use of a boroscope to inspect the cam and lifter faces may be a more reliable method than using oil filter debris alone to determine cam and tappet serviceability.
