**Precision Airmotive RSA-10AD1 Fuel Control Unit – Possible Fuel Flow Restriction**

**AWB** 73-007 **Issue :** 1  
**Date :** 21 July 2014

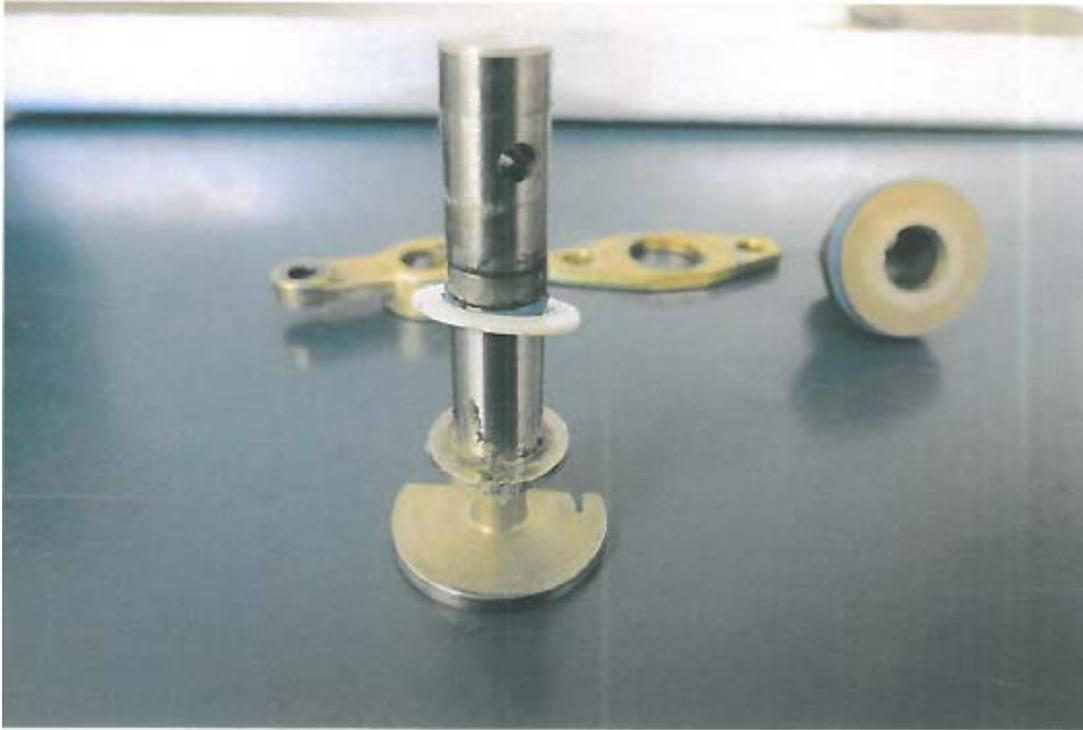
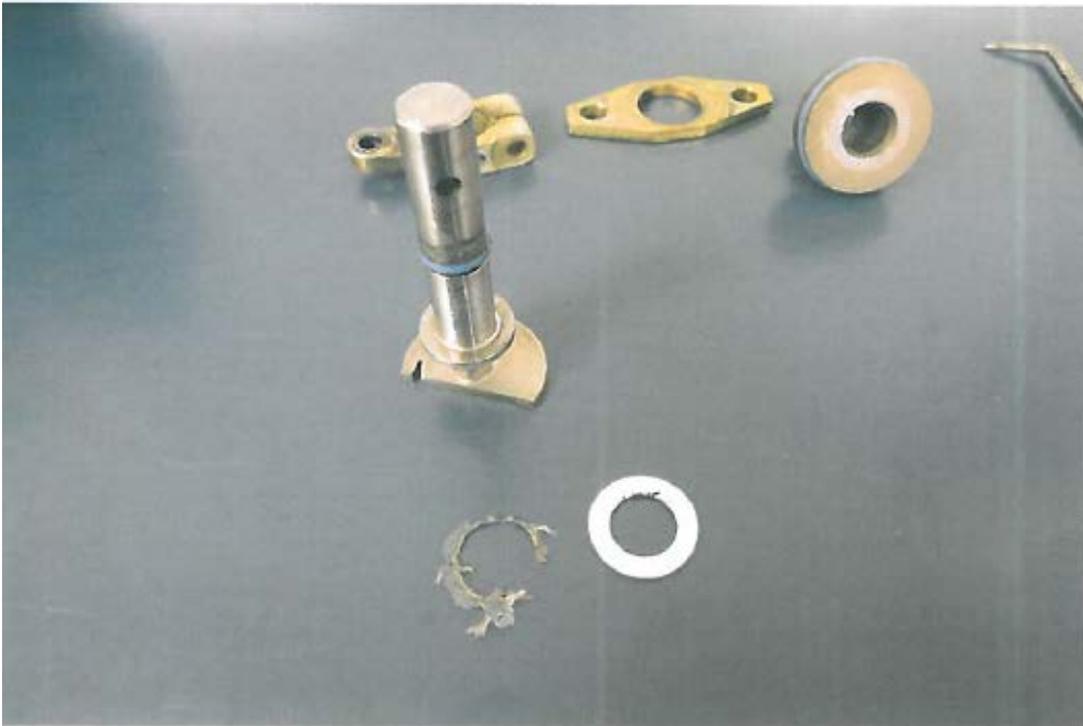
This AWB is prompted by an incident reported to the New Zealand Civil Aviation Authority (NZ CAA) of a loss of engine power on a Robinson R44 II which resulted in the pilot carrying out a successful auto-rotation landing. A subsequent examination of the FCU revealed material disintegration from washer P/N 367757 which was ingested through the fuel system and resulted in a loss of engine power.

The material found was similar in appearance to Polytetrafluoroethylene (PTFE) thread-tape. A laboratory analysis determined that the composition of the material as PTFE, a thermoplastic polymer associated with washer P/N 367757. See figure 1.

This washer is fitted to the fuel cylinder injector in the FCU and is located downstream of the internal fuel strainer. Hence, any liberated washer material may be carried through the FCU and to the fuel nozzles without further filtration.

*Figure 1 - Defective washer p/n 367757 with example of liberated material*

Incorporate the inspection requirements of Precision Airmotive Service Bulletin PRS-109 into the elected R44 maintenance program. Note the corrective actions in section C.ii) of the document If the throttle control movement becomes excessively stiff at any time between the inspections.
