Robinson R22 and R44 Main Rotor  
Blade Disbonds

**AWB** 62-002 **Issue :** 1  
**Date :** 18 July 2006

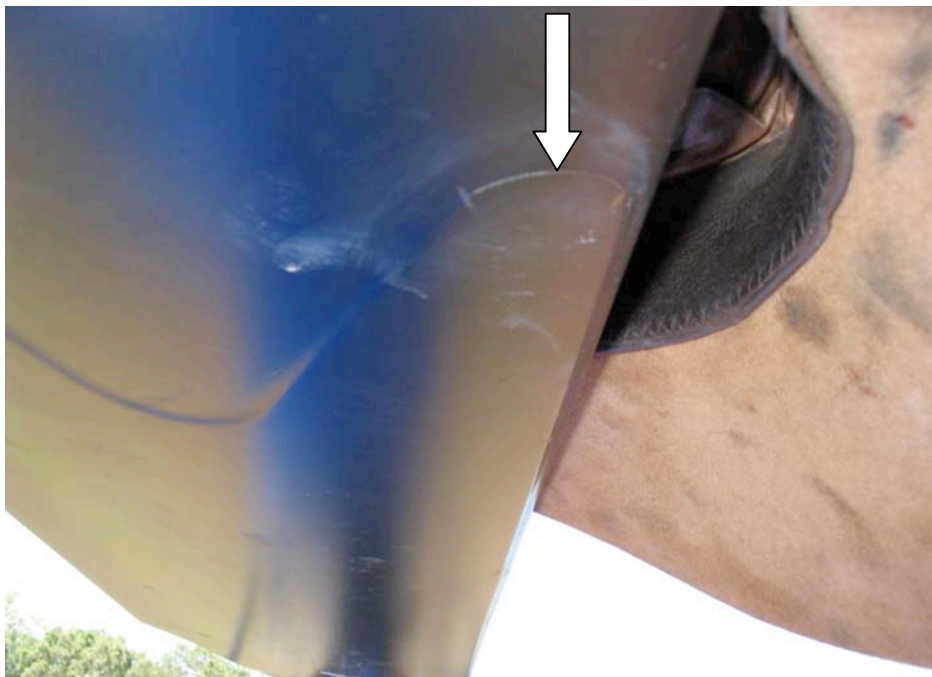
Visually inspect the ends of the upper and lower finger doublers (See figure 1 for the typical location) for:

- (i) Cracks in paint or filler material;
- (ii) Evidence of the doubler lifting; or
- (iii) Any other indication of doubler separation, such as opening up of the doubler-to-blade skin seam.

*Figure 1: Main Rotor Blade showing typical location of disbond on finger doubler.*

A suspected disbond may be confirmed by performing a standard tap test.

If you suspect that the doubler has disbonded, in the first instance contact your local Robinson representative for advice. Following this, advise CASA by submitting a Service Difficulty Report form (SDR).

It is important to note that the FAA has informed us that a small level of disbond or doubler lifting is NOT an immediate safety of flight issue. However, once disbonding is suspected, the blades should be removed from service, pending repair or other advice from the manufacturer.
