Robinson R44 Engine Exhaust - Cabin Heater
System Failures

AWB 78-001 **Issue** : 1
Date : 11 August 2011

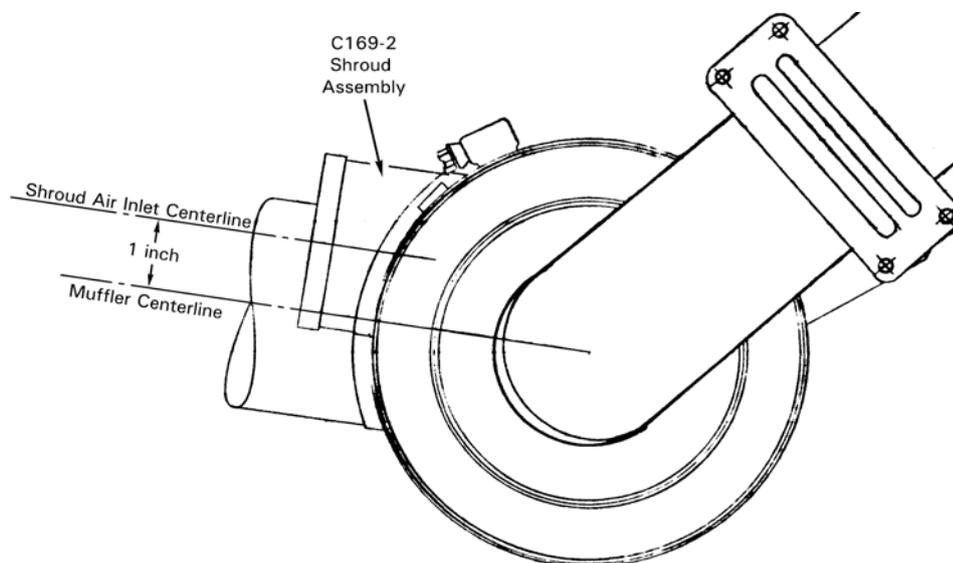
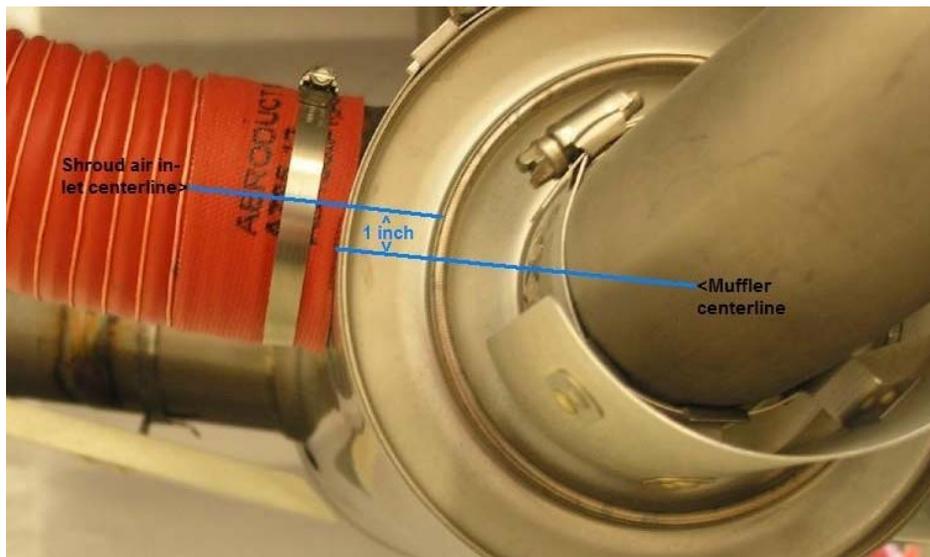
Another factor to be considered in this installation is the exhaust muffler cooling within the heater shroud. When installing the P/N C169-3 muffler sub-assembly, examine the P/N C169-2 shroud assembly and ensure it has a 1-inch vertical offset between the heater shroud inlet and muffler centerlines as shown in Figure 1 below. This offset promotes air swirling around the exhaust muffler, and thus provides better cooling.

Figure 1. Engineering sketch and photograph showing the 1-inch vertical off-set between the cooling air heater shroud inlet center line and the muffler centre line.
