Robinson R44 Main Rotor Gearbox.

AWB 63-008 **Issue :** 1
Date : 1 May 2012

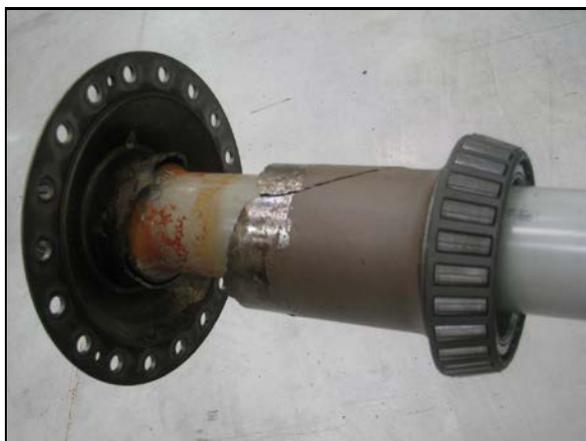
Following the loss of main rotor drive on a RHC R44 helicopter, the ATSB conducted an investigation which revealed failure of the gear carrier located in the main rotor gear box (MRGB). This failure was attributed to fatigue cracking stemming from corrosion found on the gear carrier. The owner of the RHC R44 arranged for an inspection of a second helicopter in their fleet, where the gear carrier also showed evidence of corrosion.

Figure 1
Photograph Supplied by Robinson Helicopters.
Failed gear carrier assembly.

- Request their maintenance facility conduct a MRGB oil inspection for any contaminants, ie: water, rust or paint. If any anomalies are found contact RHC for further direction.
- Where appropriate, store the rotorcraft under cover, or cover the main rotor mast and head assembly in inclement weather conditions.
- During lengthy periods (7 days or more) of storage or inactivity in tropical conditions, additional preservation action should be taken to ensure the risk of internal corrosion of the MRGB is reduced. Contact RHC for further details.
- In the event of a MRGB warning chip light indication, the helicopter should be landed immediately and the issue investigated by an appropriately endorsed LAME, in accordance with manufacturer's data.
- Report all water, rust, paint contamination of the MRGB oil system and any corrosion discovered to CASA via the SDR system.

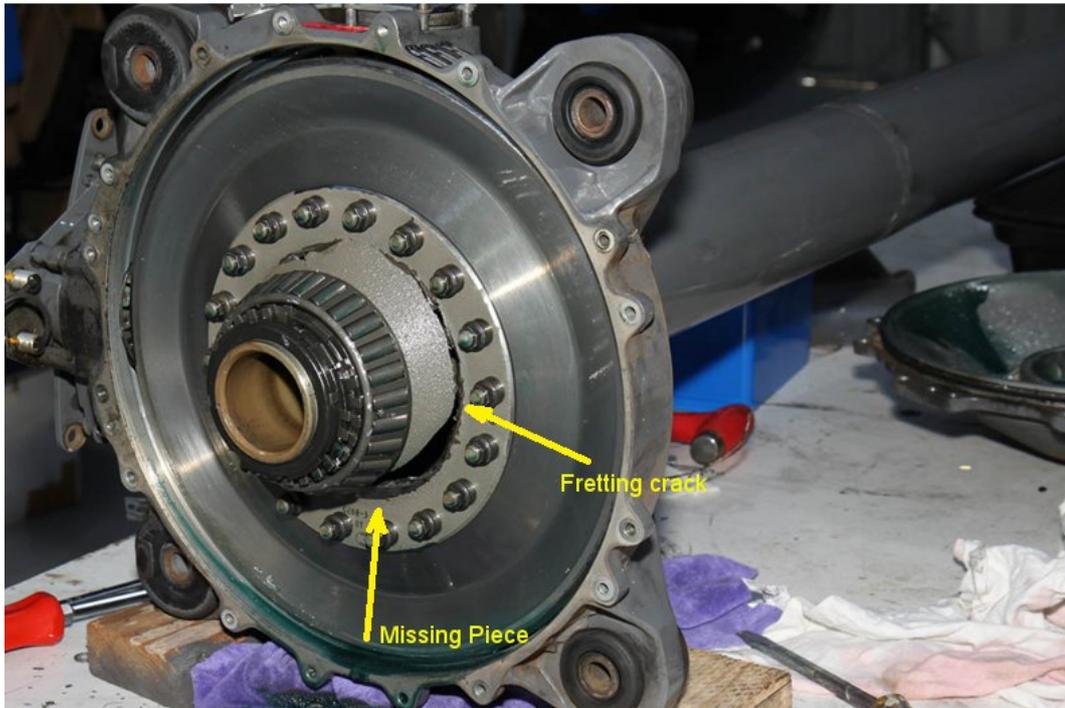
Figure 2
Photograph supplied by the ATSB.
Fractured gear carrier.

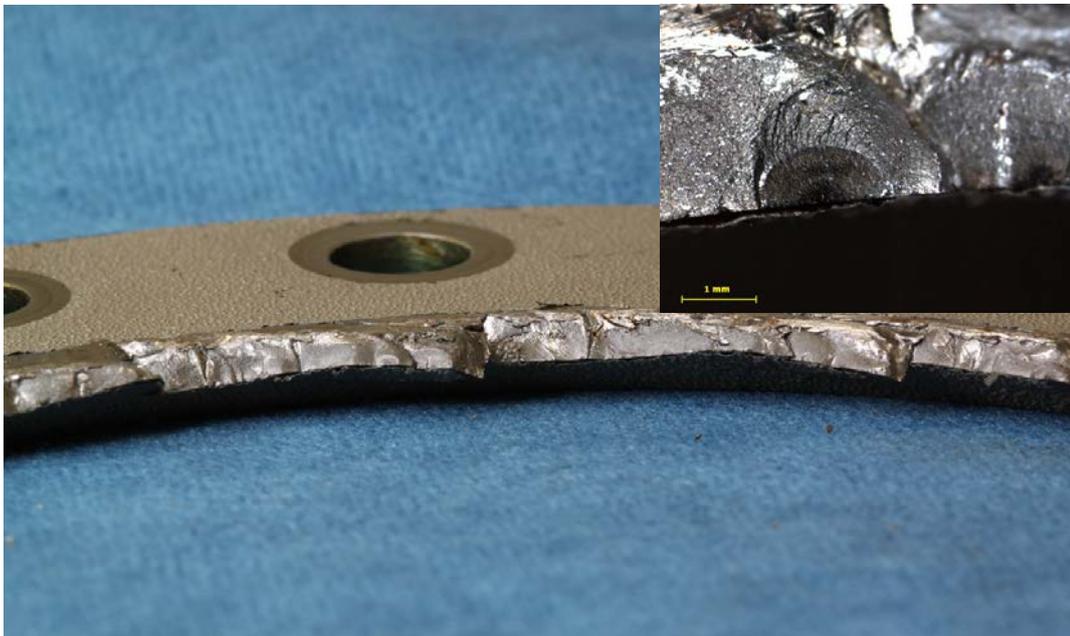
Figure 3
Fatigue cracking of gear carrier, ATSB laboratory photographs.
