Service Difficulties identified with Oxygen
Systems

AWB 35-004 **Issue :** 1
Date : 29 November 2012

AIRWORTHINESS BULLETIN

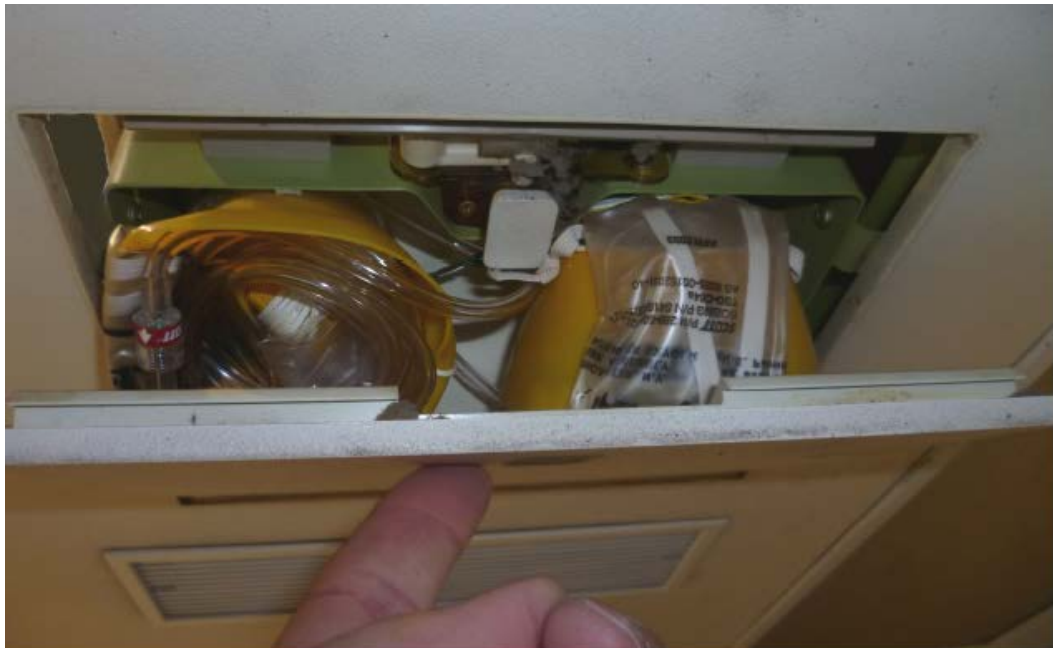
A particular recurring service difficulty reported is trapped oxygen hoses between the PSU door and the mask stowage box. Care must be taken to ensure that the Oxygen masks and hoses are stowed correctly in accordance with the applicable AMM Task and that the Oxygen mask hoses are carefully positioned so they do not become caught during final closing of the door.

Figure 1 - Oxygen mask and hoses correctly positioned before closing PSU door

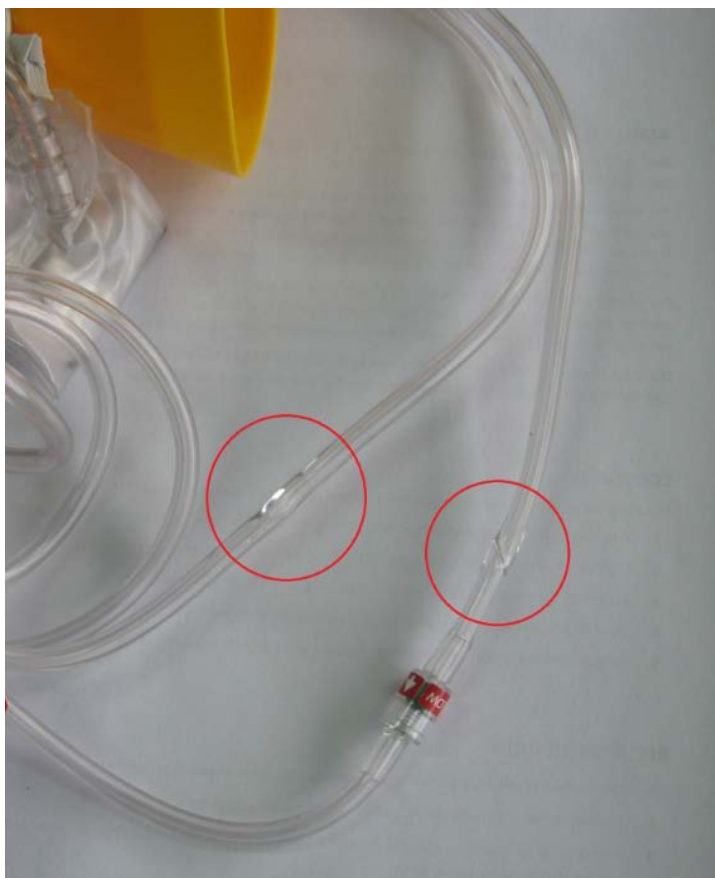
Figure 2 - Oxygen hoses showing kink damage
