# AIRWORTHINESS BULLETIN

AWB 01-036 Issue 1 - 31 August 2018

Suspected Unapproved Parts - McCauley Propeller Governor,  
Idle Gear Bearings

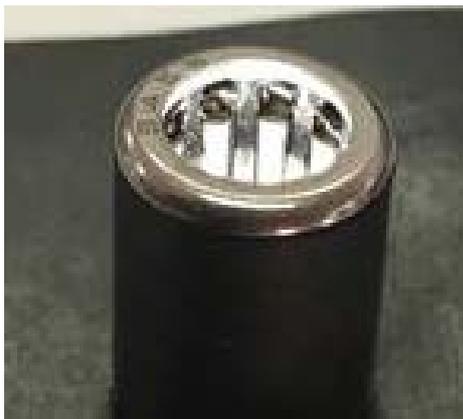
CASA has been made aware of an airworthiness concern related to partial or complete failure of McCauley Governor Idle Gear Bearing P/No: A-20028. Initial investigations have raised concerns about material non-conformity, (hardness and alloy) as well as dimensional compliance of the bearings.

This airworthiness concern is isolated to those bearings marked "BA-59".

Example Bearing showing "BA-59" marking

The bearing is installed within the oil pump idler gear of the governor to boost engine oil pressure to facilitate propeller blade control. Bearing galling or degradation will cause the clearance to increase with a consequential internal leak in the oil transfer system causing the governor to lose some or all control.

CASA recommends that aircraft owners, operators, maintainers and parts distributors review the latest and any subsequent revision of McCauley Service Bulletin SB271 Title: A-20028 IDLER GOVERNOR GEAR BEARING INSPECTION and inspect their aircraft records and parts inventory for the identified suspected unapproved parts.

If any of these suspect parts are found in existing stock, it is recommended the suspected parts are segregated to prevent inadvertent installation.
