Airworthiness Bulletin

AWB 25-037 Issue 1 – 23 August 2021

Textron C208 Passenger Seat Belts

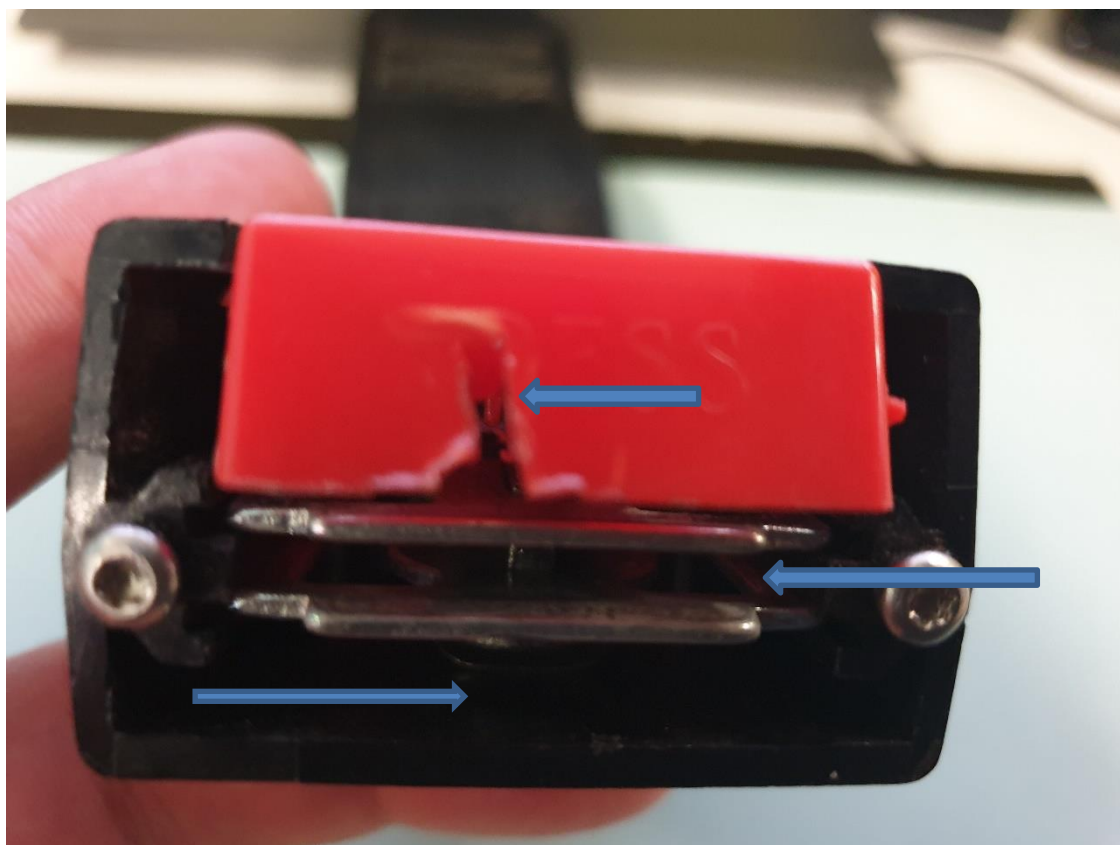
CASA has been advised of several cases where belts have had to be replaced because the plastic shell/casing has broken on the buckle assembly (see figure 1 below).

In one case part of the plastic shell was missing and the belt tongue was forced into the buckle in the wrong location between the guide (indicated by middle arrow in figure 1 below) and casing and jammed within the mechanism in the location shown by the lower arrow in figure 1 below. The passenger was unable to release the belt in the normal manner without the assistance of a sharp object being used to force open the latch (see upper arrow in figure 1 below).

Figure 1: Showing buckle with front plastic shell missing

The failure of the plastic case may affect the functional crashworthiness of the belt (if the tongue is not properly latched in the guide), and its ability to protect the occupant. A failed plastic cover may foul the latch mechanism, allow improper insertion of the belt tongue and also allow debris and other foreign objects inside the assembly.

All operators should regularly check the buckle for cracks in the plastic case which could be indicative that it is about to separate from the buckle.

If any damage is found, it is strongly advised that the manufacturer be contacted for further advice and the belt be removed from service for repair.
