Unison (Slick) Magnetos fitted to Diamond DA20 series aircraft.

AWB 74-002 Issue : 1

Date : 25 January 2007

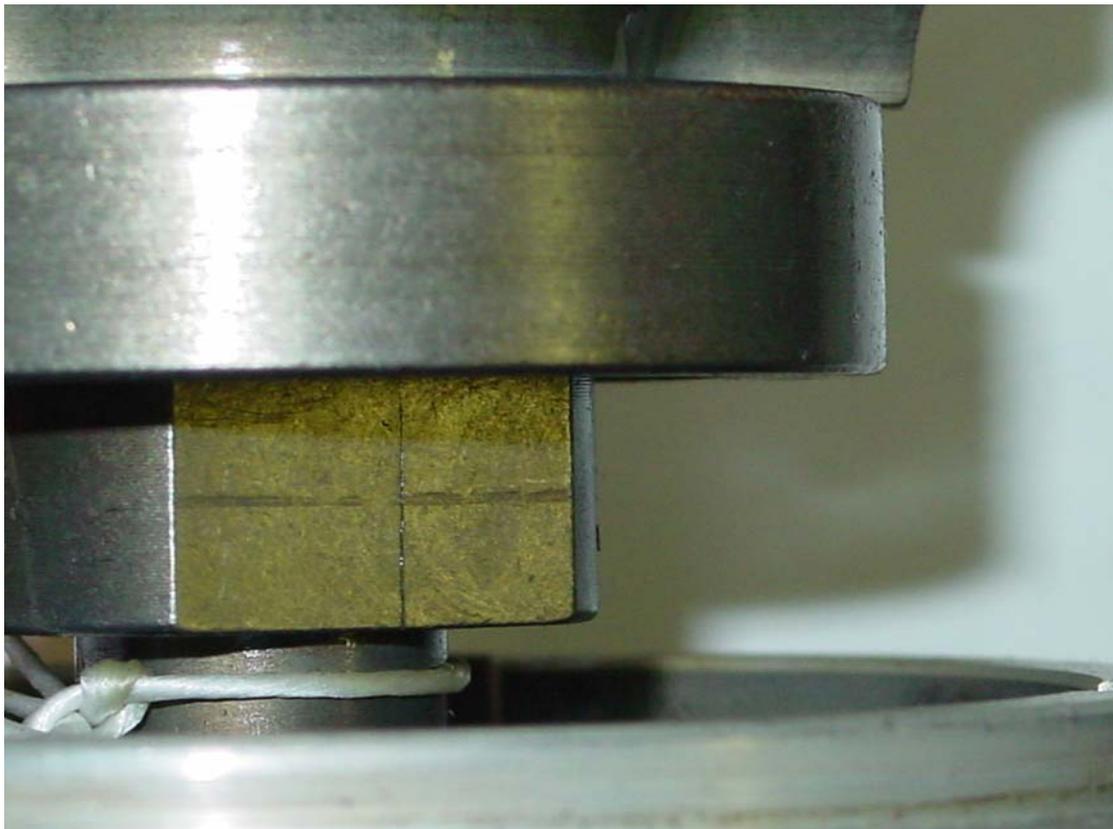
Several SDRs have been submitted concerning cracking of Unison (Slick) magneto hub(coupling)assemblies fitted to the TCM IO-240B engines installed on the Diamond DA20.

This cracking is evident anytime after installation. In some cases they have been found to crack while being torqued onto the magneto assembly.

It is recommended that operators of all Diamond DA20 series aircraft fitted with these magnetos consider incorporating a system of inspection of the hub, initially at the next 50 hourly inspection, then every 100 hourly inspection if no cracking is found.
