AIRWORTHINESS BULLETIN

Victa Airtourer - Longeron Corrosion

AWB 53-008 **Issue :** 1
Date : 12 November 2015

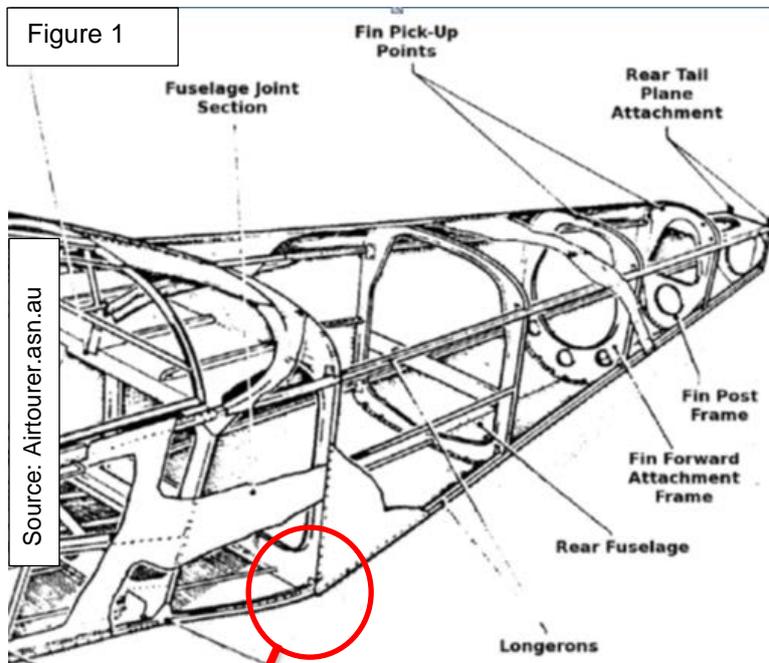
CASA has received a defect report describing severe corrosion in the lower fuselage longerons, in the area of the steel splice, which are major structural elements. The area of concern is circled in Figure 1.

Corrosion in these longerons severely reduces the structural integrity of the aircraft, which is certificated for a wide range of aerobatic manoeuvres.

Gain access to the interior of aft fuselage cone via the rear diaphragm. Carefully remove any debris around the identified area. Carry out a detailed inspection of the main fuselage left and right longerons, particularly in the area of the steel splice. Pay particular attention to any signs of corrosion and/or missing rivets. See Figure 2 and Figure 3.

If any corrosion, missing rivets or structural deformation is evident, seek appropriate engineering advice before further flight.

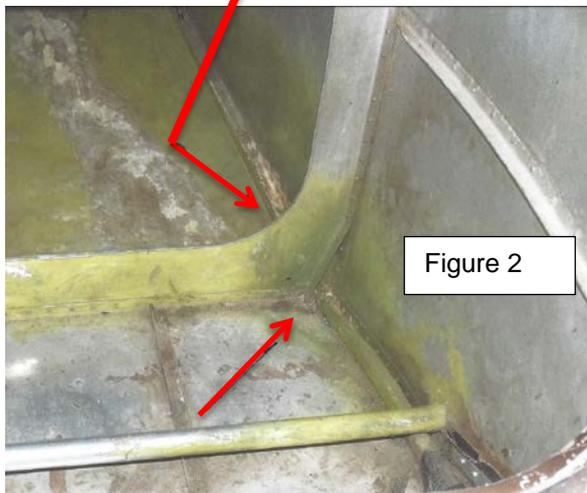
Figure 2 identifies the specific area of concern.

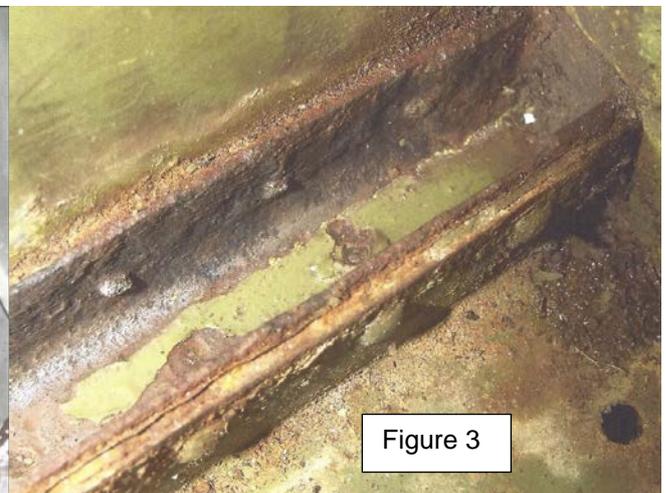
Figure 3 illustrates the corrosion damage found.
