AIRWORTHINESS BULLETIN

Yak 52 Trim-Tab Failure

AWB 55-009 **Issue :** 1
Date : 25 October 2012

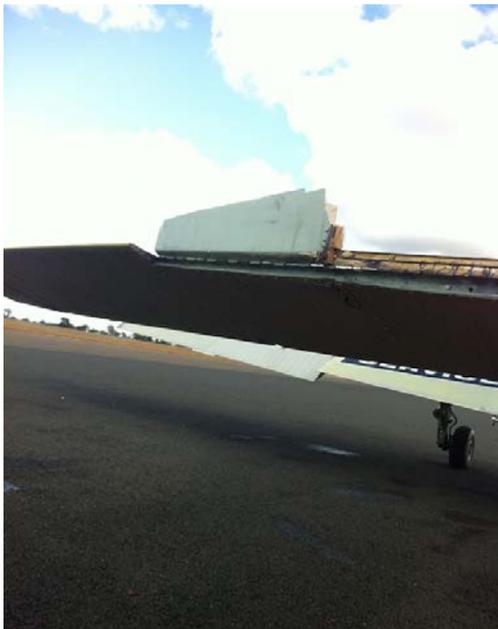
A recent incident was reported to CASA where the elevator trim-tab unit suffered a structural failure in the push-rod, triggering an episode of violent airframe vibration which itself caused the trim-tab to break into several pieces. The vibration also caused considerable damage to the elevator which has had to be replaced.

Figure 1: Damaged trim-tab from below

Whilst the cause of the failure has not been formally determined, advice from some operators has focused on the push-pull rod attachment, and in particular the prospect that the locking nut may have been over-tightened at some point in the aircraft's life. Such over-tightening leads to the crushing of the inner elastic material which could lead to reduction in strength of the attachment, itself having the potential to cause the fitting to fail.

1. Operators are recommended to talk with their LAME as well as the aircraft manufacturer about the trim-tab issue in order to determine any suitable course of action.
2. It's recommended that Operators make contact with other operators of the Yak 52 aircraft, through such forums as the Warbirds Association, to share any insights or discoveries associated with the trim-tab issue.
3. If operators and/or maintainers discover defects on the trim-tab mechanism and attachment, as well as any other defects with the aircraft of any nature, submit a Service Difficulty Report (SDR) to CASA. This information is used by CASA to monitor inherent technical issues with aircraft, and is the basis for issuing airworthiness advice, such as this Bulletin.

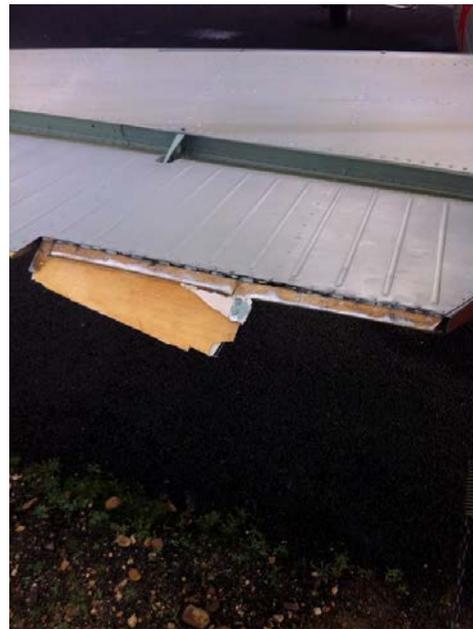
Figure 2: Damaged trim-tab from above
