Airworthiness Bulletin

AWB 25-031 Issue 8 – 3 September 2021

Defects with Night Vision Imaging Systems

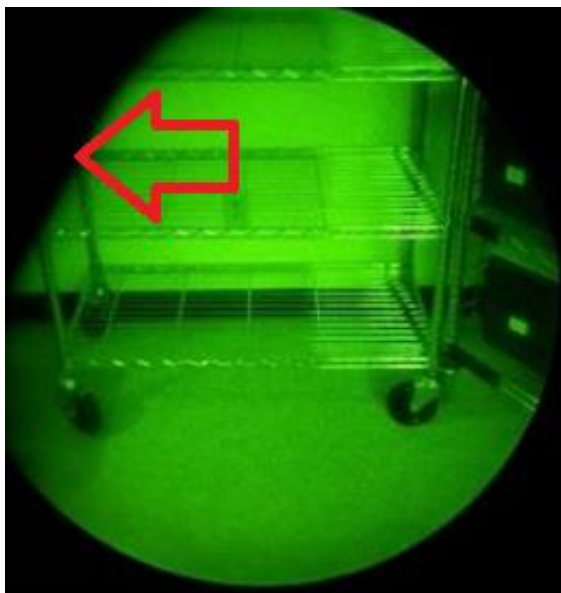
Figure 1 - Shading

- shading – image is not fully circular (see Figure 1)

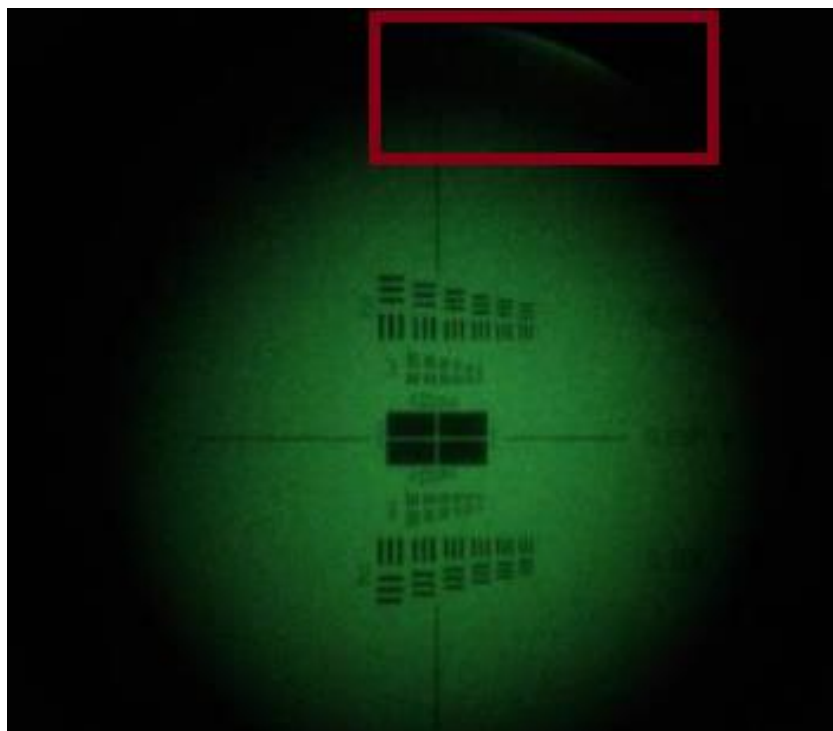
Figure 2 - Edge glow or sparkling

- edge glow – brighter area in outer portion of viewing area (sometimes this appears as sparkling) (see Figure 2); if the edge glow is brighter than the background scintillation, this is grounds for rejection.

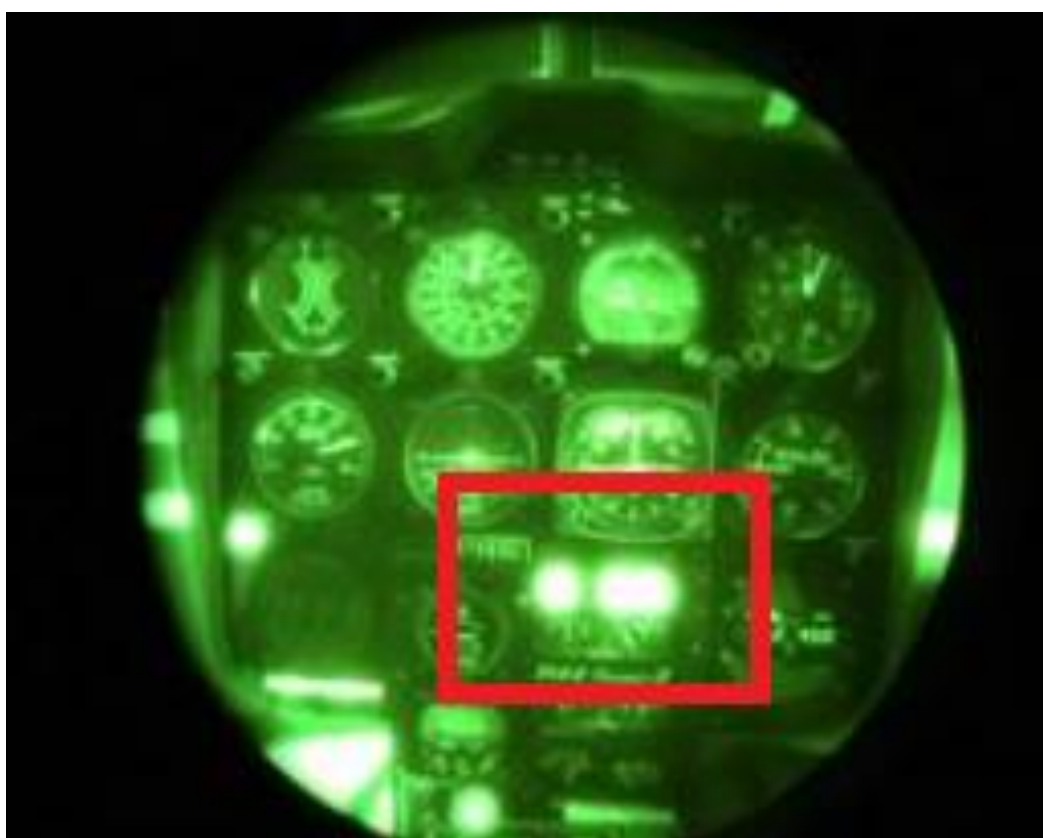
Figure 3 - Lighting incompatibility

- flashing – most cases caused by faulty electrical connection (either in one or both tubes)
- flickering – most cases caused by faulty electrical connection (either in one or both tubes)
- intermittent operation in one or both image intensifier tubes
- power supply failure
- excessive play or looseness between in the visor attachment on the helmet
- NVIS image vibrates in flight due to movement or play in the mount attachment
- NVIS self-detaches from the helmet or visor
- cracked or missing filters that cause lighting incompatibility with other installed equipment in the flight compartment (see Figure 3).

For further information on lighting compatibility see [FAA NVIS/NVG cockpit compatibility checklist: GROUND](#) or Appendix E of RTCA/DO-275 and RTCA/DO-268.

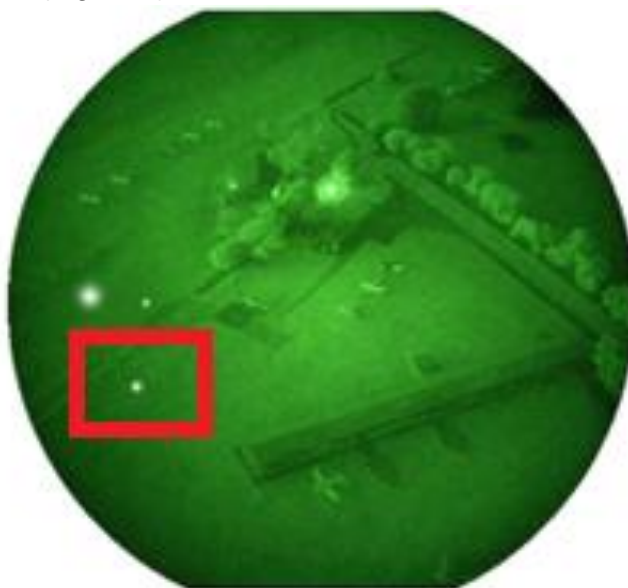
Figure 4 - Bright Spot

- bright spots or emission spots (small non-uniform bright areas). A bright spot (Figure 4) will go away when all the light is blocked and emission point does not go away when all the light is blocked (Figure 5)

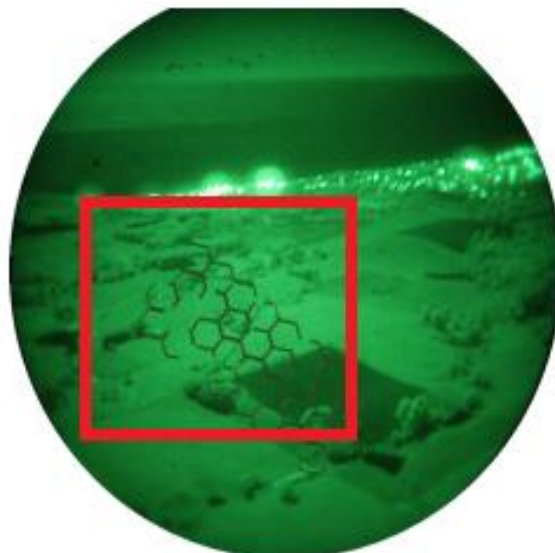
Figure 6 - Chicken wire

- fixed pattern noise or honeycomb
- chicken wire or other fixed-pattern noise – faint hexagonal or square –wave pattern; caused by fibres that do not transmit light at the boundaries of fibre cables (see Figure 6)

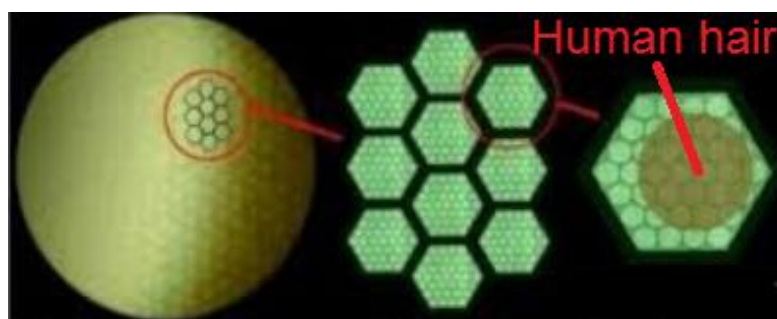
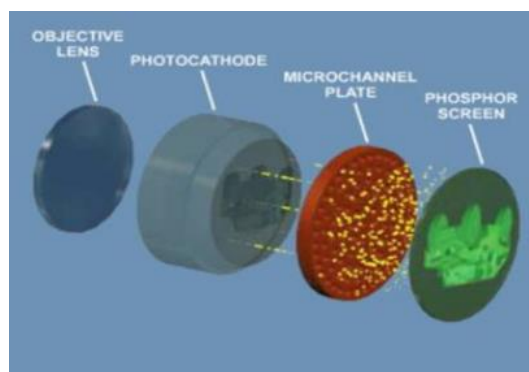
Figure 7 – Microchannel fibres

- the honeycomb image is formed from several thousand single hollow fibres in the microchannel plate. Figure 7 has a comparison of the diameter of human hair to the size of the honeycomb microchannels

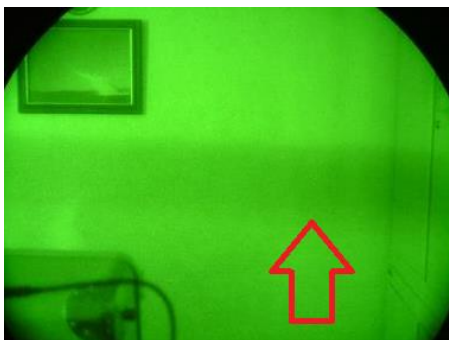
Figure 8 - Output brightness variation - lens cap string

- image disparity or difference in gain
- output brightness variation or difference in gain; exposure to bright light can cause output brightness variation where the image is “burned into” the image intensifier tube in relatively dark conditions over a long period of time. The example in Figure 8 was caused by the lens cap string installed and the NVIS powered for over 24 hours. The example in Figure 9 was caused by a camera flash.
